ASSEMBLY

The Assembly Process

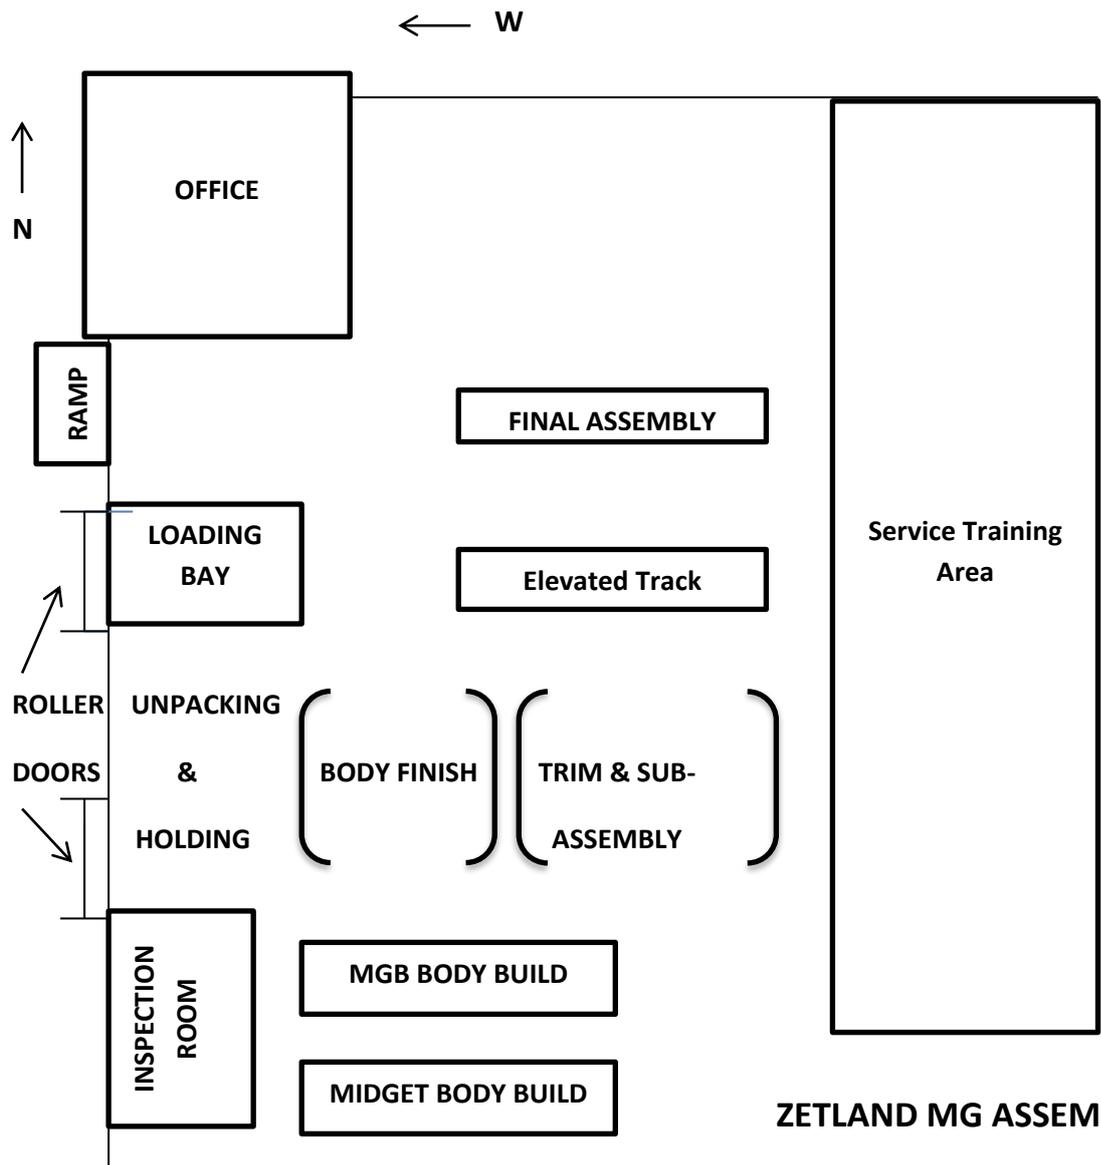
ZETLAND MG ASSEMBLY
 (mudmap by J. Lindsay)

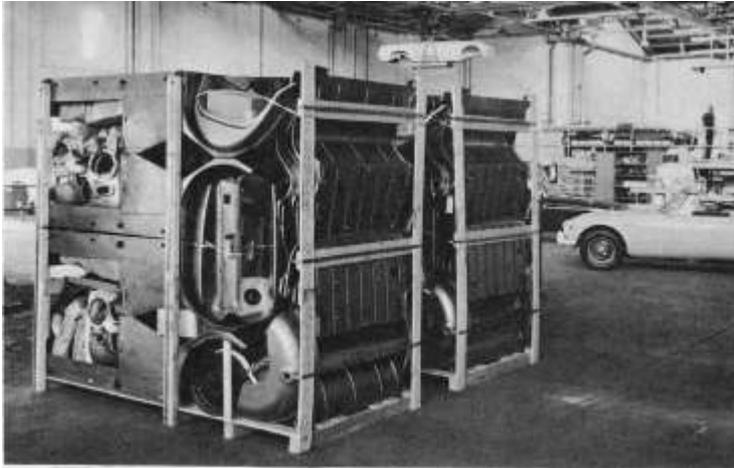
Figure 3 Crates (midget) (photo: K. Robbins)

CKD crates arrive in Australia. CKD components were shipped in what was called a 'pack',

usually the components for six vehicles. Components were in three separate crates; one with engines, one with mechanical parts, and one with the body and sheet metal components. Engine, gearbox and overdrive were pre-assembled; some parts (outer skin to door frame, underframe rear end assembly, main floor panel and gearbox cover assembly) were already welded.

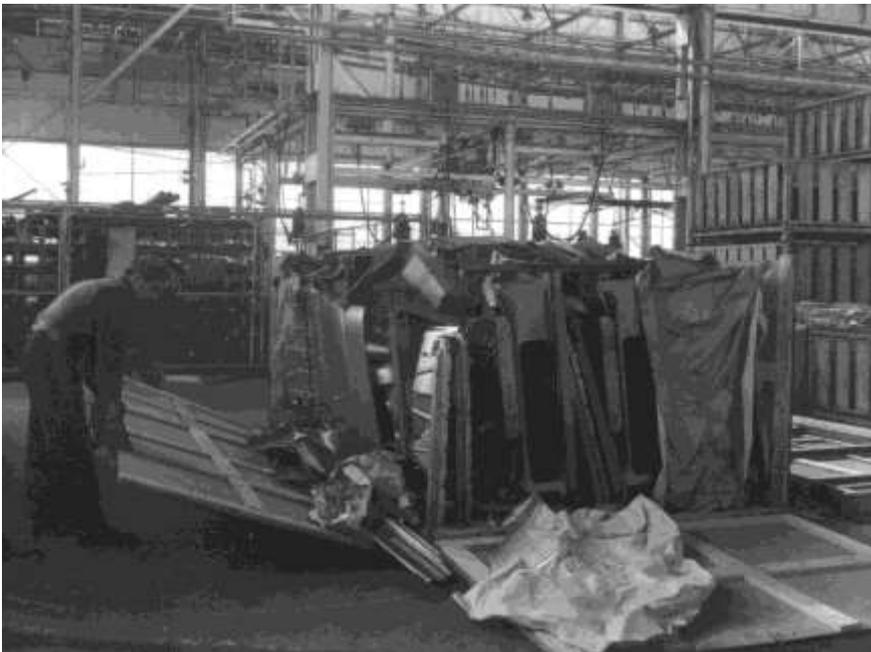
Figure 4 Unboxing (photo: K.Robbins)

There was a special area of the plant known as the 'CKD unboxing area' where the boxes were received and opened and checked for shipping damage and shortages.

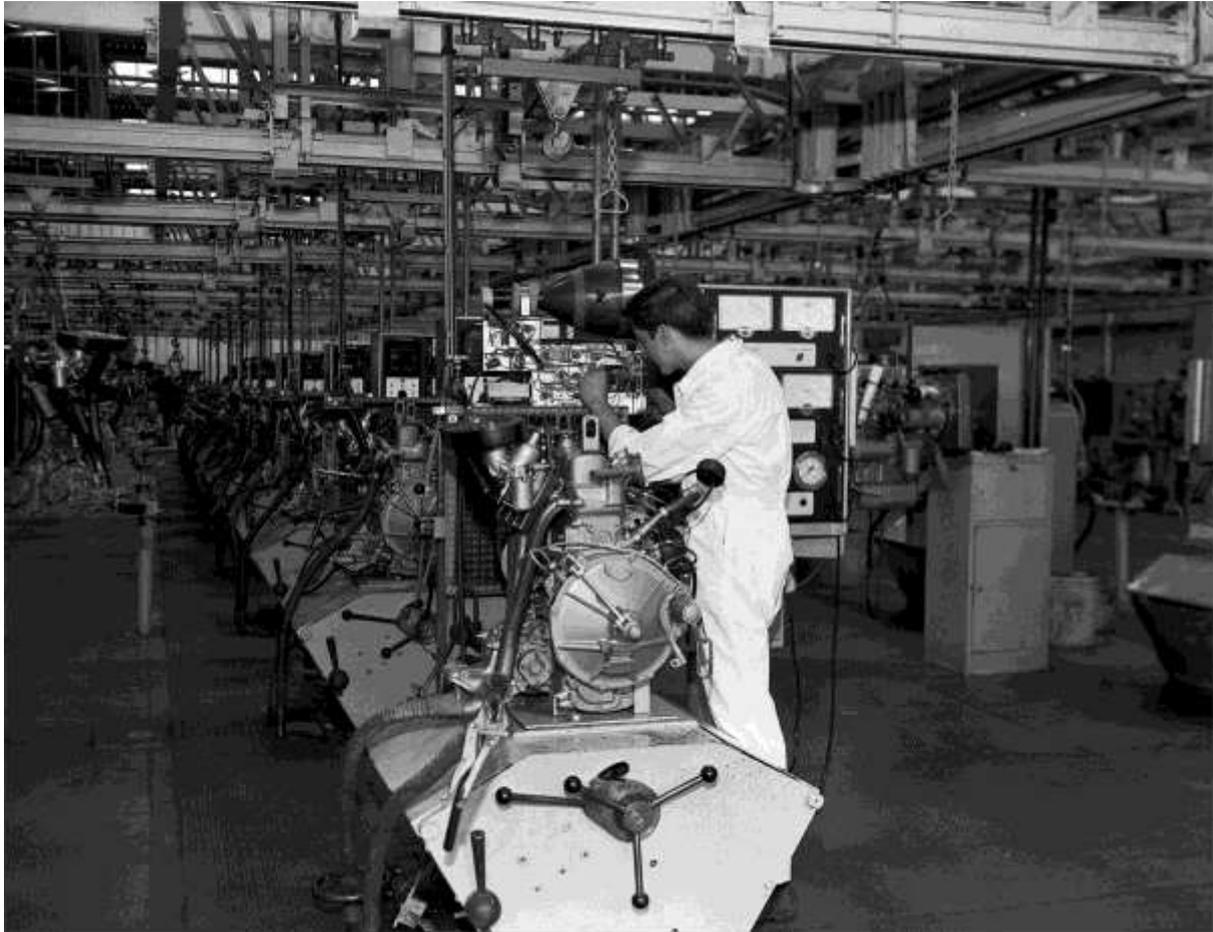
Figure 5 Hot Run Area (photo: BMCLHG)

Next, engines were sent to the 'Hot-Run department', where they were placed on test beds and run for approx. ½ hour, whilst 29 separate tests were carried out, before transfer to 'CAB3' (Car Assembly Building 3).

NB: Due to economic reasons, the hot-run testing on the Mk II was discontinued from YGHN5/1015, reverting back to dealer organizations providing pre-delivery checks that were in existence previously

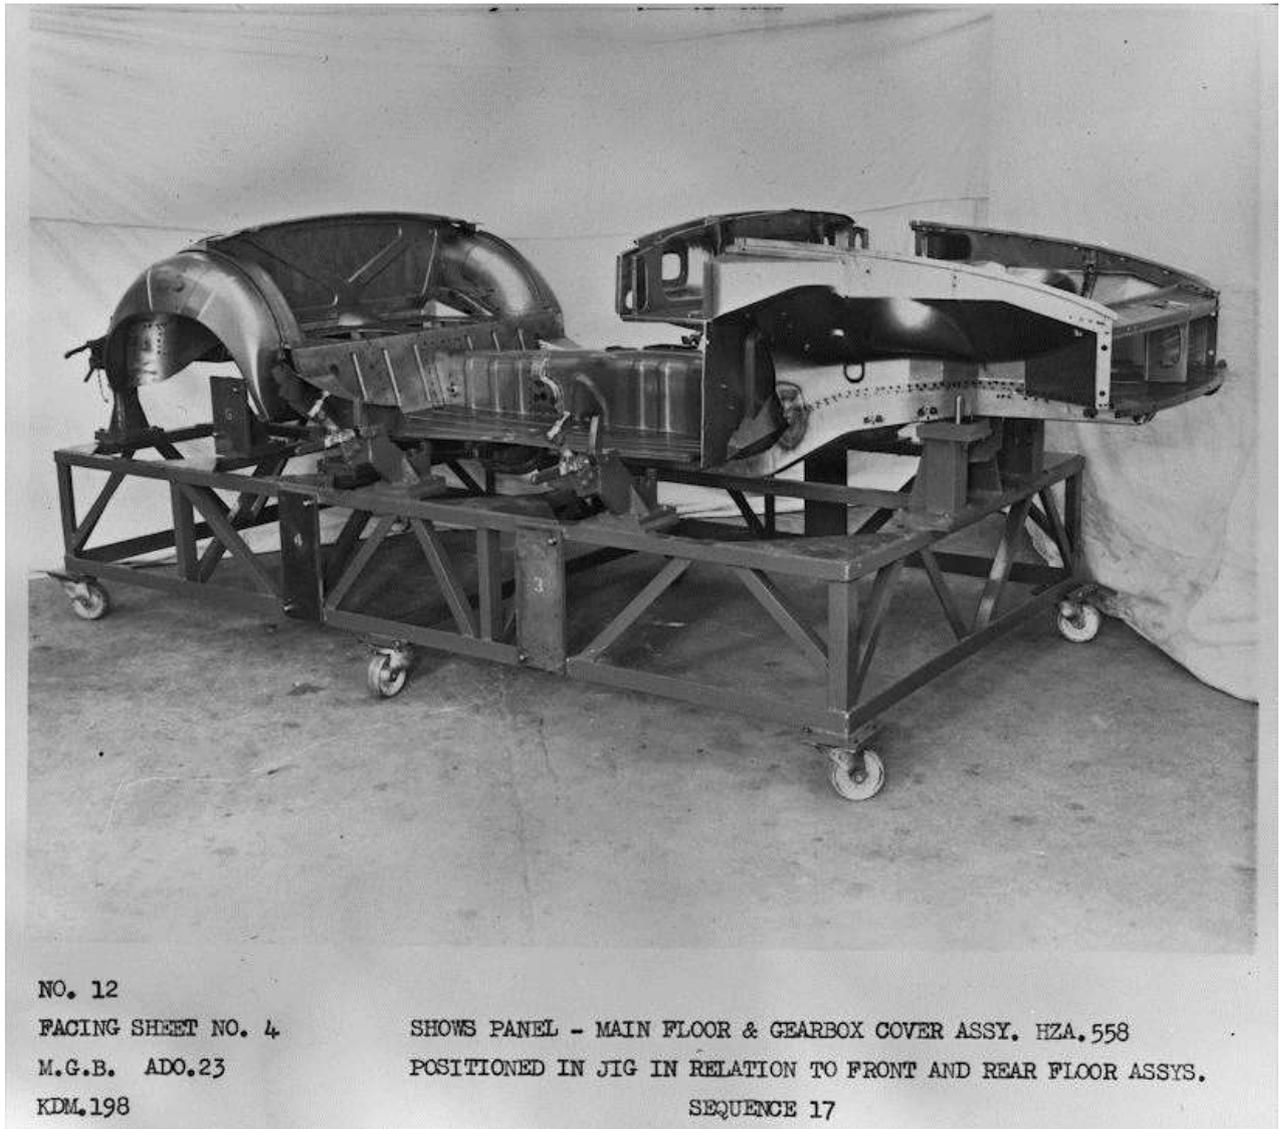
Figure 6 Body jig (photo: J Lindsay)

Panels were assembled on jigs (spot-welded) to form the chassis in the body shop in 'CAB3'. Rear guards, rocker panels, cowl and upper back panel, together with front and rear aprons were welded in place. Front guards were then bolted on, then the doors were hung.

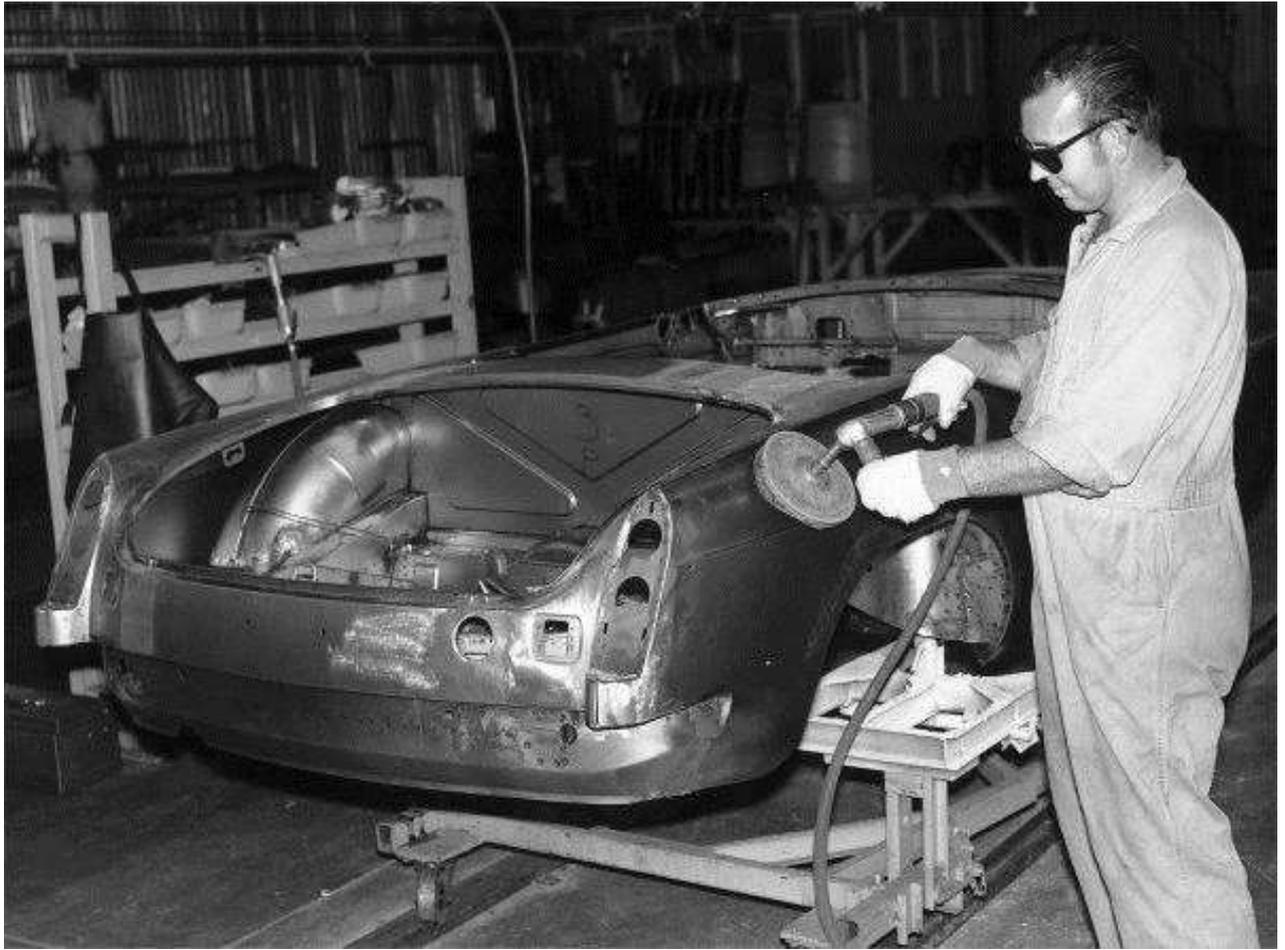
Figure 7 Body Preparation (photo: BMCLHG)

In the 'metal finishing bay', any imperfections to the outer body were rectified. Lead-loading of some seams was carried out then final metal finishing.

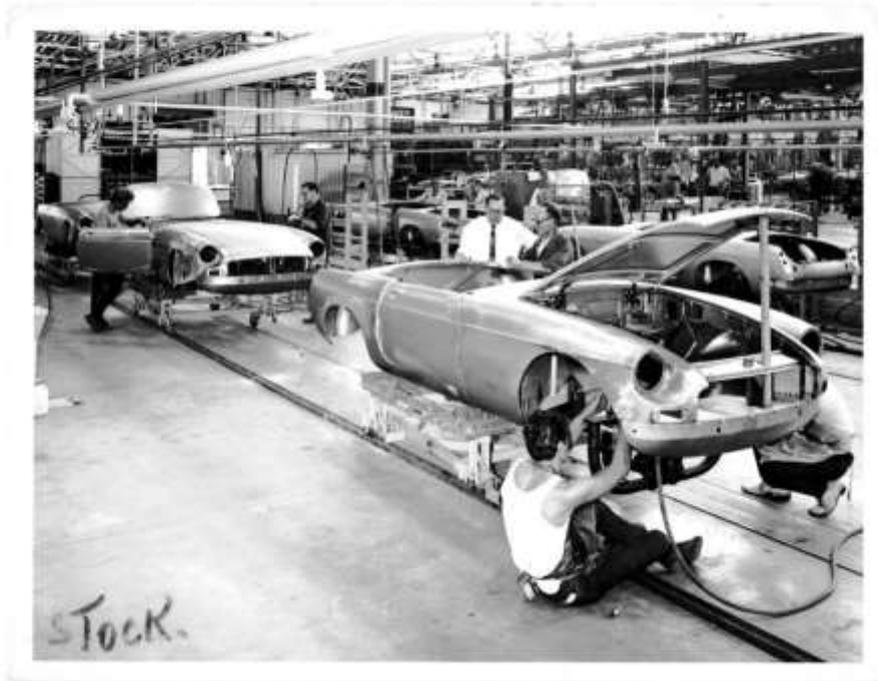
Figure 8 Body preparation (photo: BMCLHG)

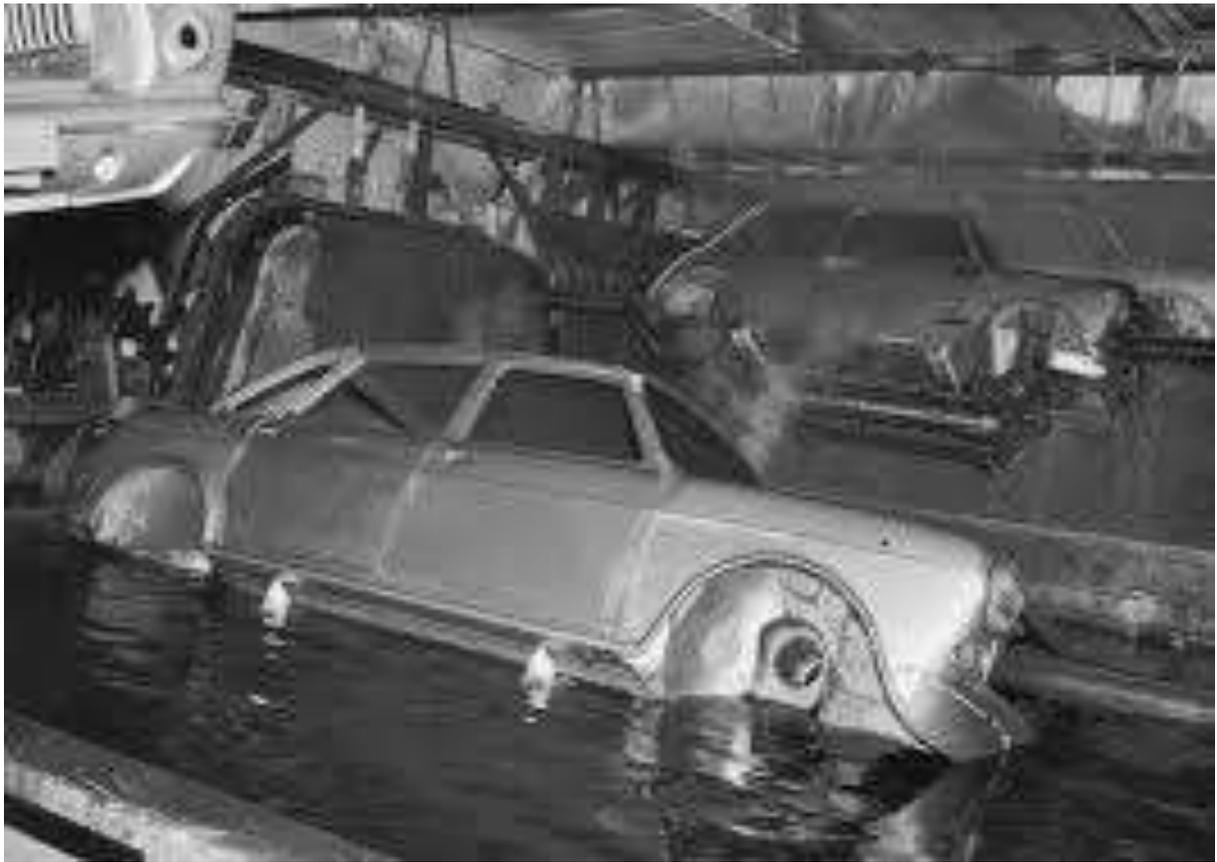
Figure 9 Rotodip (photo: BMLHG)

From the 'body shop', it was then trolled (on special wheeled frames ['Skuks'], being towed by a small industrial tractor called a 'Towmotor') over to the 'Paint shop', where it would pass through the 'Rotodip' system (to be thoroughly and entirely coated with rust-resistant paint).

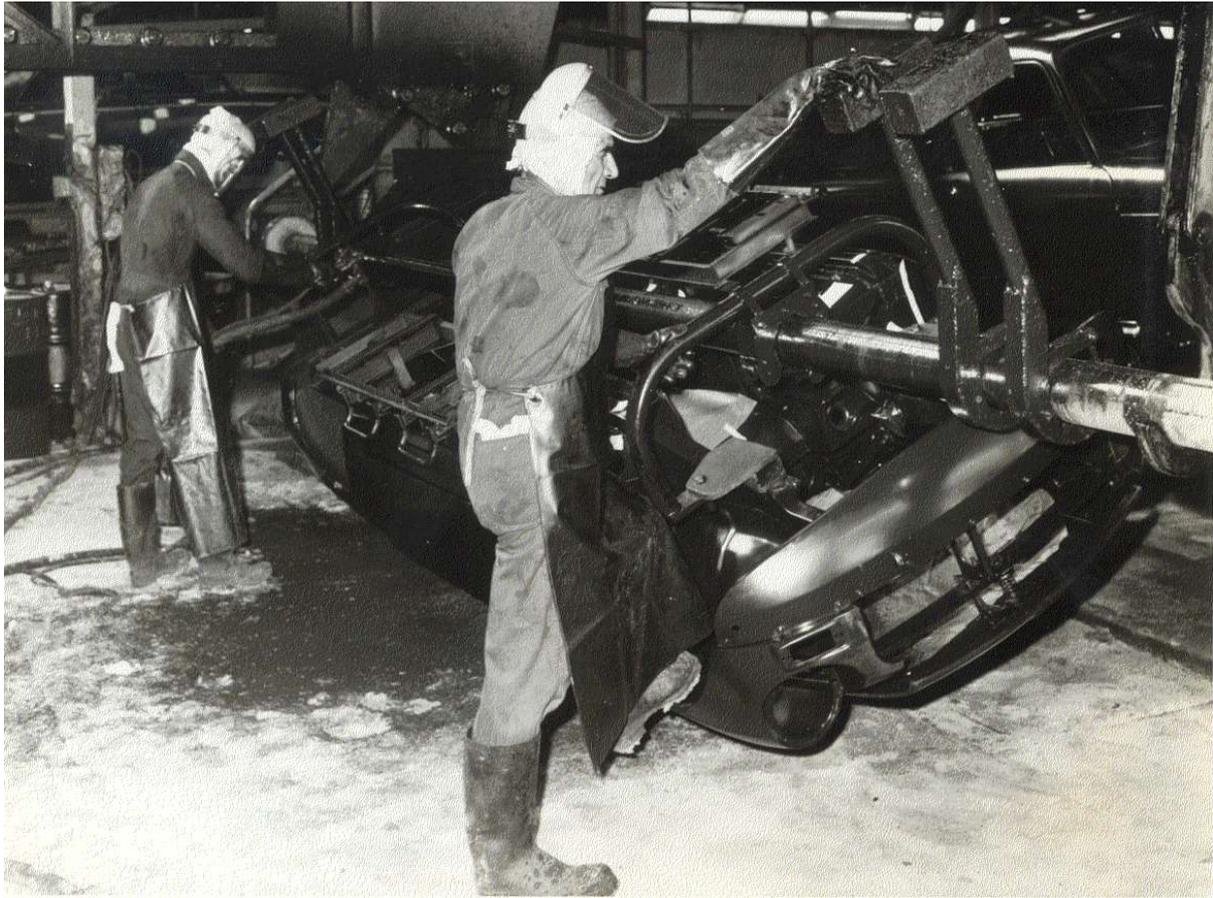
Figure 10 Proof-coating (photo: J. Lindsay)

After emerging from the rust-proofing process, the chocolate brown body was under-proofed with sound-deadening paint, giving further corrosion protection. The body would now go to the main part of the paint shop, where it was primed and coloured.

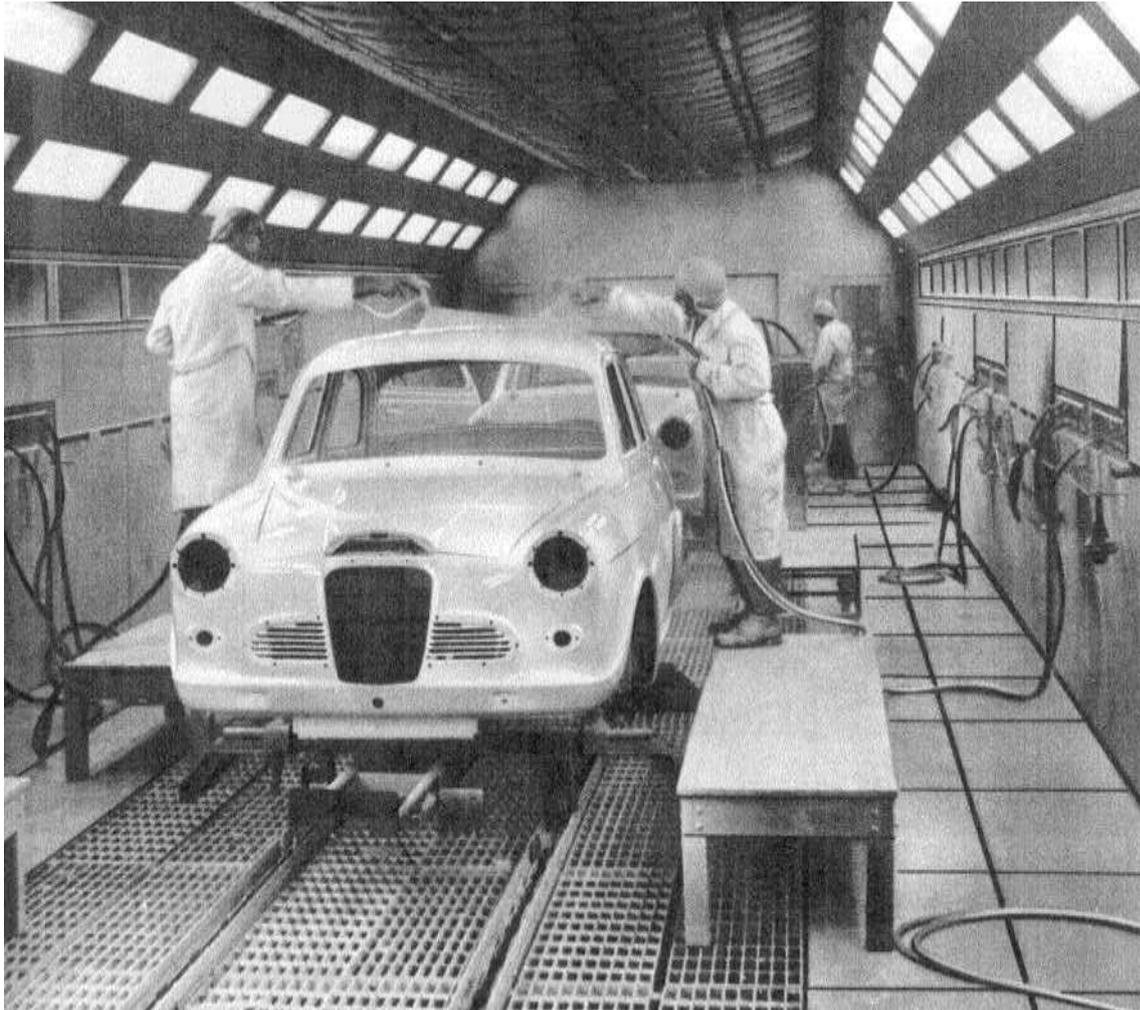
Figure 11 Paint booth (photo: BMCLHG)

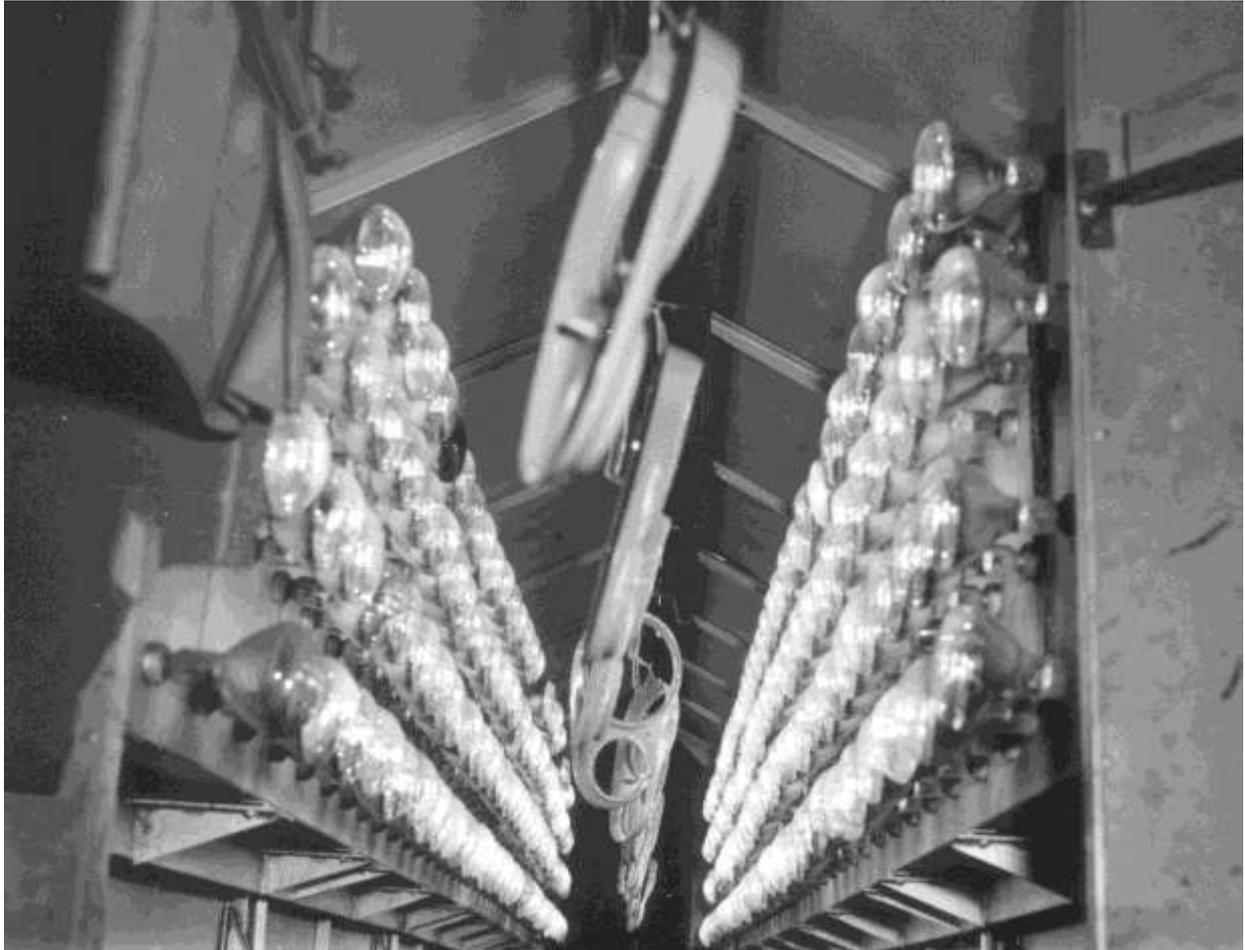
Figure 14 Small Parts Paint Shop-CAB1 (photo: BMCLHG)

Road wheels were sent to the Small Parts Paint Shop in 'CAB1' to be painted,

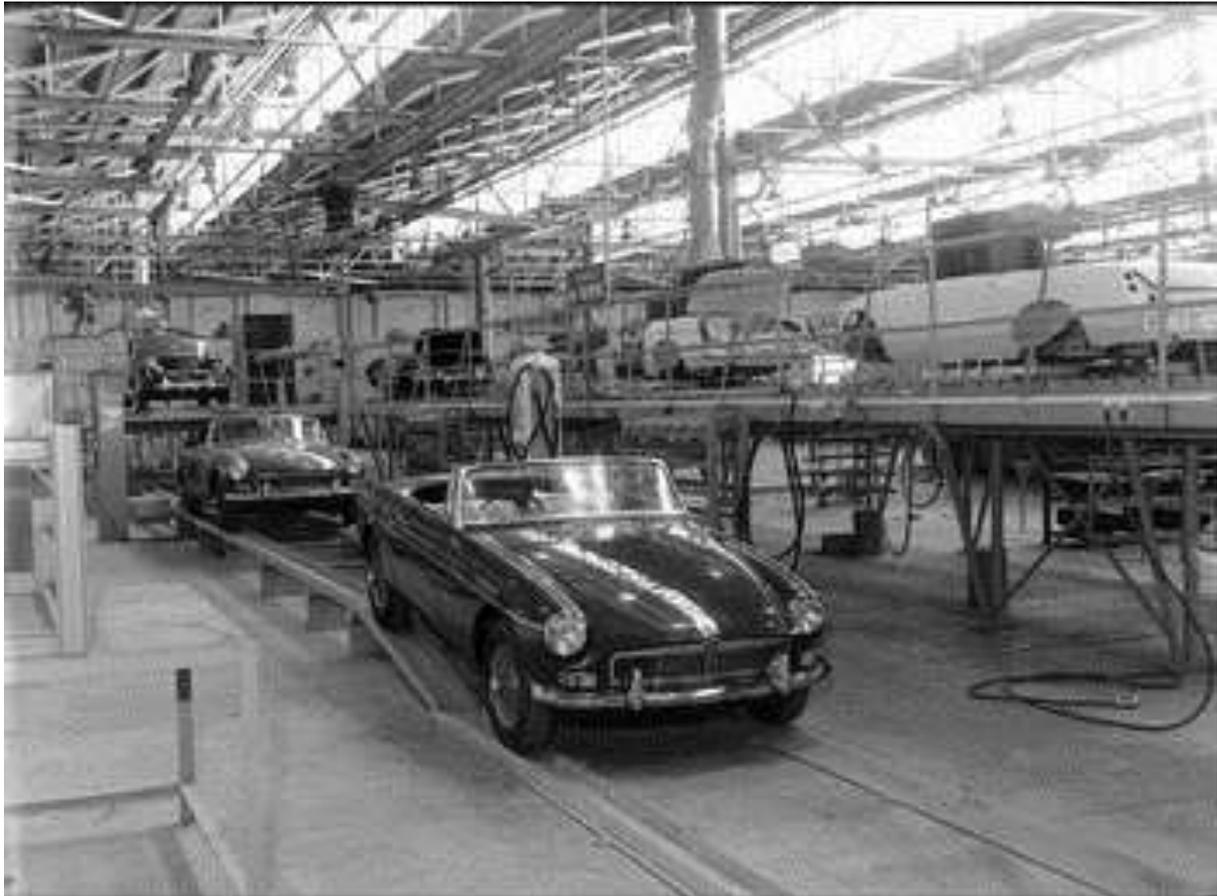
Figure 16 Assembly nearly complete (photo: J. Lindsay)

2nd Leg: shell receives its engine and transmission, along with the rest of the running gear. By the end of this leg, headlights have been aligned, suspension geometry adjusted, seats and bonnet added, and the engine started. It is now driven to the 3rd leg.
