ASSEMBLY

The Assembly Process

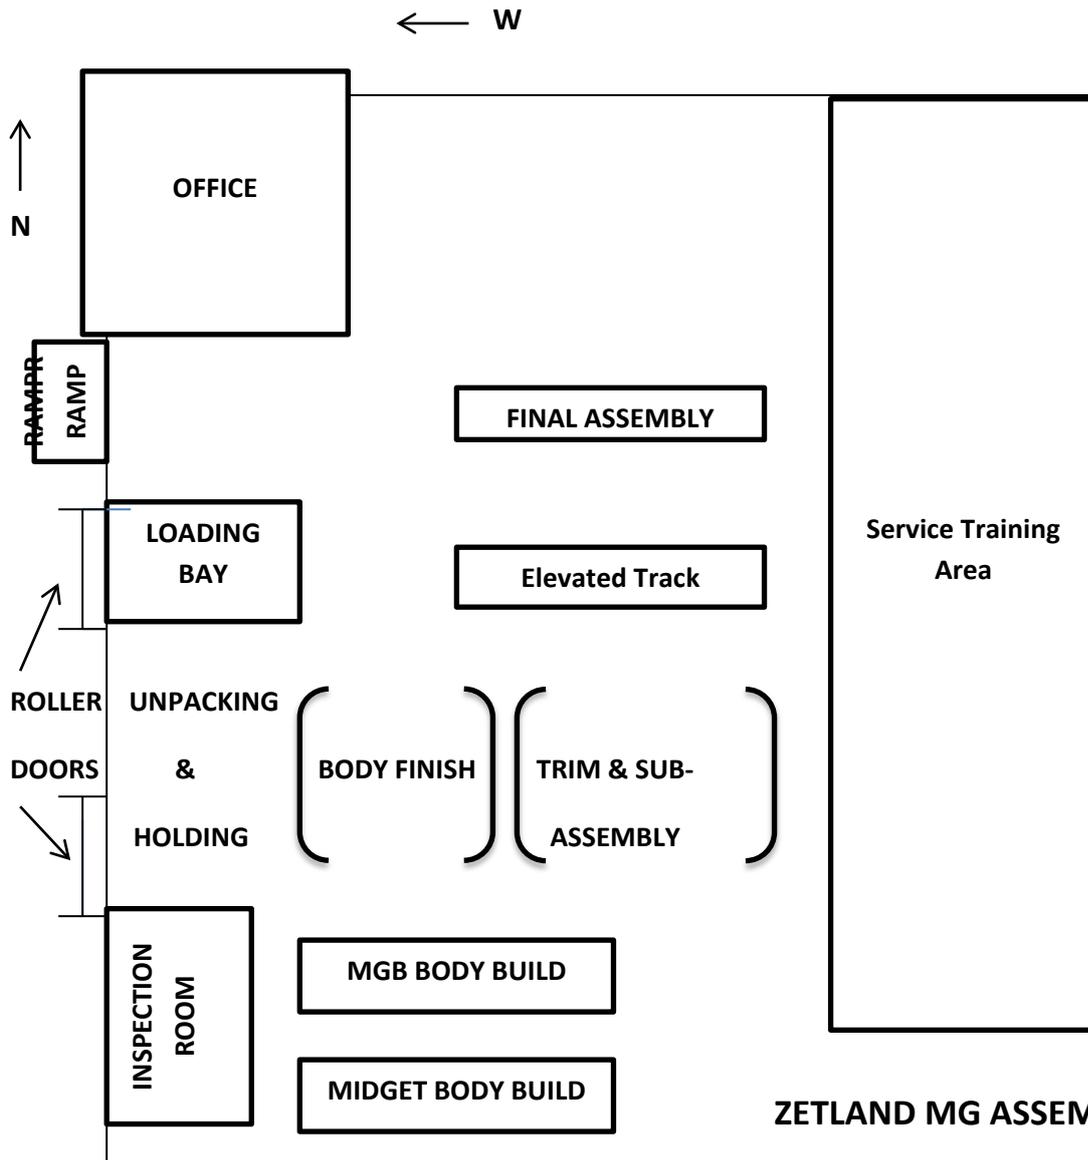
ZETLAND MG ASSEMBLY

(mudmap by J. Lindsay)

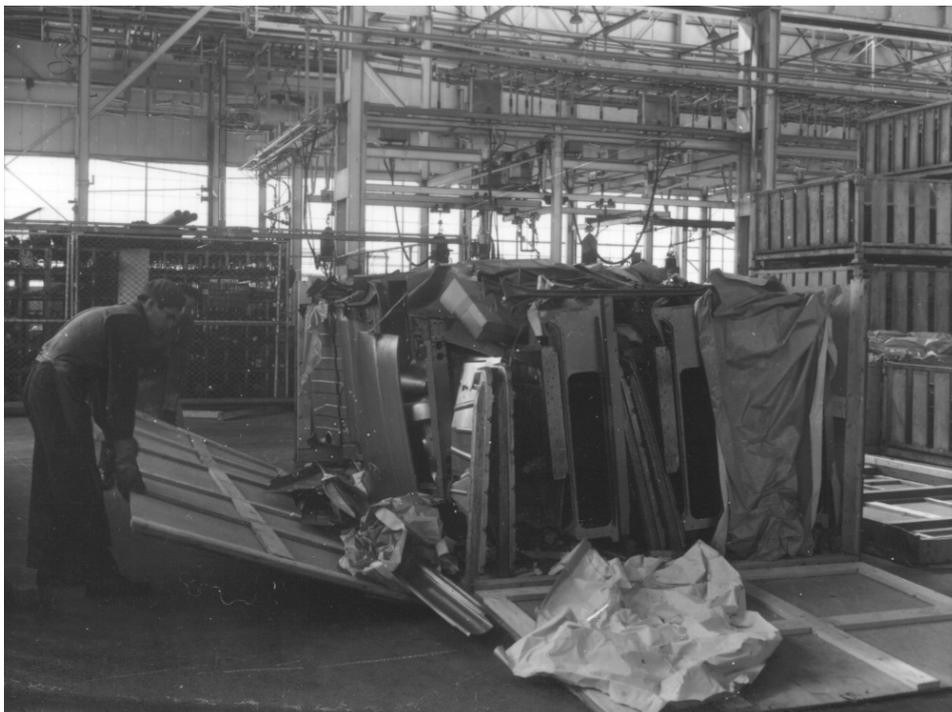
Figure 4 Unboxing (photo: K.Robbins)

There was a special area of the plant known as the 'CKD unboxing area' where the boxes were received and opened and checked for shipping damage and shortages.

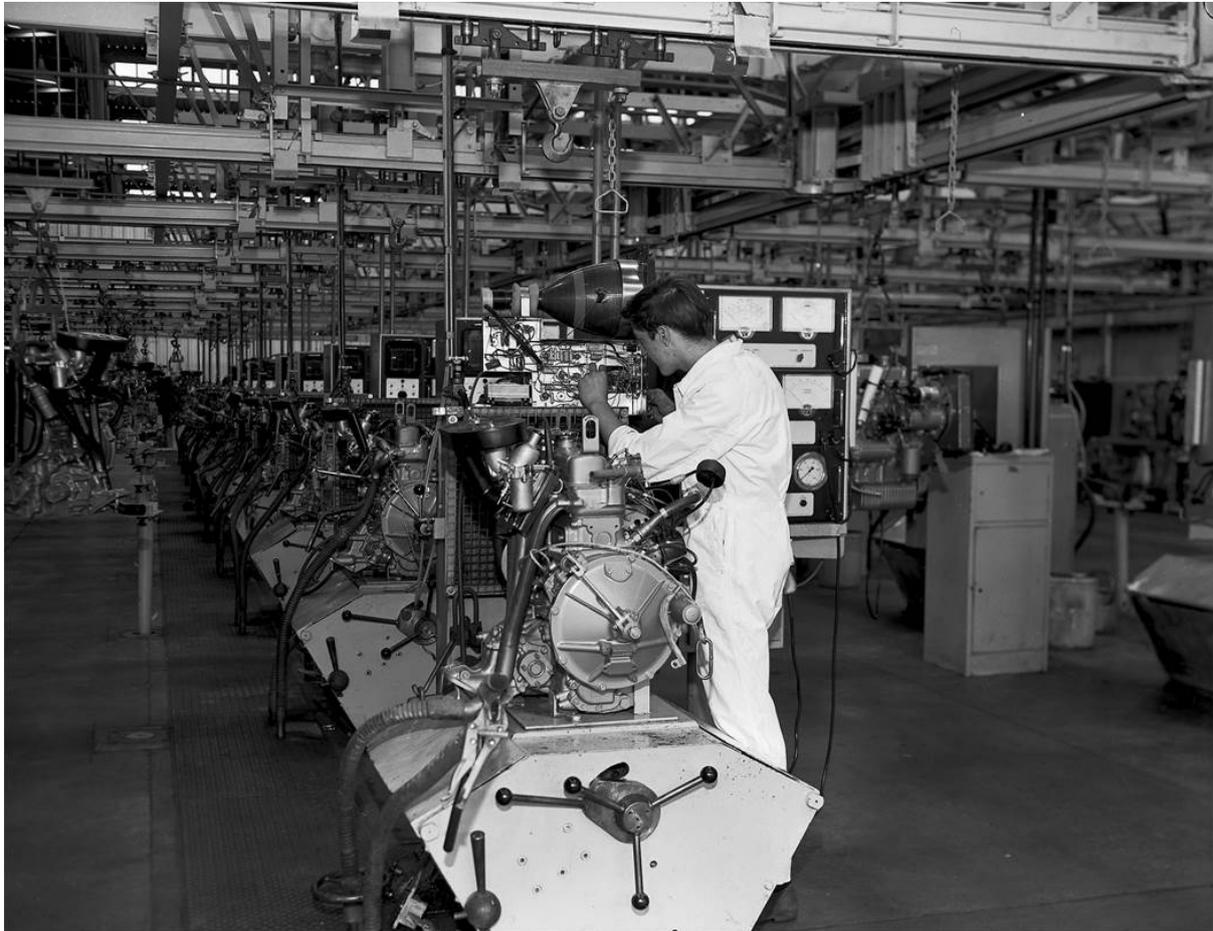
Figure 5 Hot Run Area (photo: BMCLHG)

Next, engines were sent to the 'Hot-Run department', where they were placed on test beds and run for approx. ½ hour, whilst 29 separate tests were carried out, before transfer to 'CAB3' (Car Assembly Building 3).

NB: Due to economic reasons, the hot-run testing on the Mk II was discontinued from YGHN5/1015, reverting back to dealer organizations providing pre-delivery checks that were in existence previously

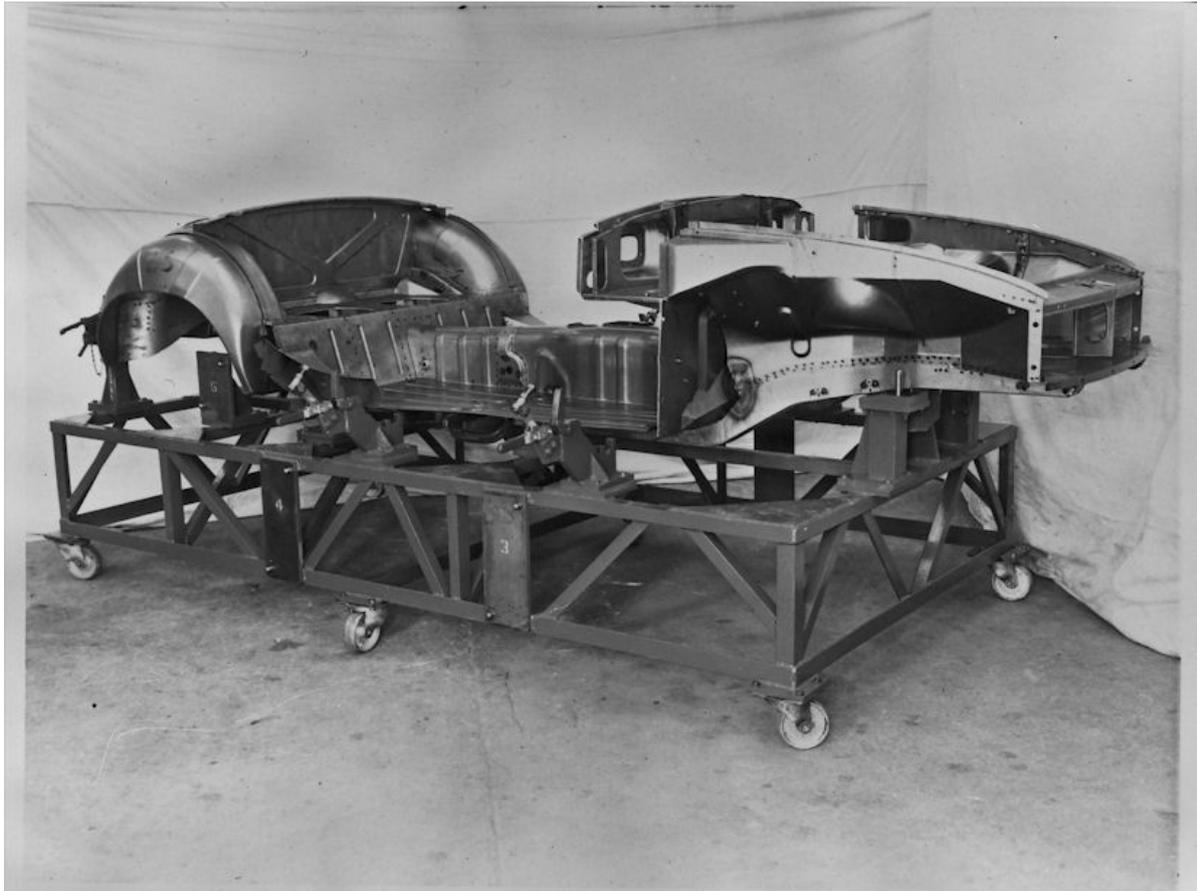
NO. 12
 FACING SHEET NO. 4
 M.G.B. ADO.23
 KDM.198

SHOWS PANEL - MAIN FLOOR & GEARBOX COVER ASSY. HZA.558
 POSITIONED IN JIG IN RELATION TO FRONT AND REAR FLOOR ASSYS.
 SEQUENCE 17

Figure 6 Body jig (photo: J Lindsay)

Panels were assembled on jigs (spot-welded) to form the chassis in the body shop in 'CAB3'. Rear guards, rocker panels, cowl and upper back panel, together with front and rear aprons were welded in place. Front guards were then bolted on, then the doors were hung.

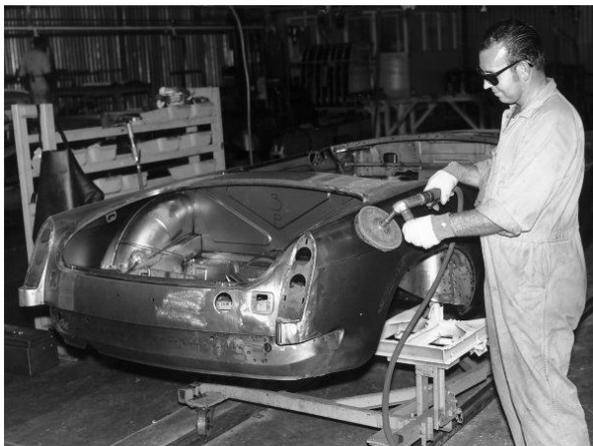
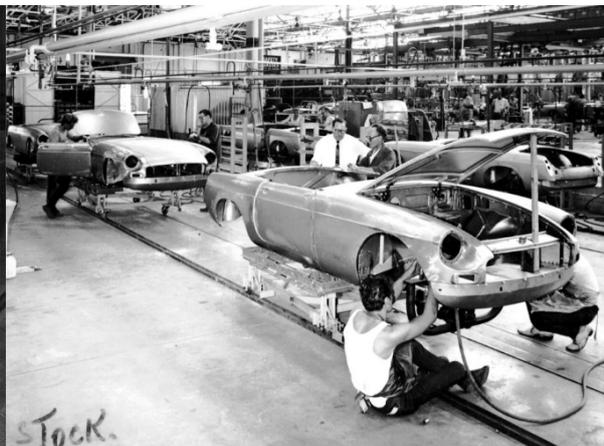
Figure 7 Body Preparation (photo: BMCLHG)

Figure 8 Body preparation (photo: BMCLHG)

In the 'metal finishing bay', any imperfections to the outer body were rectified. Lead-loading of some seams was carried out then final metal finishing.

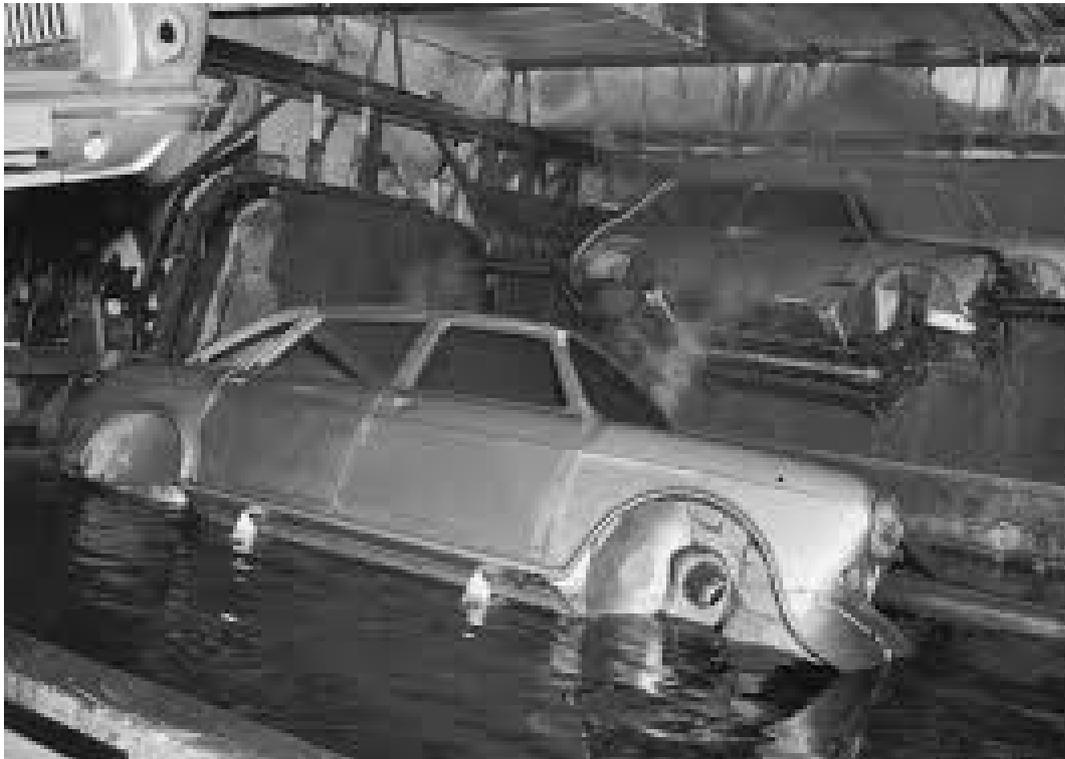
Figure 9 Rotodip (photo: BMLHG)

From the 'body shop', it was then trolled (on special wheeled frames ['Skuks'], being towed by a small industrial tractor called a 'Towmotor') over to the 'Paint shop', where it would pass through the 'Rotodip' system (to be thoroughly and entirely coated with rust-resistant paint).

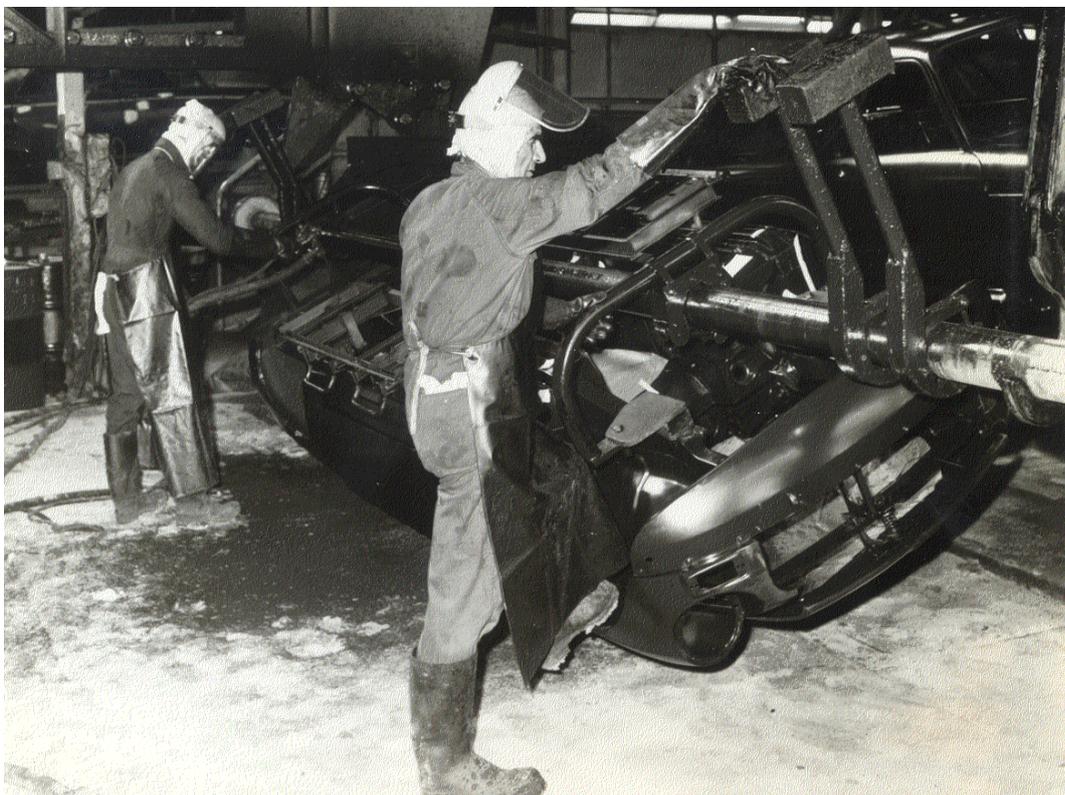
Figure 10 Proof-coating (photo: J. Lindsay)

After emerging from the rust-proofing process, the chocolate brown body was under-proofed with sound-deadening paint, giving further corrosion protection. The body would now go to the main part of the paint shop, where it was primed and coloured.

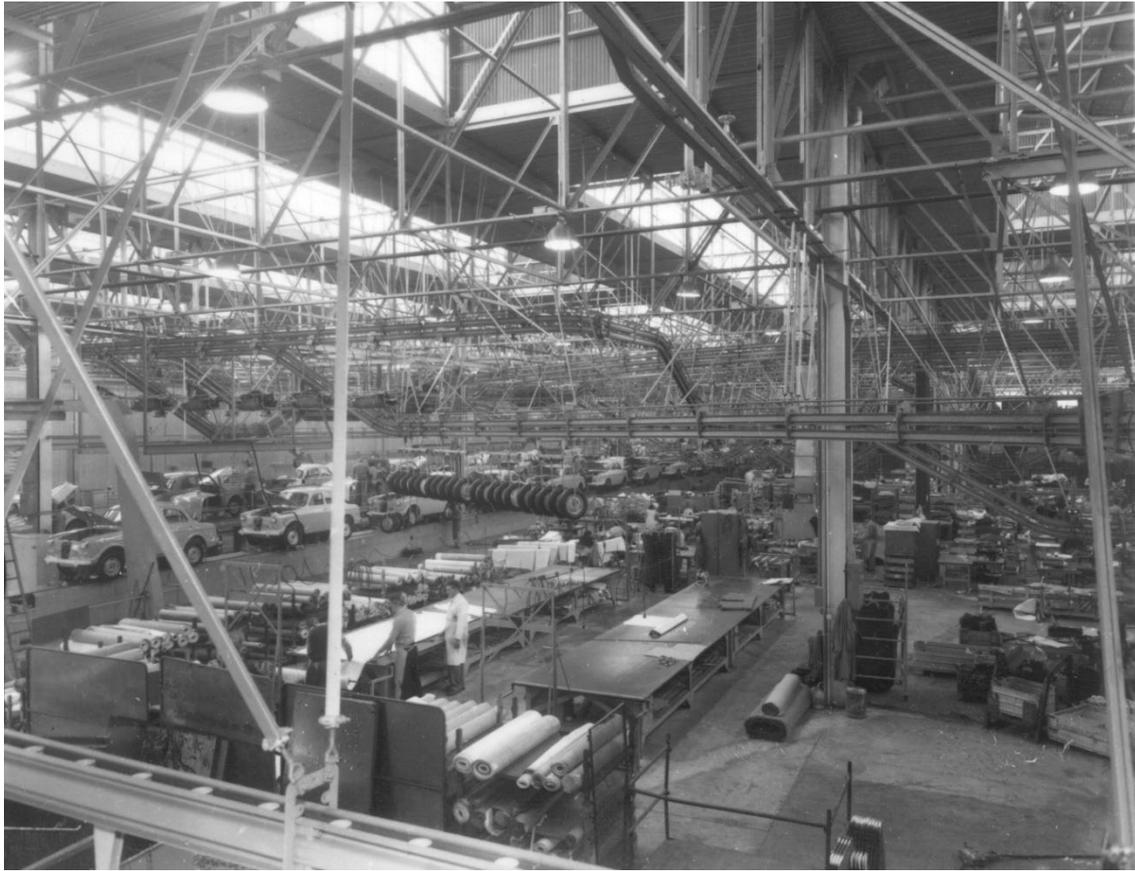
Figure 12 Trim Shop (photo: BMCLHG)

The interior trim was being manufactured in 'CAB1'.

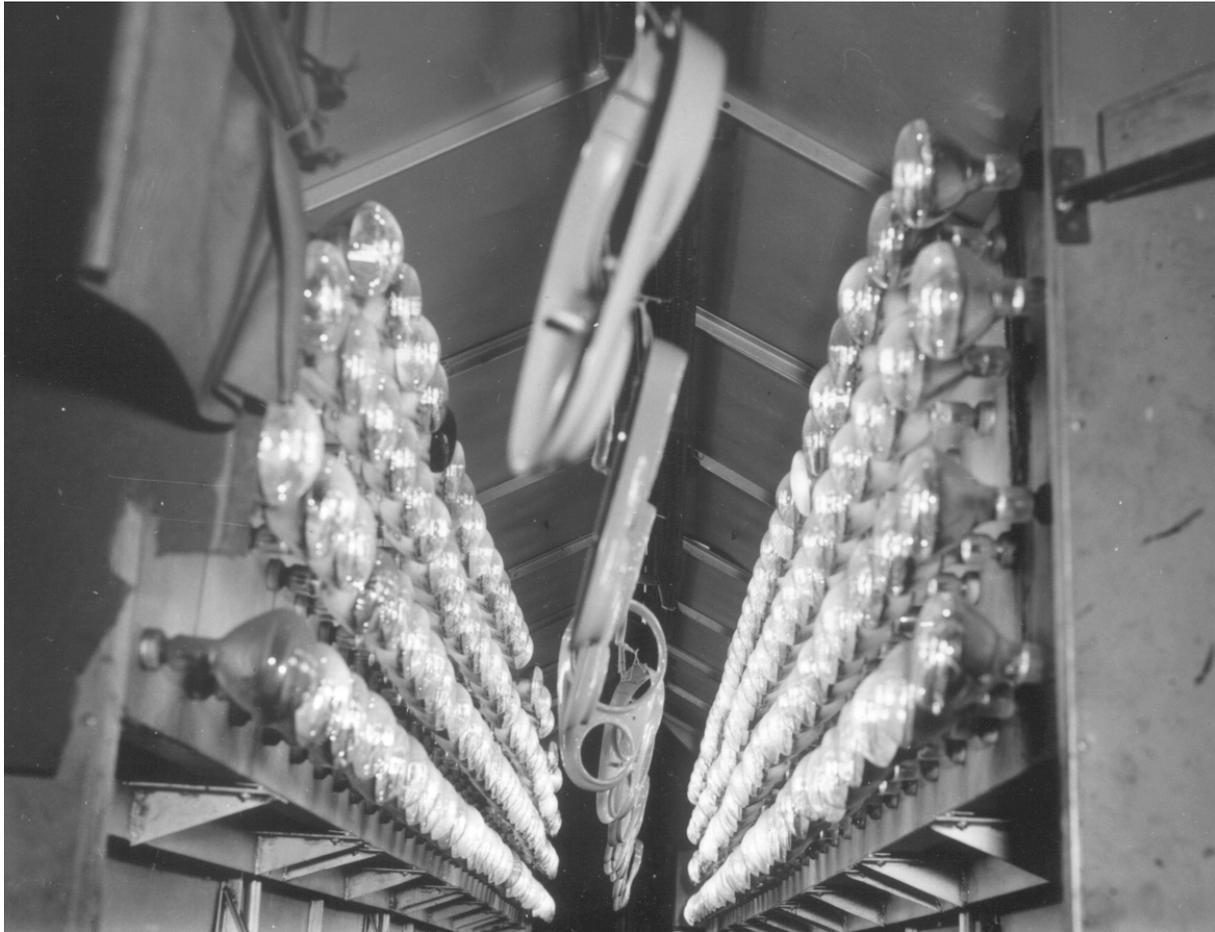
Figure 14 Small Parts Paint Shop-CAB1 (photo: BMCLHG)

Road wheels were sent to the Small Parts Paint Shop in 'CAB1' to be painted, then sent to the tyre fitting area in 'CAB1' where tyres and tubes were fitted.

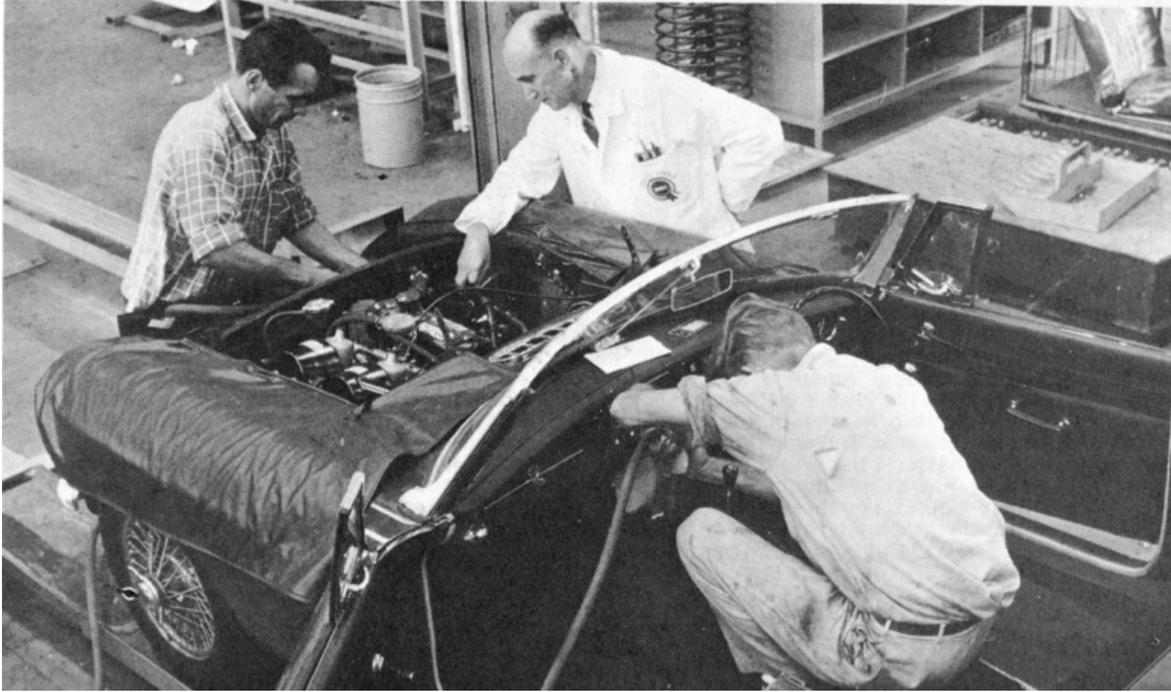
Figure 15 "Just checkin'" (photo: J Lindsay)

1st Leg: most of the minor items were fitted (head and tail lights, dash panel and wiring loom, hydraulics and windows. On the first leg, as well as the parts strategically positioned along the leg, the vehicle is accompanied by a 3 tier, multi-binned arrangement, containing additional required components.

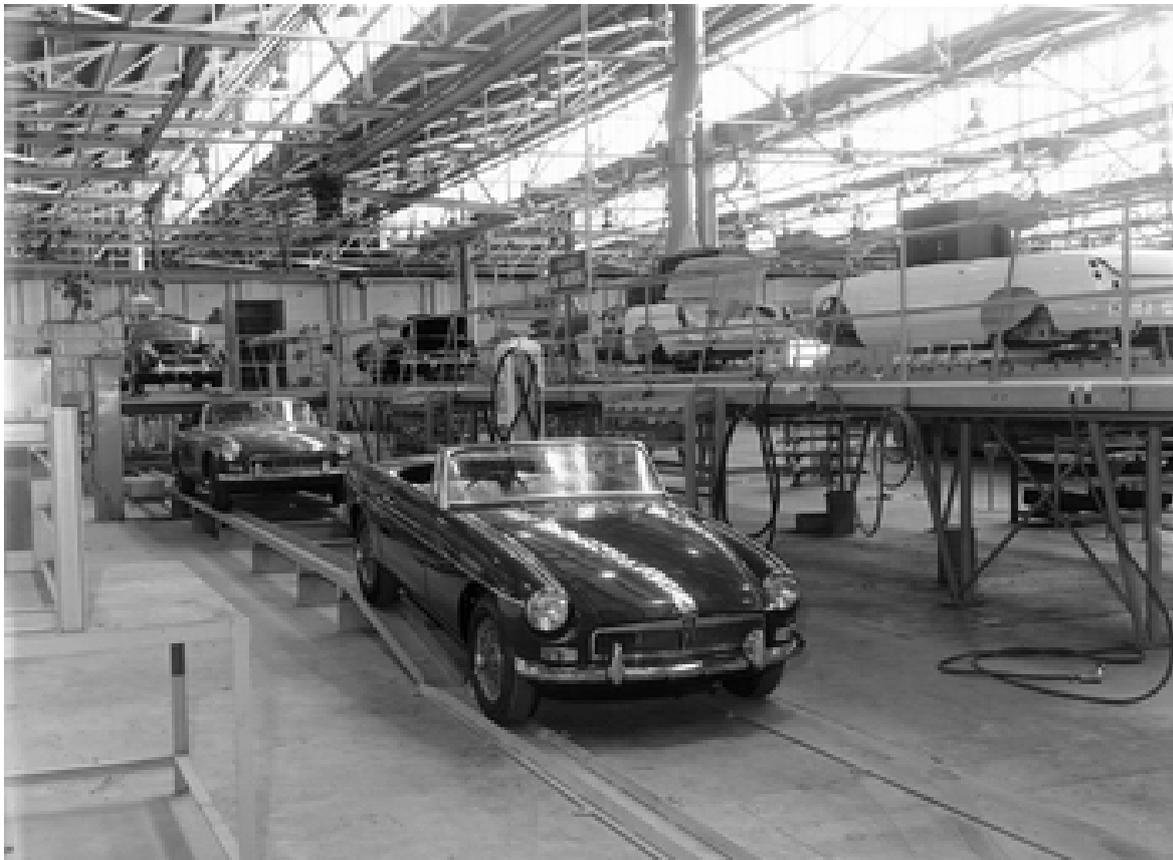
Figure 16 Assembly nearly complete (photo: J. Lindsay)

2nd Leg: shell receives its engine and transmission, along with the rest of the running gear. By the end of this leg, headlights have been aligned, suspension geometry adjusted, seats and bonnet added, and the engine started. It is now driven to the 3rd leg.
