HOODS

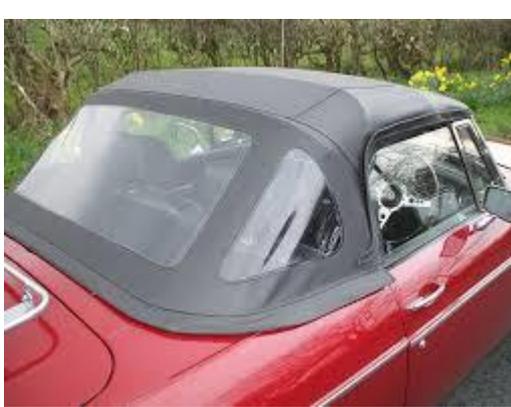
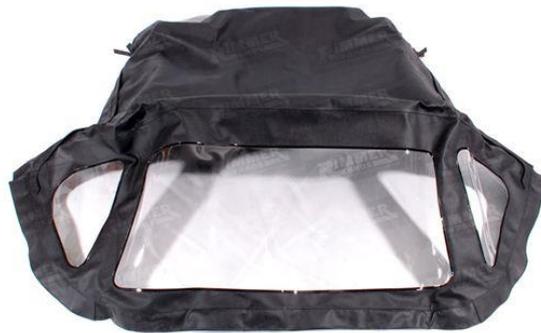
Hood unassembled

From 1963 to 1970, all Australian-assembled MGBs were sold with a locally produced ‘pack-away’ hood. There was the hood, which was a PVC material, the frame, which came in two separate pieces to be joined and the two bags to carry each part when not in use.

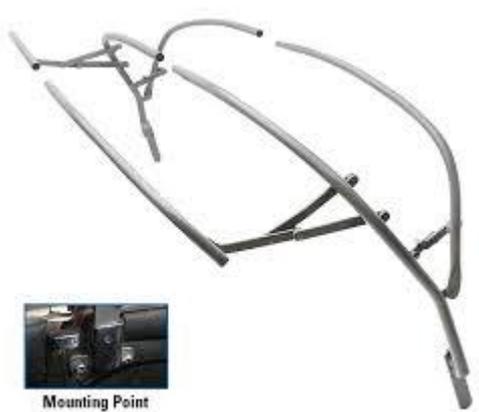
Mounting Point

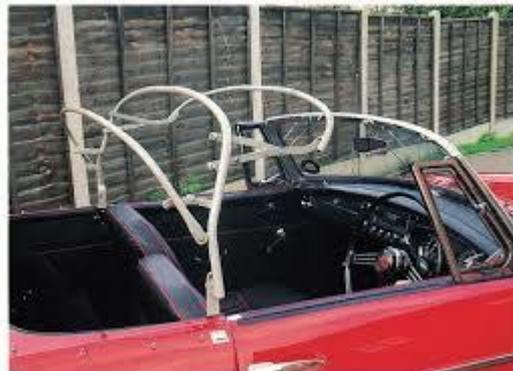
The two separate components (which interlock) Hood frame assembled

The MGB hood was considered to be a fairly efficient design, with little ingress of water or wind. However, there was always concern about the seams. In 1966, after laboratory testing, instructions were given as to how to treat the hoods with 3M Bitrile sealer (complete instructions found in ‘Good Stuff’). In 1968, a more serious attempt at rectifying the problems was carried out at Zetland, from YGHN4/669 onwards. Seams were double-stitched; needle size reduced from 22 to 20; redesign of hood at A post for appearance and water sealing; redesign of flap attachment at B post area to overcome draught issues and a jig made to improve fitment.

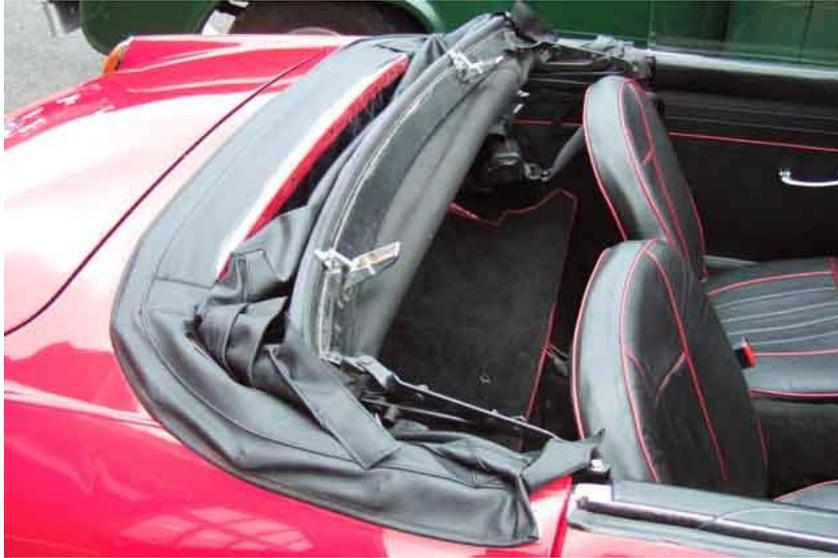
Finally, it seemed that the previous issues with sealing were resolved. From cars YHN9/1063 and YHN10/537, a new foldaway hood with welded seams was introduced.

Michelotti fold-away hood (this one has zip-out rear window)

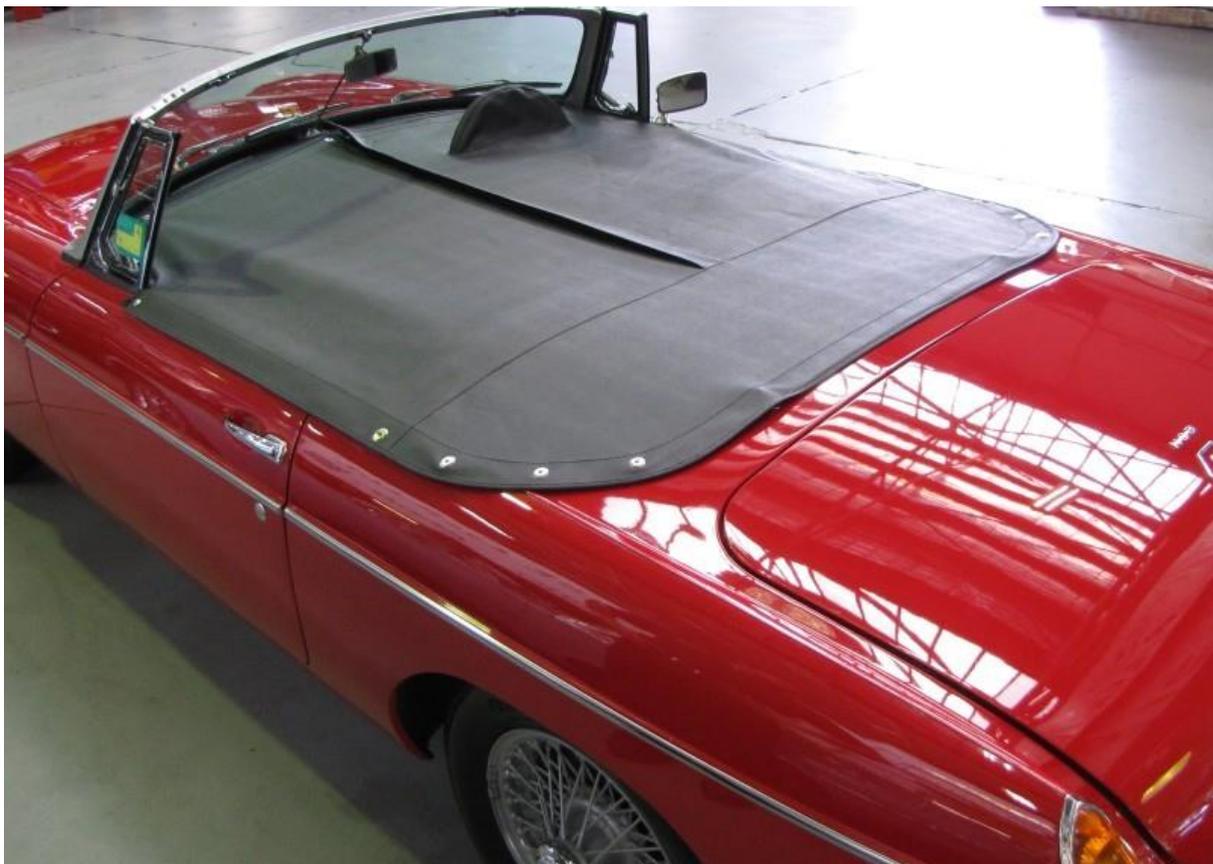
Optional Tonneau cover

Always an optional extra in Australia, the tonneau cover came in a variety of sizes and patterns. At the time (and I guess today also) many auto trim firms would make them.
