INTERIOR

Many subtle (and not so subtle) changes were made to the interior of the MGB over the 10 years of Australian assembly. These largely followed those in the UK, albeit with varying dates of introduction. I have broken this topic into the following sections:

FASCIA PANEL

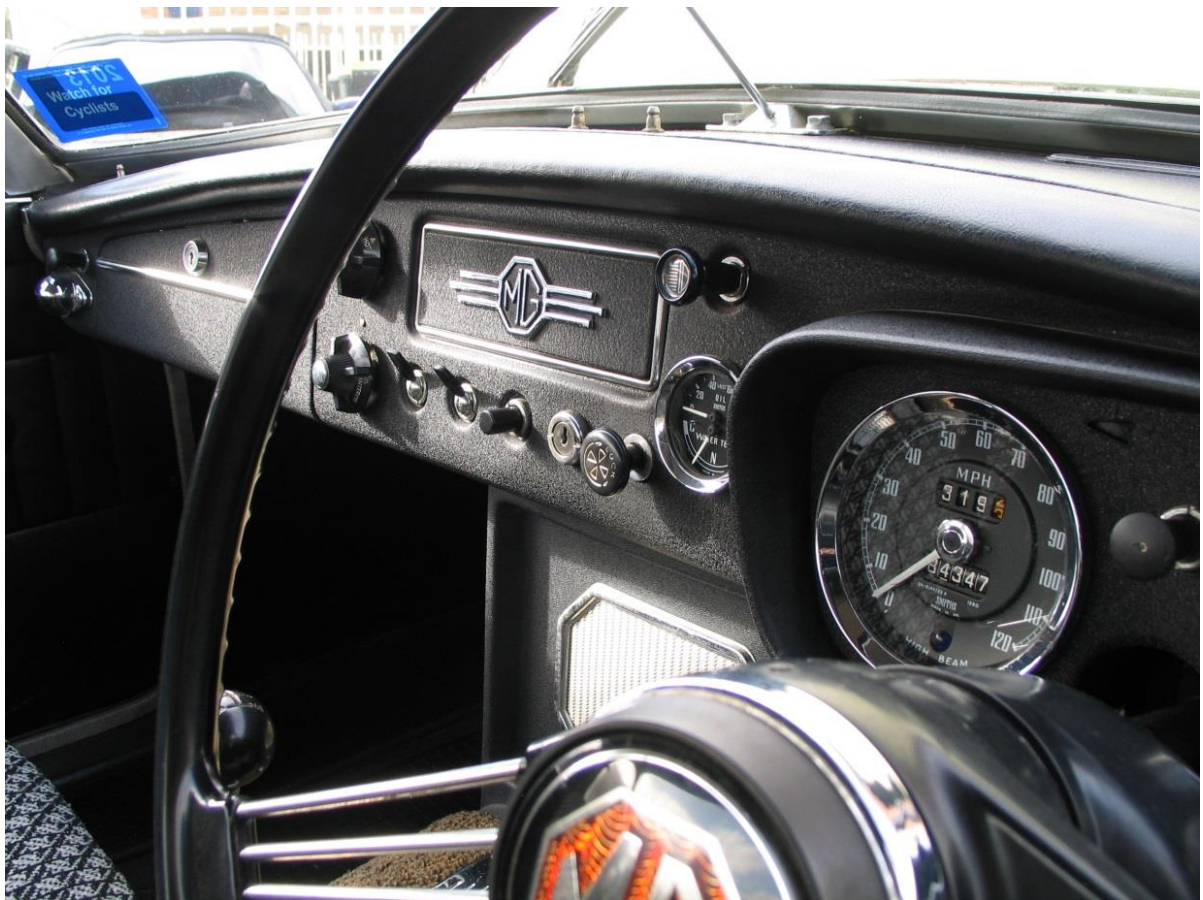
Starting with the fascia panel (with the standard black 'crackle' paint), the features (and changes) are detailed on the following page.

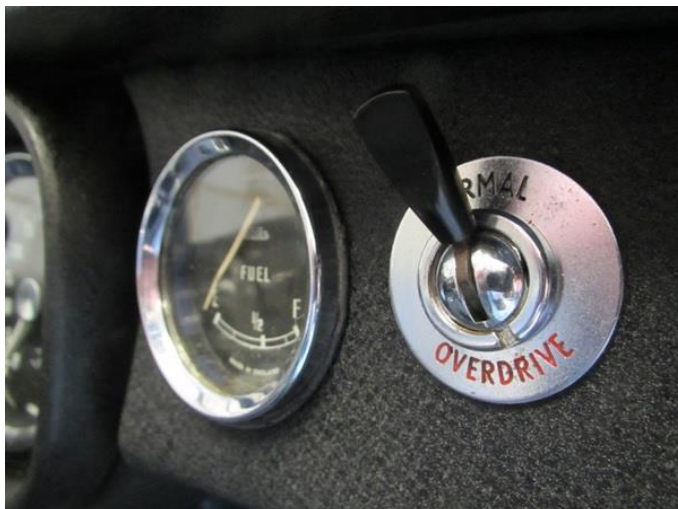
Overdrive switch and escutcheon (early type)
(NOT USED IN AUSTRALIA)

1. Overdrive switch: The overdrive switch was not present on the early Australian vehicles as overdrive was not offered until much later than in the UK. The location on the fascia panel was filled with a blanking plug instead. When overdrive was finally offered, a chrome, pressed escutcheon, bearing the words (pressed into the escutcheon) 'NORMAL' and 'OVERDRIVE', surrounded a black, plastic toggle switch. Initially it was a matching toggle switch to the others on the fascia panel, but soon changed (1965) to a 'hooked' style as shown below. As overdrive didn't arrive in Australia until 1968, there should be NO cases of the straight toggle switch being used. *T Aczel*

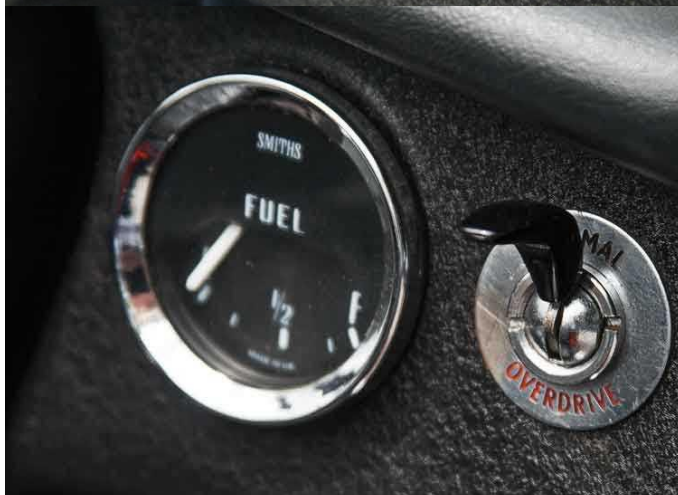
Later style 'hooked' overdrive switch . (ALL
Australian overdrive switches should be of
this type.)

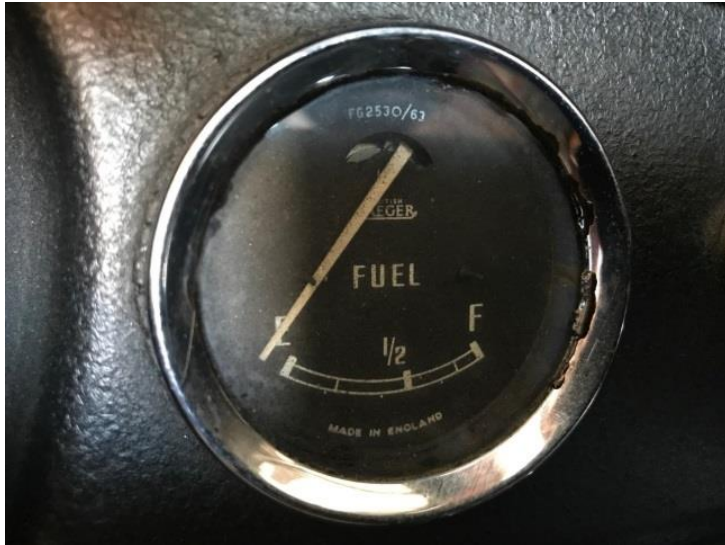
Jaeger fuel gauge (later to be Smiths)

2. Fuel Gauge: Smiths' gauge, with the markings 'E ½ F'. (initially this gauge was a 'Jaeger').

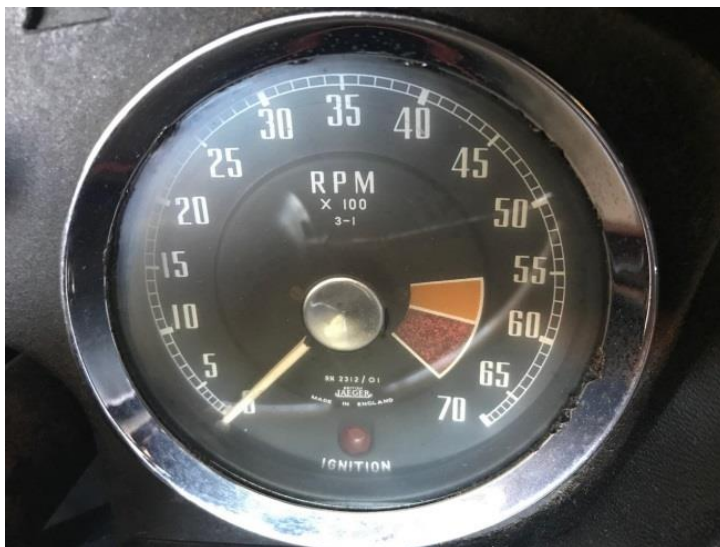
3. Tachometer:

The first tachometer was branded 'Jaeger' and was mechanical. This was changed around Feb. '65 to an electrical tachometer, now bearing the name 'Smiths'. This all coincided with the introduction of the **18GB** engine. In the bottom centre of this dial was a red ignition warning light.

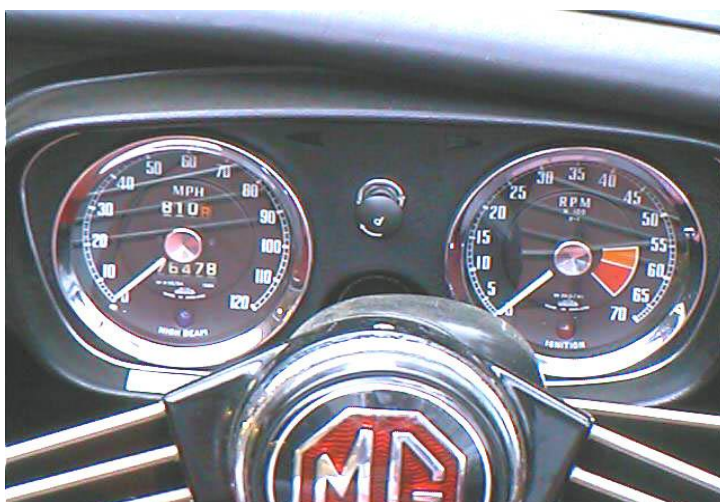
Mk 1 showing the rheostat switch. Note also the thin chrome strip around the inside of the instrument hood

4. Rheostat switch: Black plastic switch (with a white 'P' pressed into the face) for controlling instrumentation brightness.

5. Indicator warning lights: Triangular cut-outs with green plastic

background, situated above the rheostat.

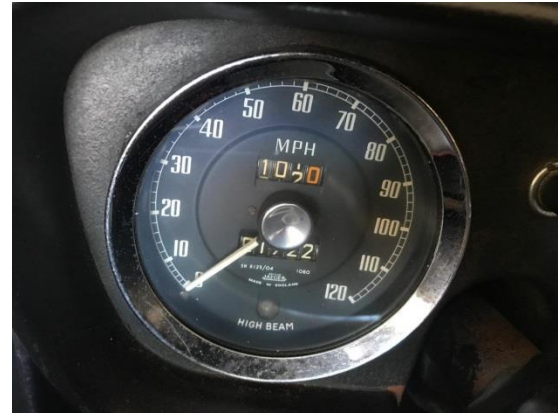
Jaeger speedometer (later to be Smiths)

6. Speedometer: Jaeger initially, changing to Smiths (as in **3.** above) with a trip meter and a mileage meter incorporated, with the reset device underneath (and protruding from) the fascia. A blue 'High Beam' indicator light was at the bottom of the speedo.

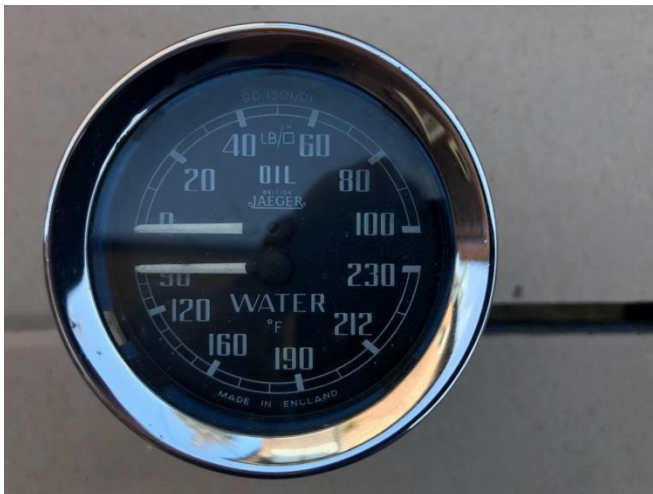
Jaeger oil & water gauge (note temp displayed in Fahrenheit)

7. Oil & Temperature gauge: This was a dual gauge; oil pressure on the top half and coolant temperature on the bottom half. The initial gauge read temperature in Fahrenheit. There are also examples of Centigrade gauges as well as those marked with the simple 'C-N-H' marking. Whilst the Parts manual shows gauges changing from F° to C° at YGHN3 3820, there is enough evidence to render

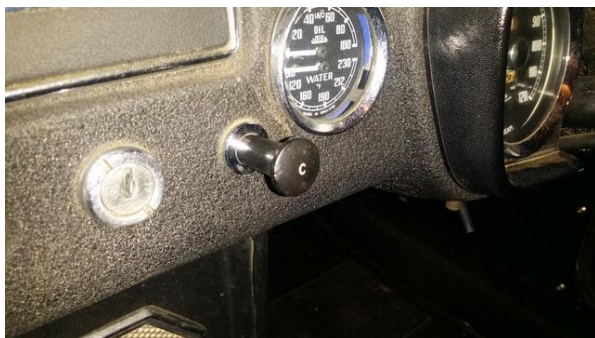
Early style choke knob

9. Choke knob: Originally, this was a smallish black plastic knob (similar to item 4.), with a white letter 'C' in the centre. This was changed to a larger knob showing a 'fan' symbol. Evidence suggests this was done with the introduction of the Mk II.

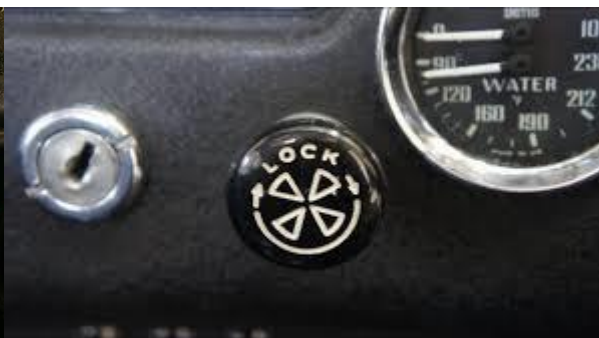
Later style choke knob

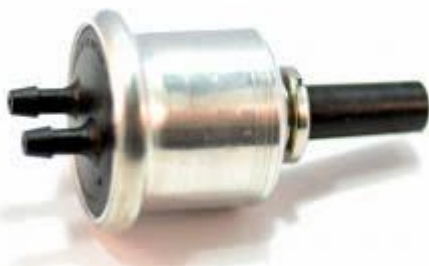
Windscreen washer pump

12. Windscreen washer pump: Originally, this was the location of a two-stage, black plastic toggle switch for the lights. This was replaced by the washer pump in late 1966.

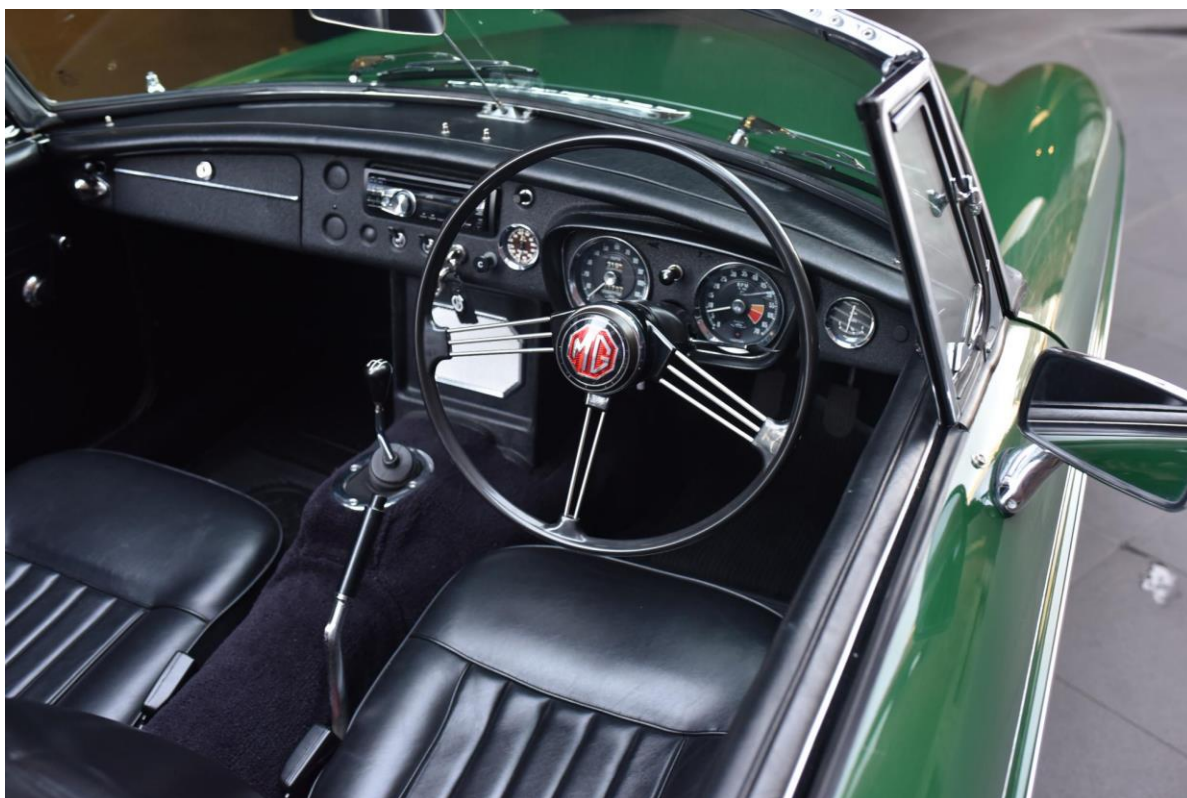
YGN3 719, clearly showing the early locations of the washer pump (above the oil/temp gauge) and the headlight toggle (next to ignition). Also note the 3 blanking plugs for heater (on left) and overdrive switch (on right).

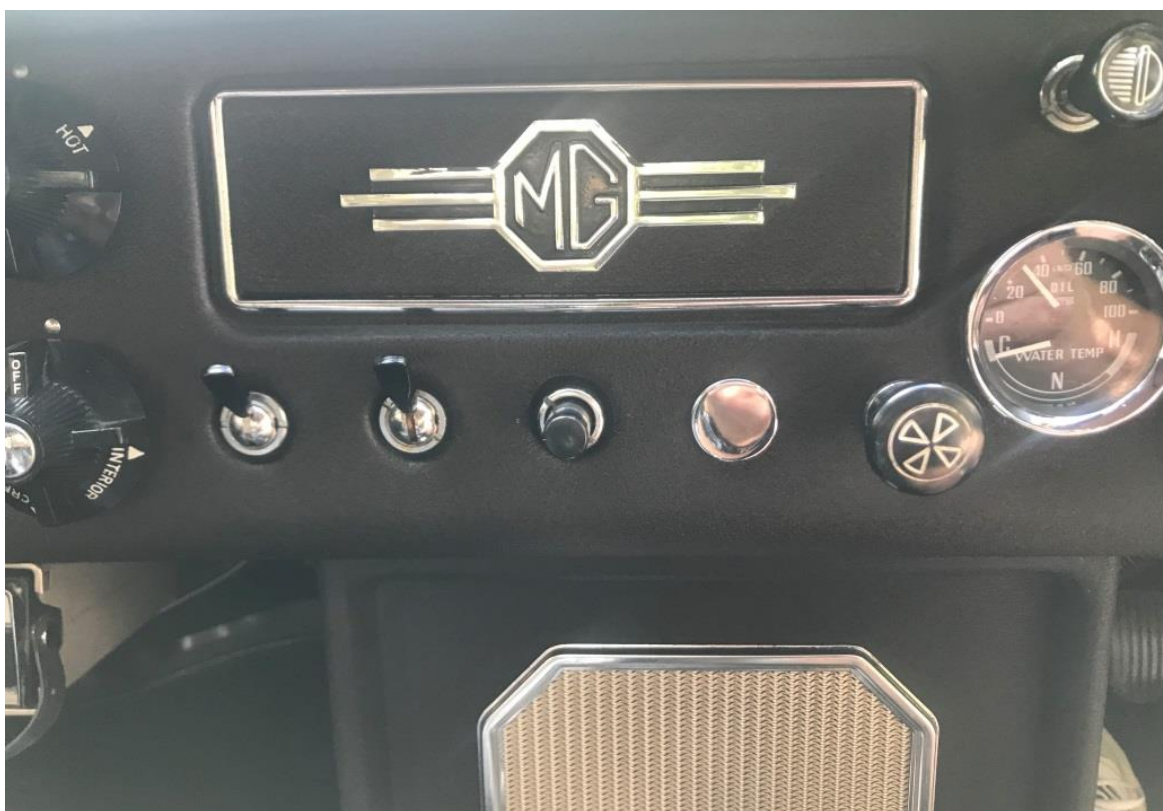
1970 MGBL showing heater controls (just), toggle switches, washer pump, chrome ignition blanking plate (that is not a blob of chewy – it's the reflection of the photographer's finger), later style choke knob, later style headlight switch, temp (C-N-H) & radio blanking plate.

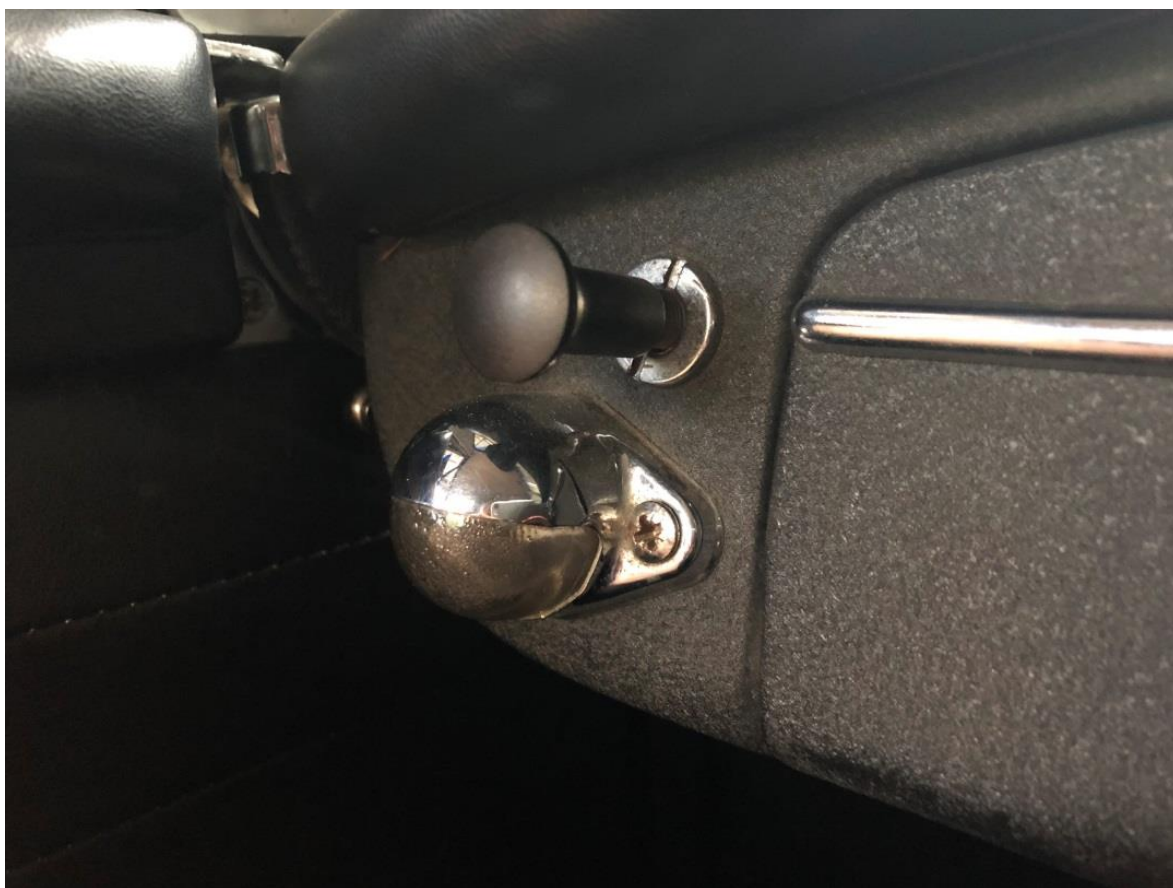
Map light and switch (Bakelite on this Mk I)

18. Map light switch: black plastic (originally Bakelite)

19. Map reading light: chrome and glass (Note: the same light is used on the rear bumper overrides for illuminating the number plate)

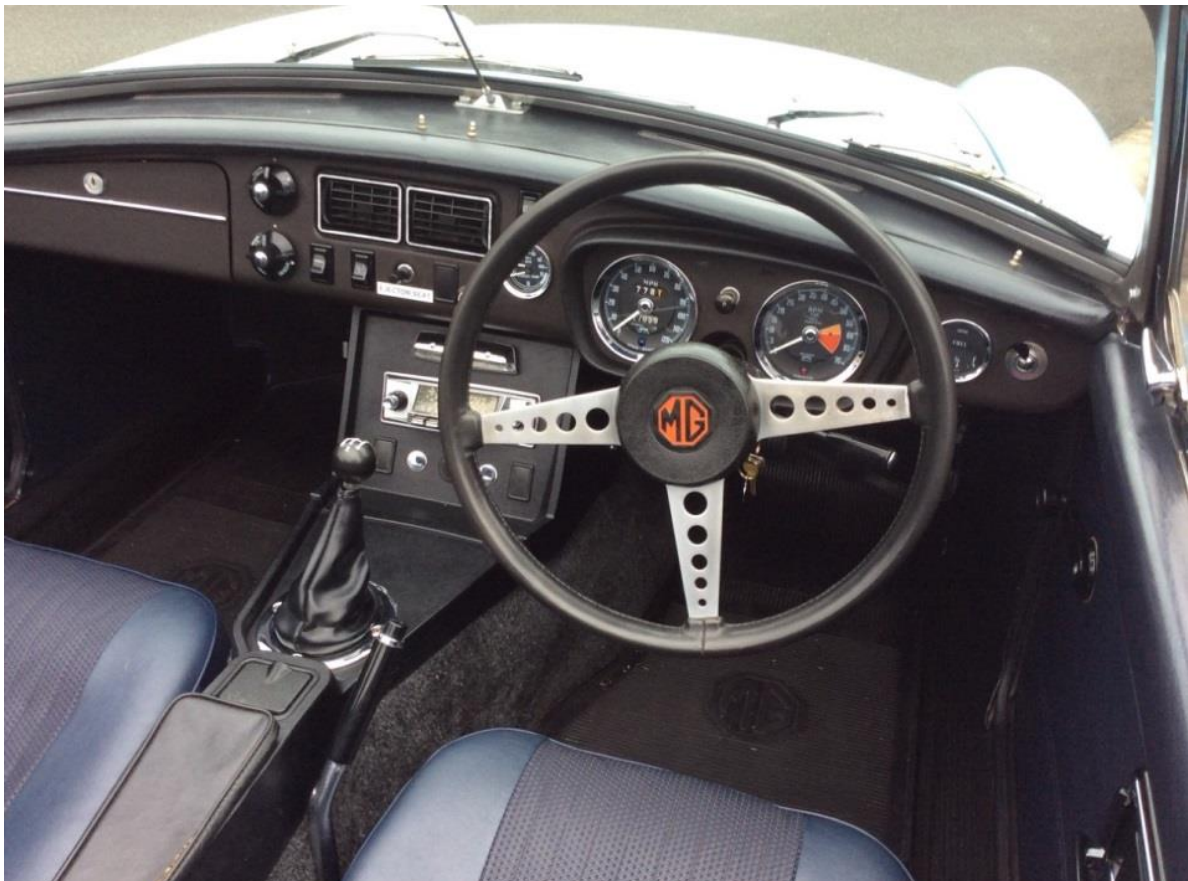
Photo showing MGBL (facelift) with air vents (11). Note: rocker switches instead of toggle, new console with radio, map light above radio, toggle switches or blanks. Also note new seat design (blue), arm rest and ash tray, temp gauge in C-N-H, steering wheel and column ignition/steering lock.

With the introduction of the 'facelift' vehicle, its whole purpose changed. Starting from the top, a new design, chrome, map-reading light was positioned. This could be operated by either a rocker switch or remote door switch. Below this was the familiar radio blanking plate, with the chrome winged MG symbol. Finally, a row of controls (or blanks in many a case) were positioned. Reading from R to L: map-reading light rocker switch; cigarette lighter; a round 'hazard lights' warning light,

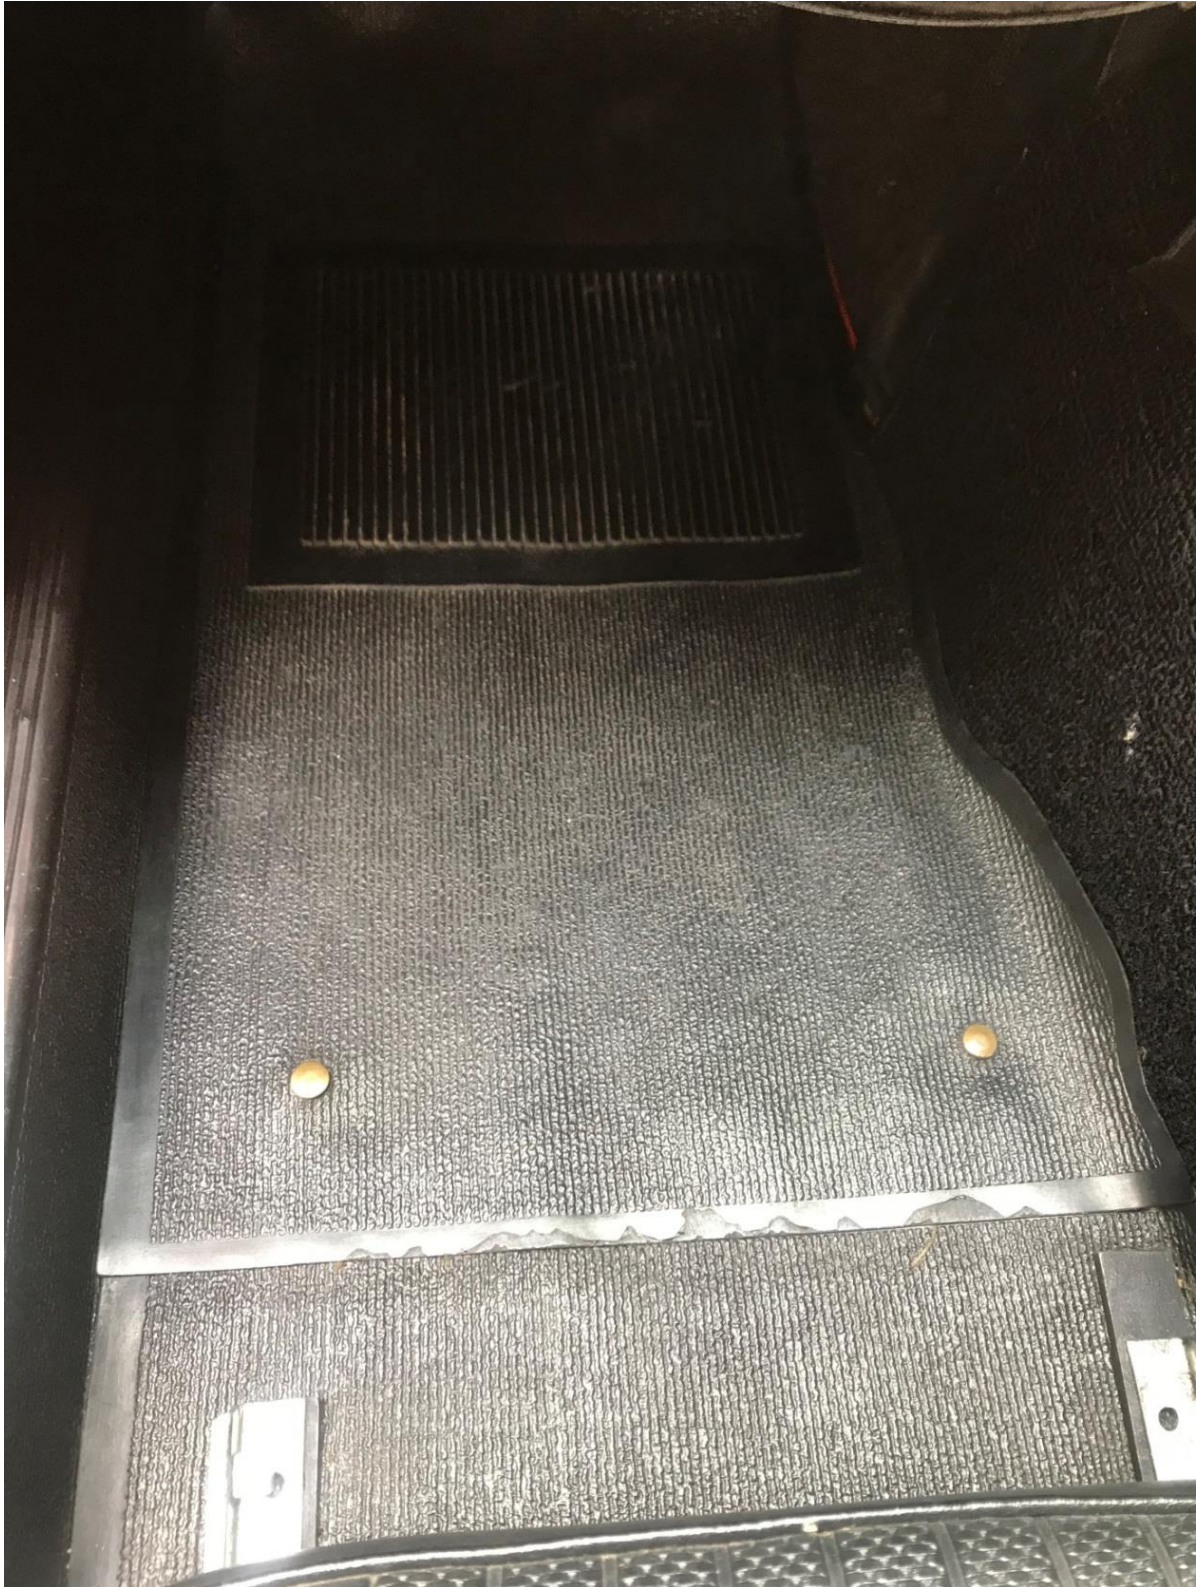
Two-pieced mats used in all Australian MGBs

Floor covering in the Australian MGB was only ever PVC-coated rubber mats. At the time of writing, there is only one place in the world that still provides these mats and that is in Sydney.

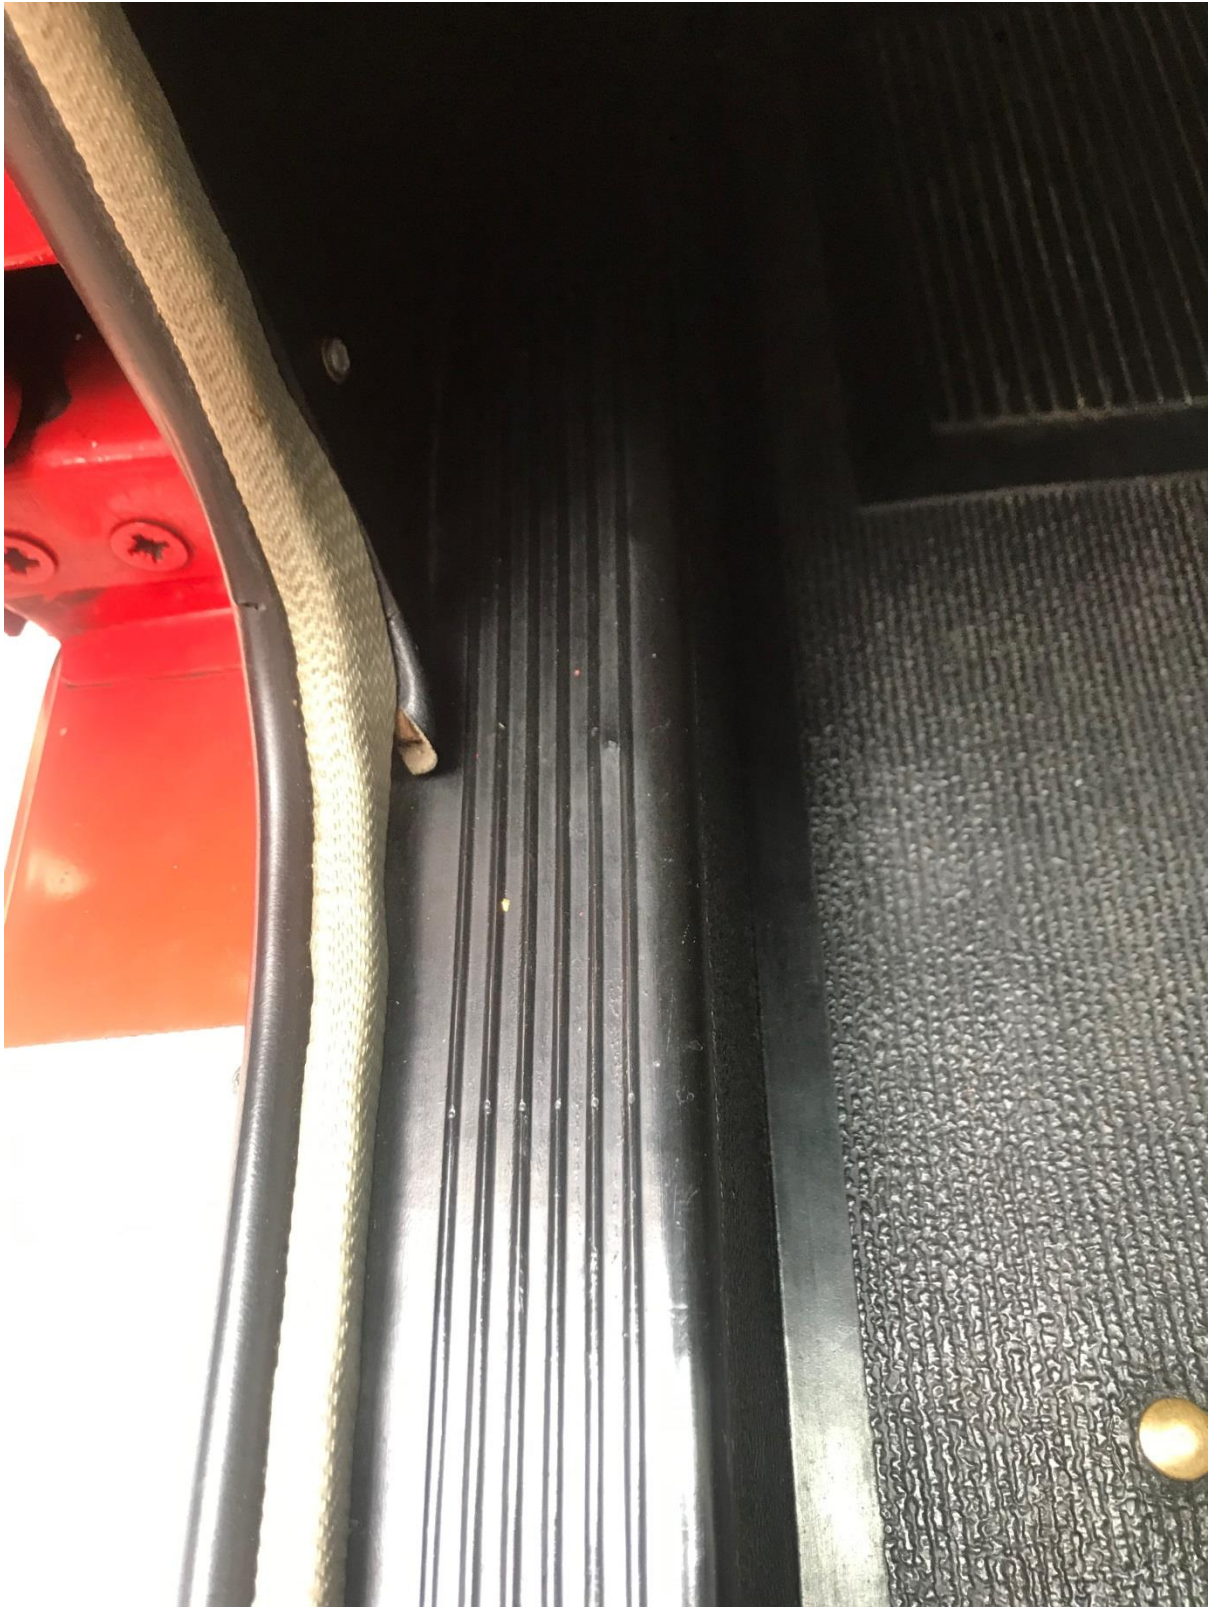
Rubberised sills

The sills of the car were covered in a ribbed PVC-coated rubber strip.

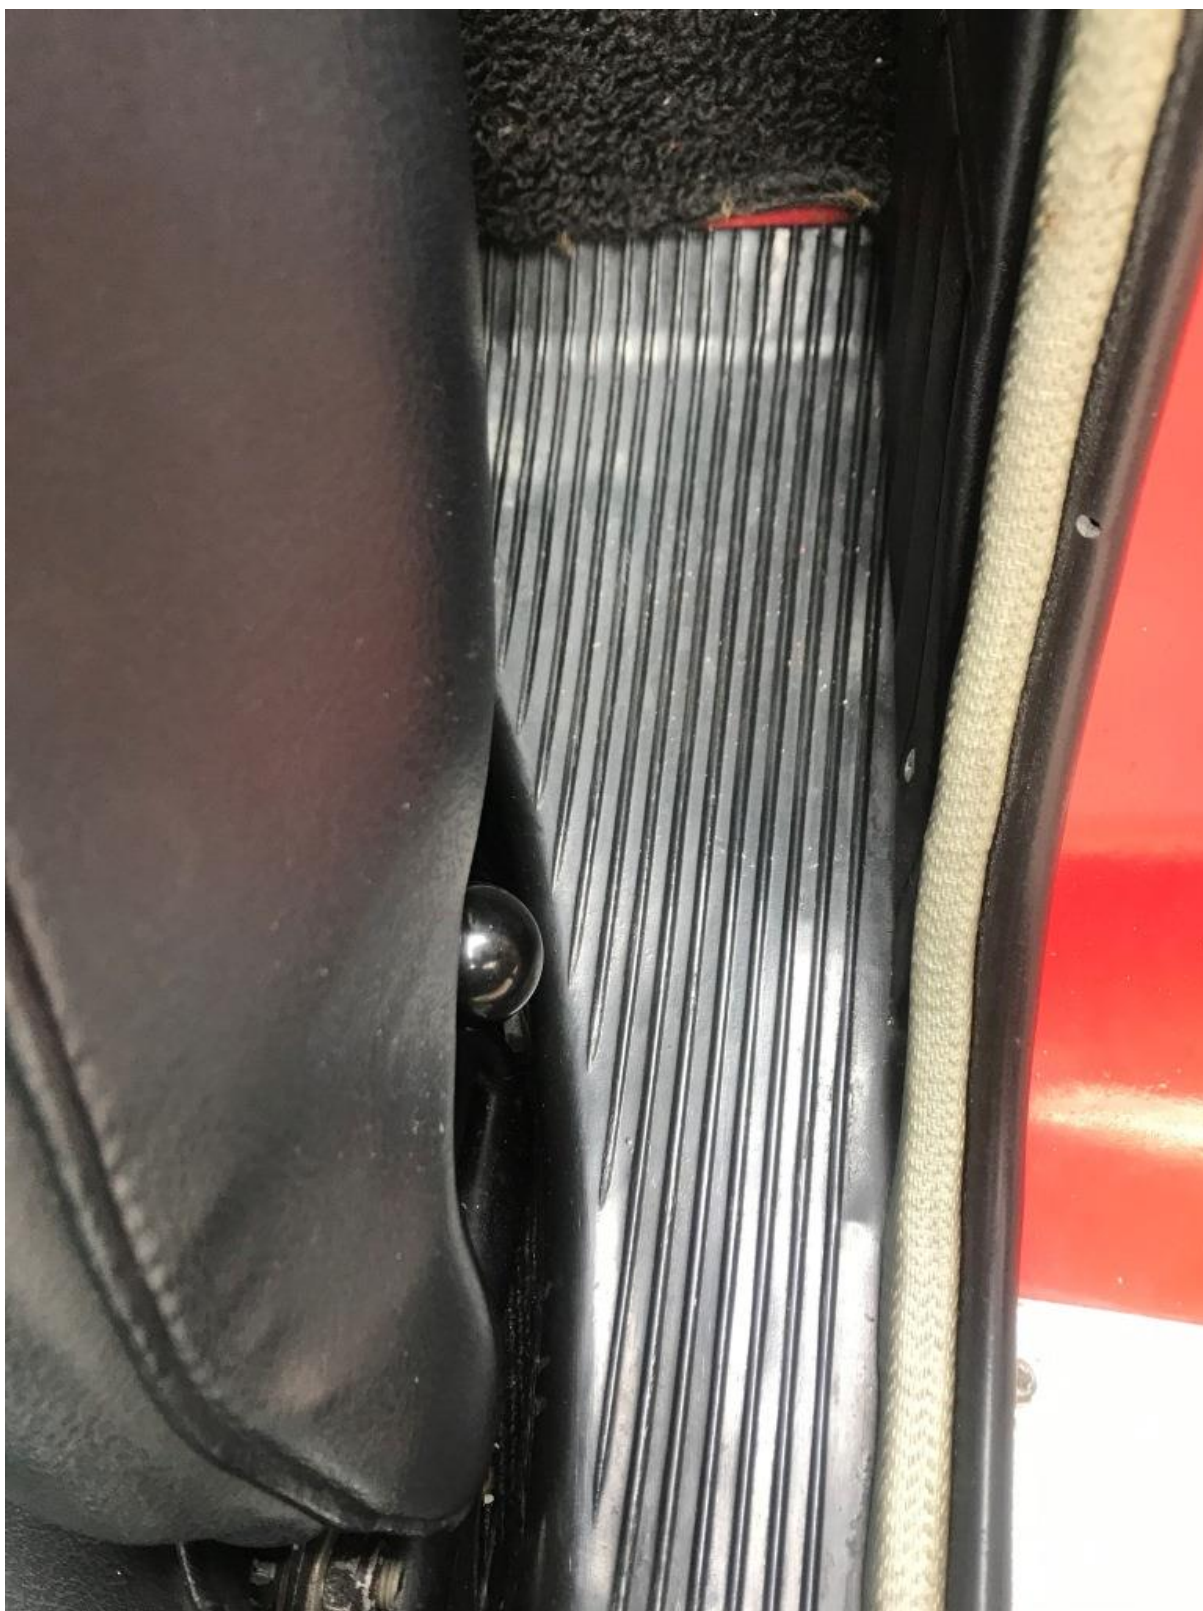
Rear of rubberised sills

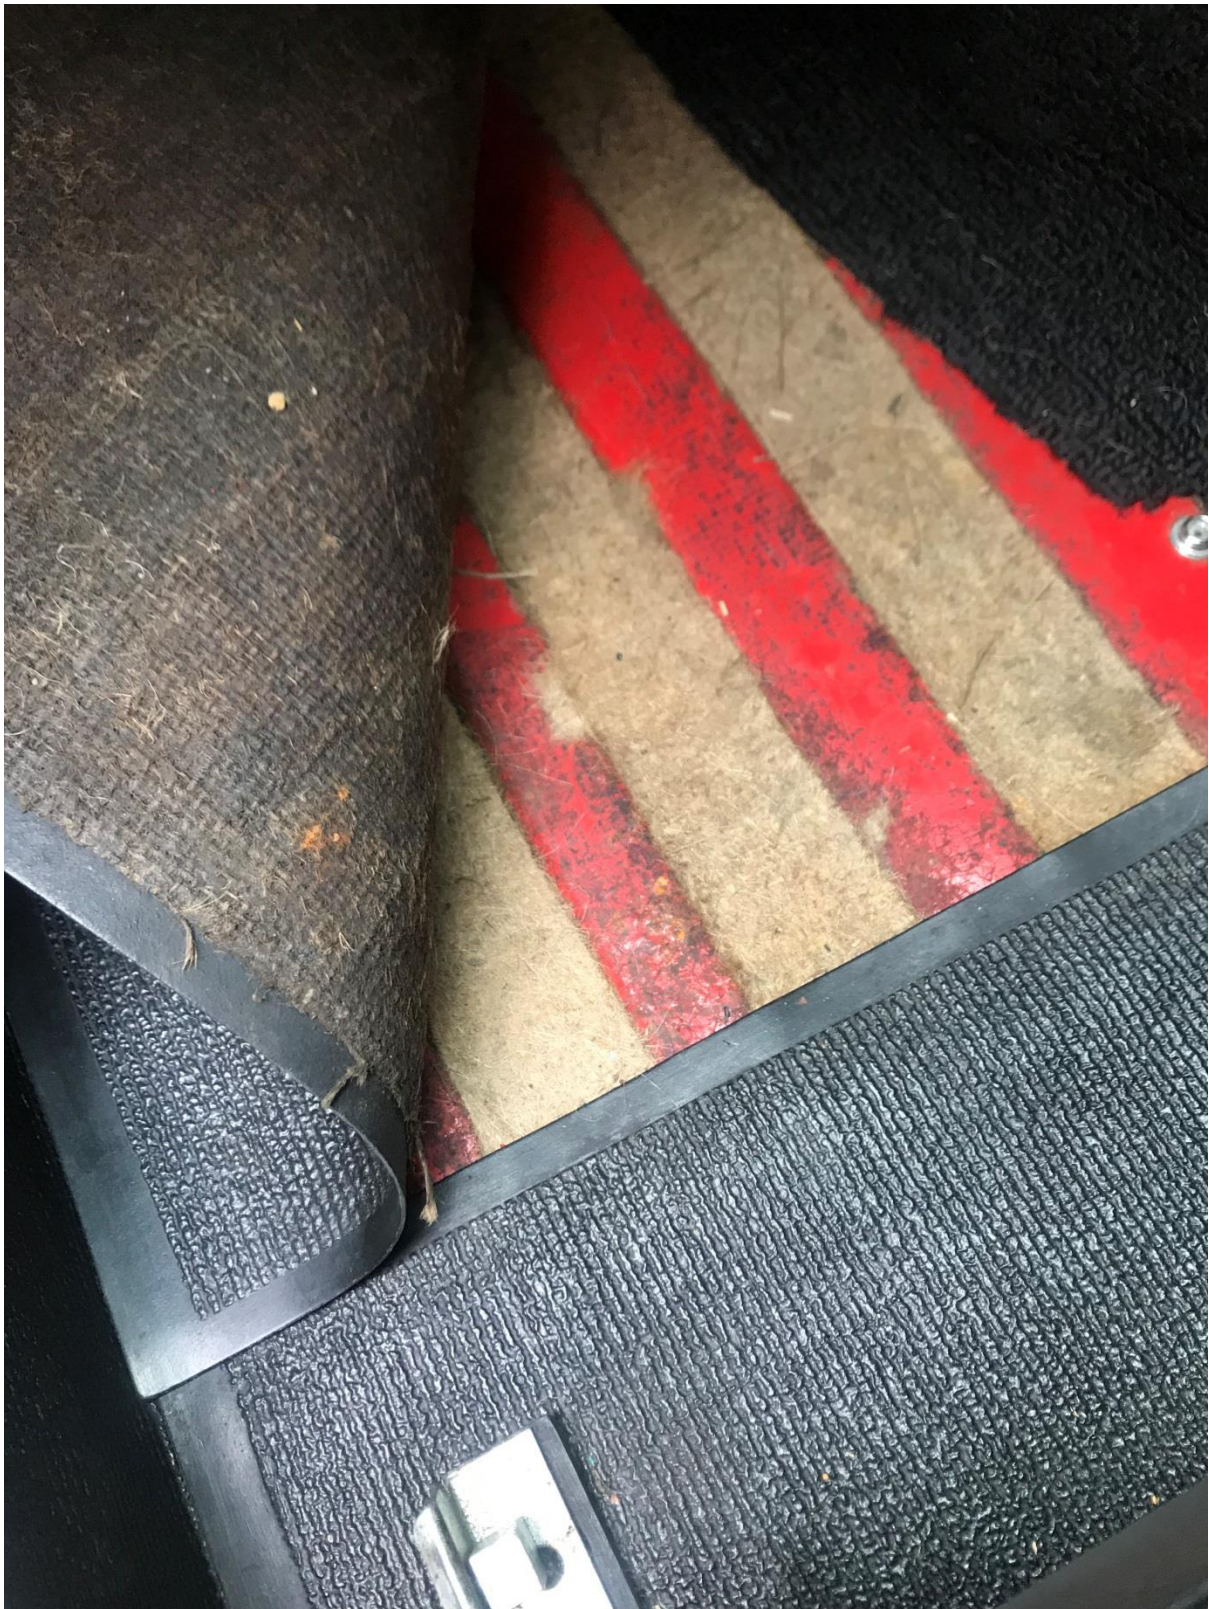
Under-felt

The following photo shows the under-felt that was used on the floor.
