# STEERING

The Australian MGB steering stayed pretty much the same throughout its life. It was of the direct-acting, rack & pinion type, consisting of a rack bar and toothed pinion, mounted on the front suspension cross-member, with a non-collapsible column for all local iterations.

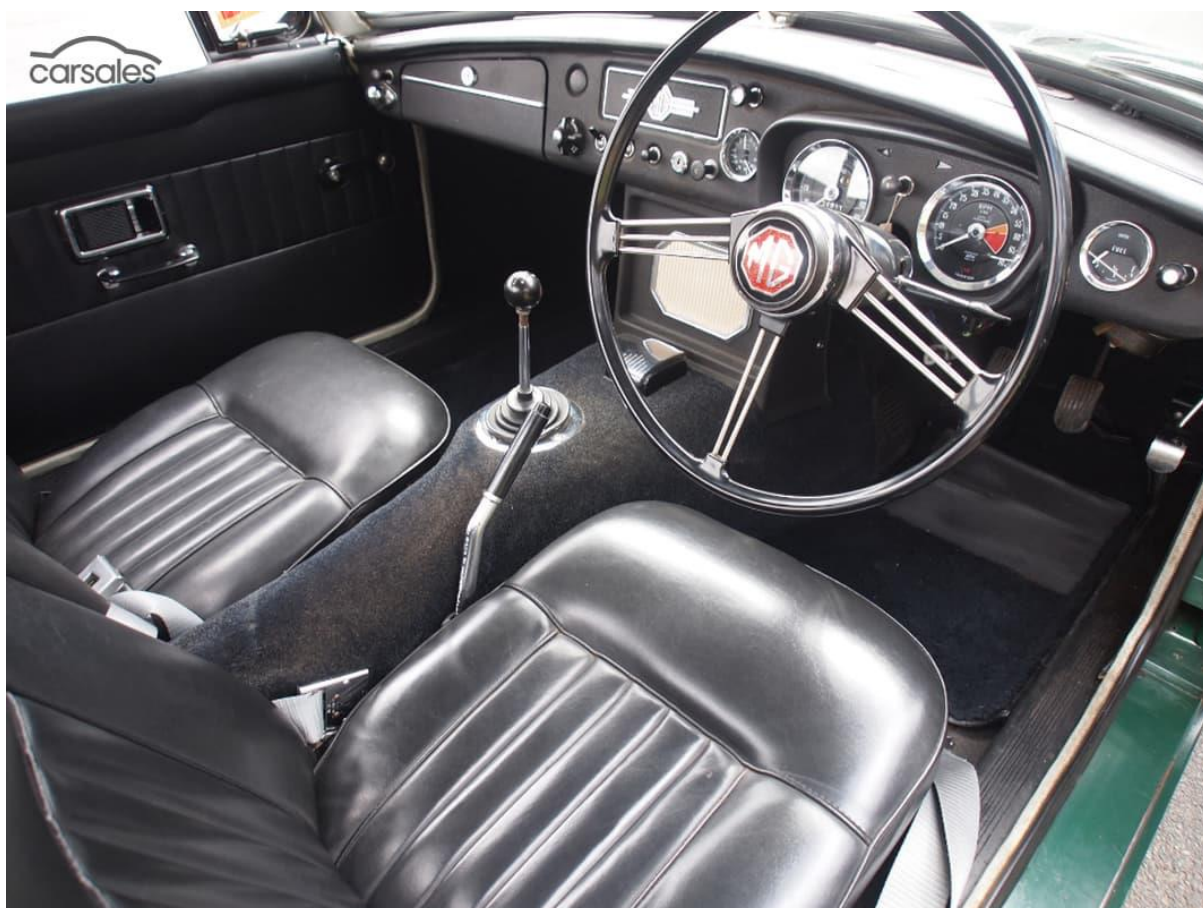
The original steering wheel offered was a 16 ½ " diameter, black plastic wheel with three chrome spokes bisecting the wheel. At 90° to these were two chrome spokes.

Early style steering wheel

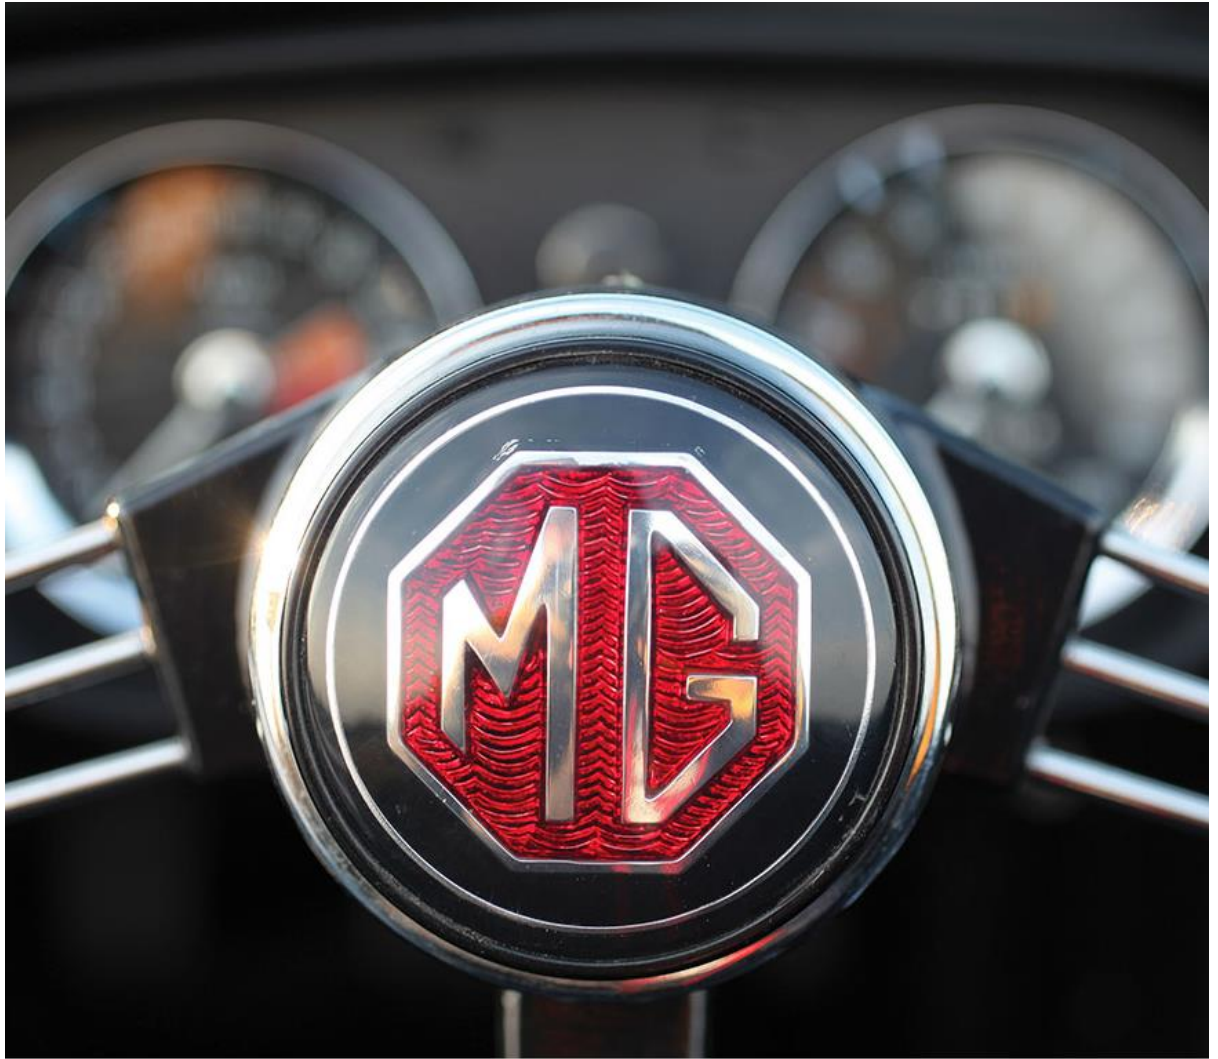
The hub was made of the same material and colour, with a large horn push, featuring a silver MG logo on a red, 'curtained' background.

Early style wheel showing horn push

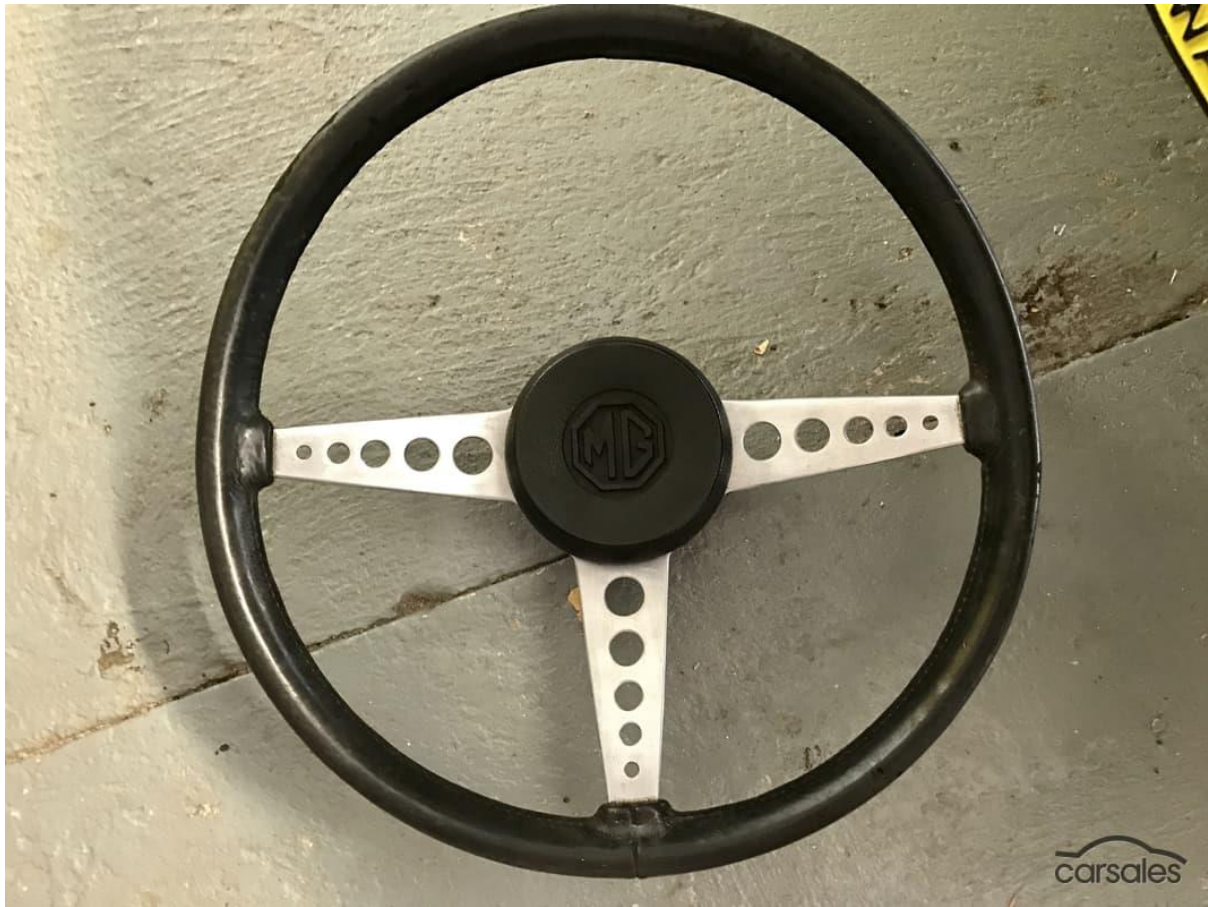
The above wheel was replaced in 1970 with a smaller, simulated leather bound wheel with three spokes, each with 5 diminishing sized holes and changed centre (see below). The smaller size gave much needed room between the driver's legs and the wheel. At this stage, the horn was changed to operate from the indicator stalk. In Australia, this continued to be the location until the end of production, whereas in the UK, the horn operation returned to the centre of the steering wheel for a brief period of time.

Later style steering wheel

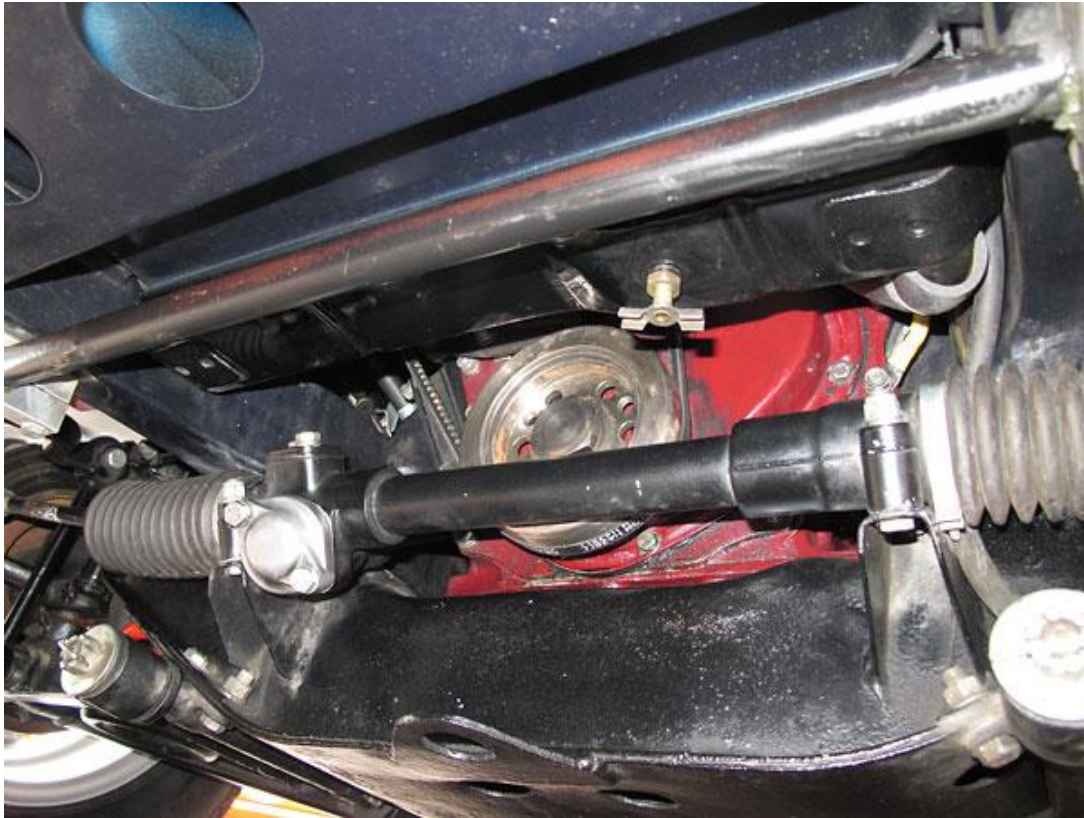
Photo showing steering rack

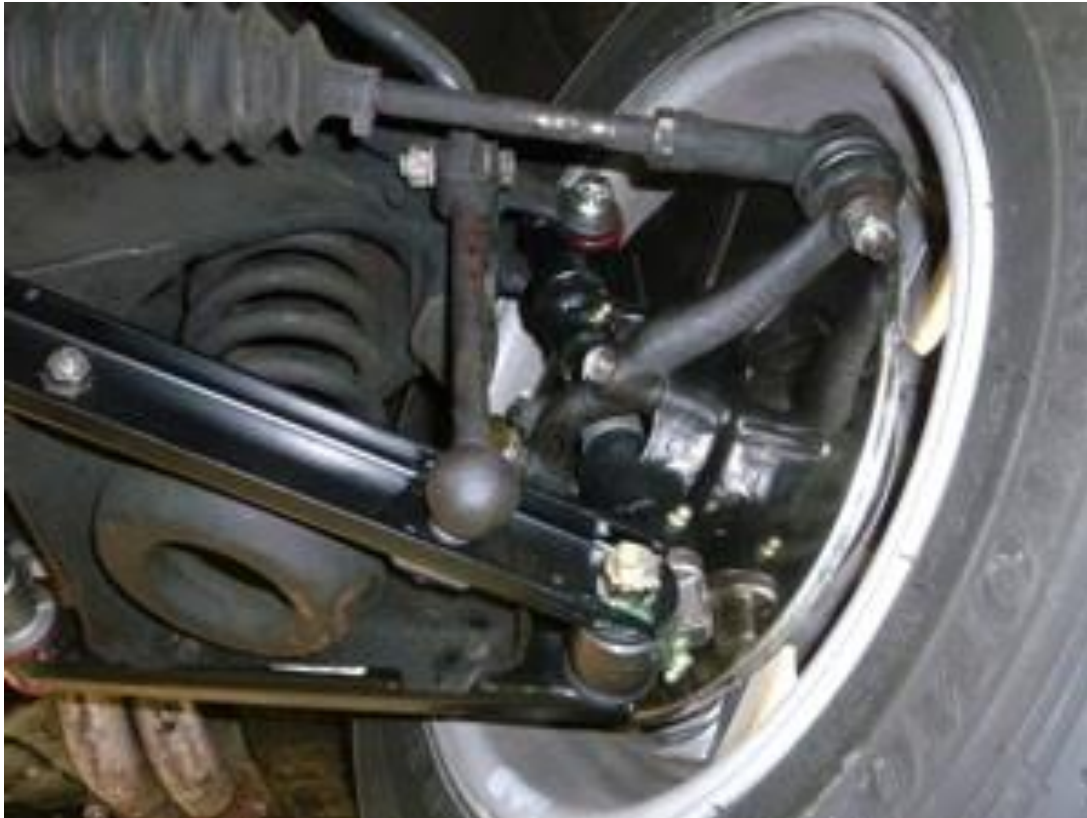
Photo showing steering rack connected to steering lever

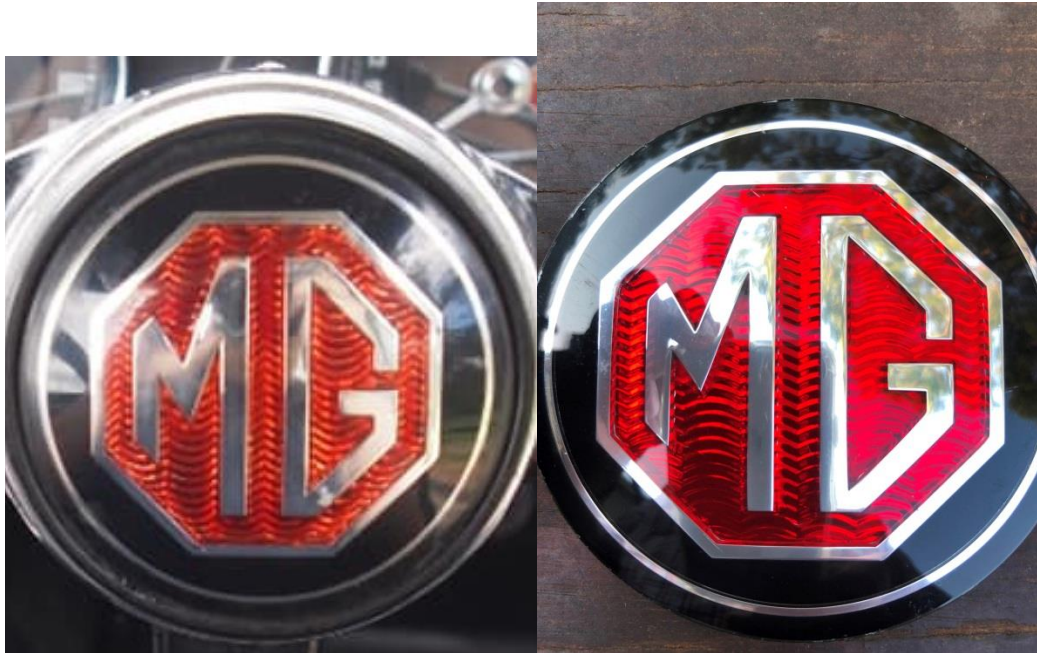
Owners wishing to ensure that their vehicle is as true to original as possible are always on the lookout for accuracy (so should Concours judges be!). Below is a typical example of 'minute' differences that matter to a lot of people. Can you pick the difference? (clue: it has nothing to do with colour).

Easy yeah? The first hub is the original and the second one is an impressive aftermarket hub. If you look at the red background curtain, you'll notice that the chevrons go in opposite directions (noticeable between the 'M' and the 'G').
