STEERING

The Australian MGB steering stayed pretty much the same throughout its life. It was of the direct-acting, rack & pinion type, consisting of a rack bar and toothed pinion, mounted on the front suspension cross-member, with a non-collapsible column for all local iterations.

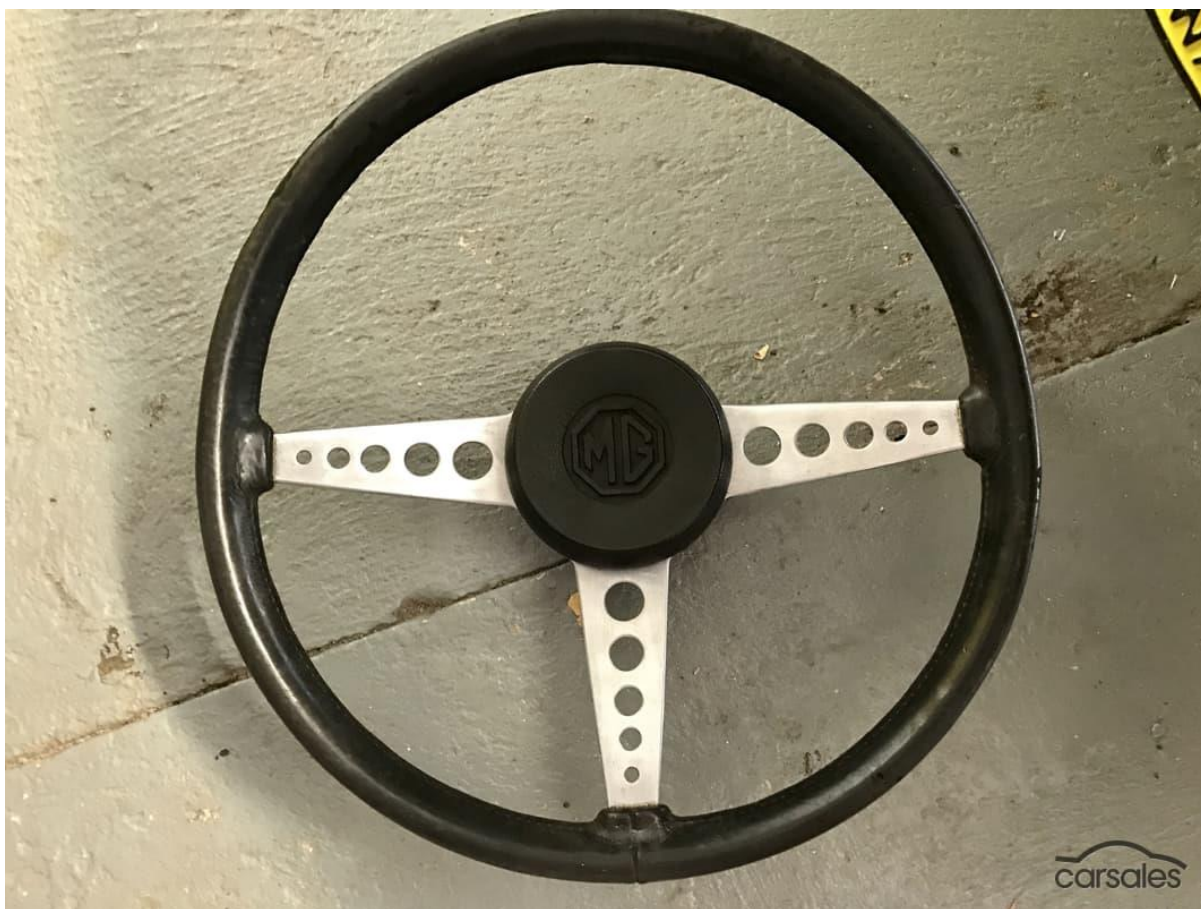
The above wheel was replaced in 1970 with a smaller, simulated leather bound wheel with three spokes, each with 5 diminishing sized holes and changed centre (see below). The smaller size gave much needed room between the driver's legs and the wheel. At this stage, the horn was changed to operate from the indicator stalk. In Australia, this continued to be the location until the end of production, whereas in the UK, the horn operation returned to the centre of the steering wheel for a brief period of time.

Later style steering wheel

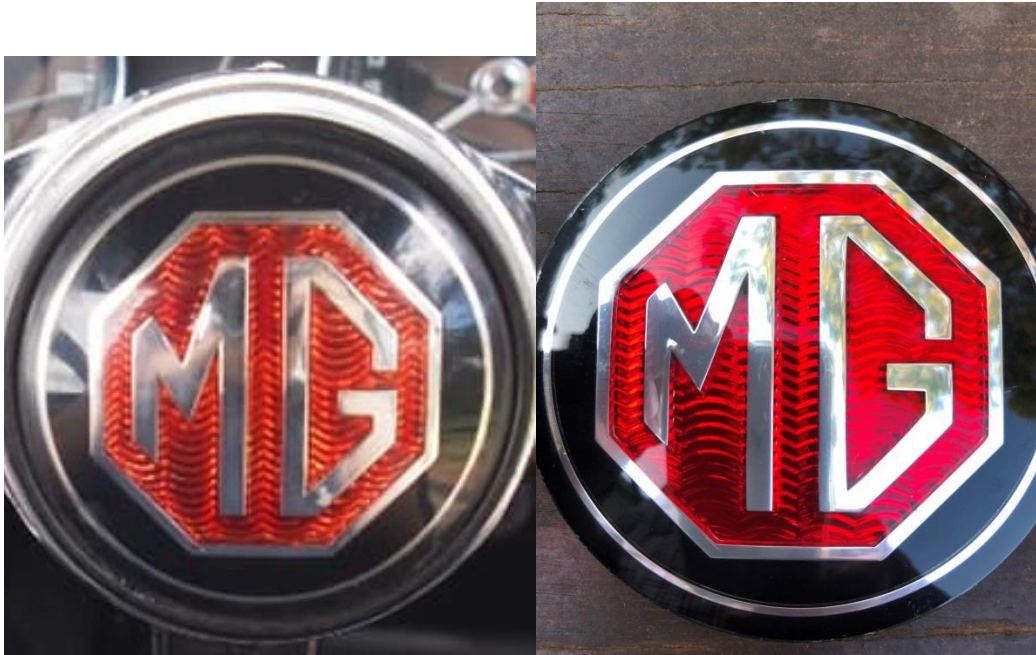
Owners wishing to ensure that their vehicle is as true to original as possible are always on the lookout for accuracy (so should Concours judges be!). Below is a typical example of 'minute' differences that matter to a lot of people. Can you pick the difference? (clue: it has nothing to do with colour).

Easy yeah? The first hub is the original and the second one is an impressive aftermarket hub. If you look at the red background curtain, you'll notice that the chevrons go in opposite directions (noticeable between the 'M' and the 'G').
