BODY

The MGB's body was a major change in engineering direction for MG. The decision was made to use the monocoque construction method that they had used on the ZA Magnette sedan. The body was made of steel, with aluminium bonnet (until 1969).

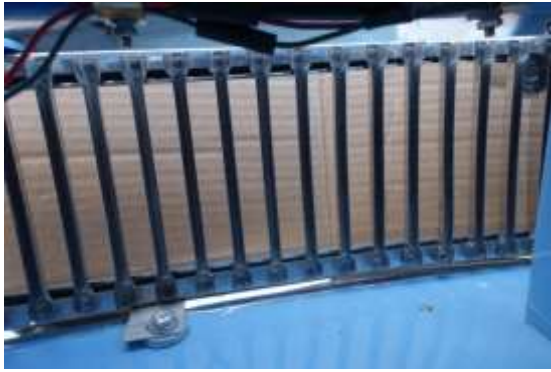
Early grille – slats individually riveted (photo: mymgb.net)

The grille of the early YGHN3 vehicles (up to and including the 18GA engine) had separate stainless steel slats riveted on to the grille frame.

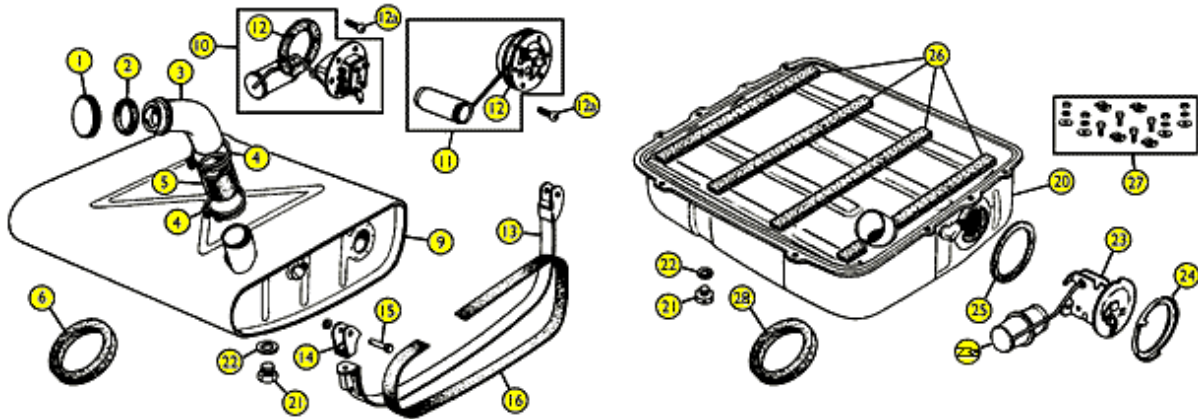
Both tanks – 10 gal and 12.7 gal (on right)

1965 saw modification to the boot floor to allow for the change of fuel tanks, from the 10 gallon tank (which was attached by straps), to the 12.7 gallon tank which was bolted to the boot floor. This change started with YGHN3/2246 and from YGHN3/2258 onwards.

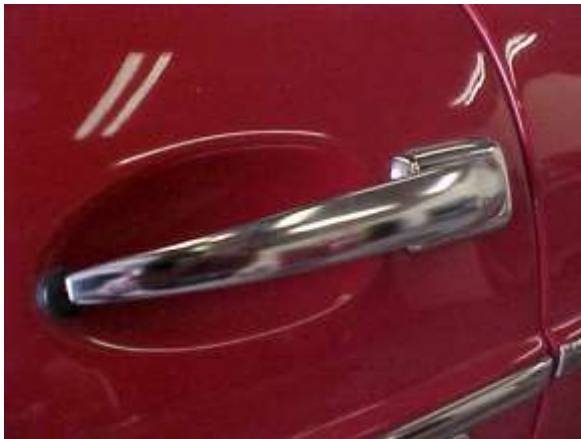
Early 'pull' handle c/f later 'push button'

At about this time (1965), the doors were also slightly modified to accommodate the change from 'pull-out' handles to the 'push-button'.

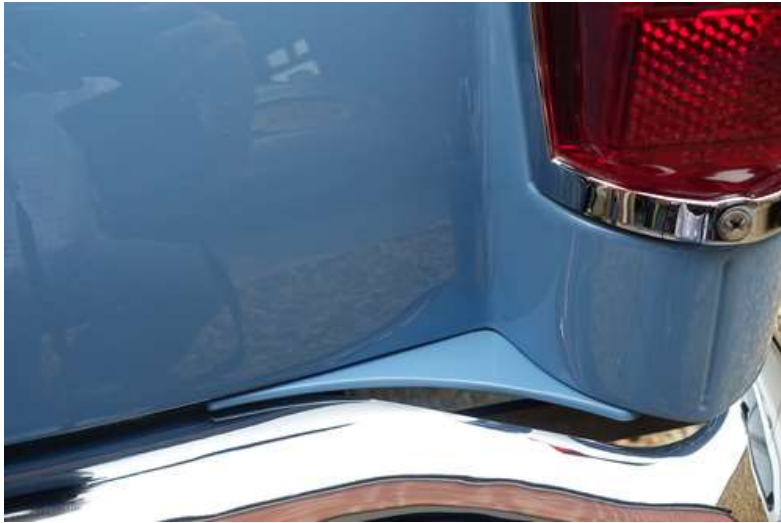
Early, large, painted bumper infill

On the early Mk I cars, the infills between the rear bumper and the body (next to tail lights) were painted body colour.

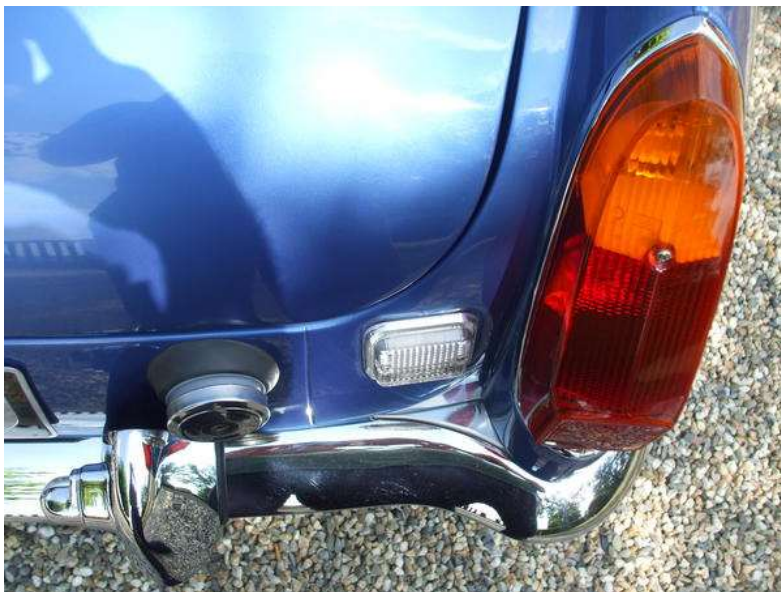
Later smaller bumper infill (polished alloy)

Thereafter (YGHN3/1001) they were smaller and polished aluminium.

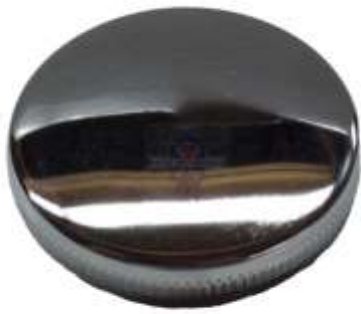
Petrol caps were the non-lockable, vented type. Plain stainless steel with grooves around the circumference

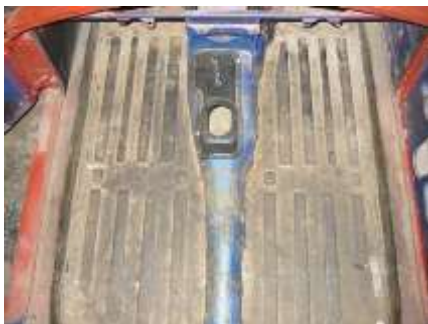
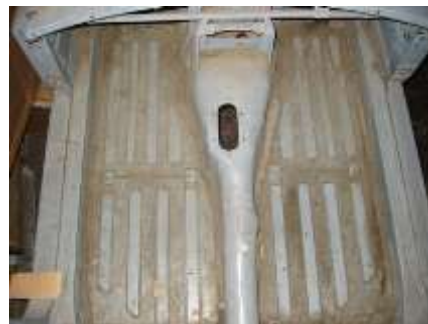
Figure 1 Early 3-sync tunnel c/f wider 4-sync tunnel. Compare the ribs on both sides to see the difference

Most of the changes occurred with the introduction of the Mk II series (YGHN 4 onwards); A wider gearbox tunnel was introduced to accommodate the new automatic gearbox configuration .

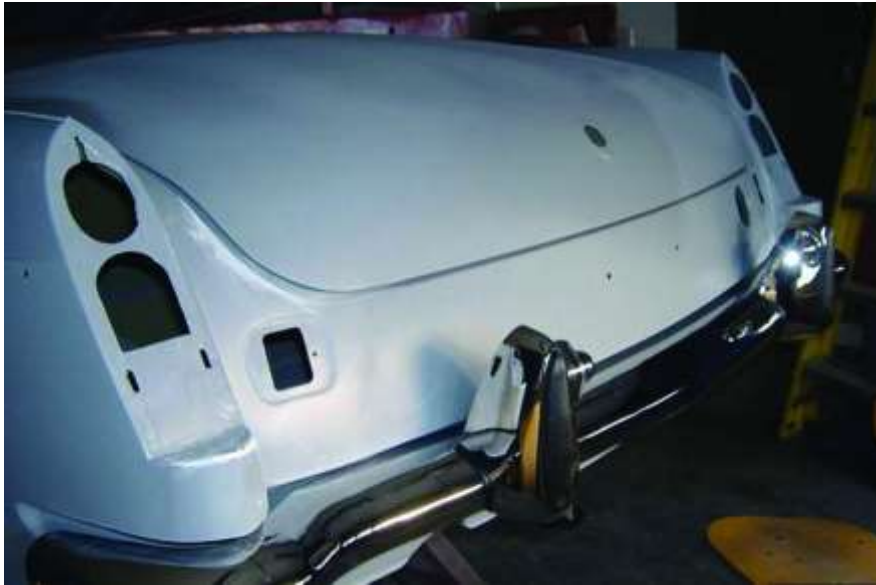
This photo shows the pressings made for the reverse lights (photo: A Helgeson)

Pressed cut-outs for the inclusion of reversing lights (from car YGHN3/4487)(circa June 1967)

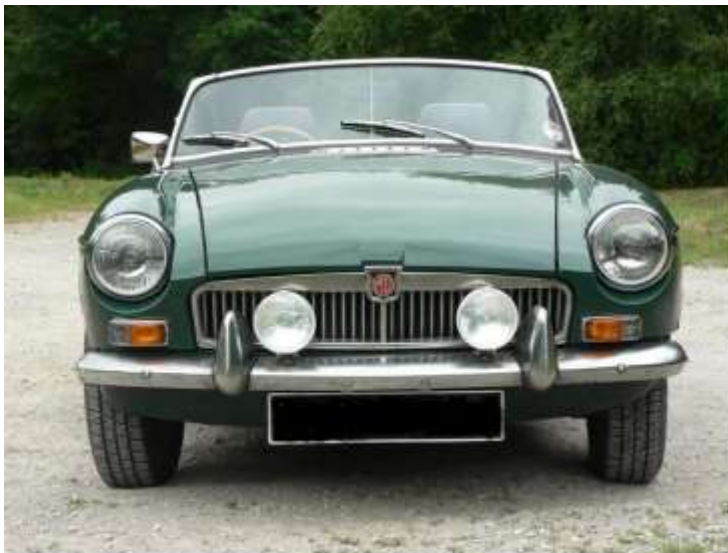
There is no better way to show this change. This car has mismatched guards. Look at the distance the park lights are from the grille.

Also, from car YGHN3/4487, the slight inward movement of the parking/indicator cut-out on the front fender assembly. NB: *“While not recorded in contemporary publications at the time, this was done in the UK because of legislation introduced in some European markets that the parking (side) lights centre point should line up with the centre point of the headlights. While the modified front mudguards were introduced for the Australian assembled MGB as these panels came on line, the indicator/parking light units remained reversed compared to the UK built product, till the introduction of the YGHN9 models with their recessed grilles.”* (Tom Aczel, 2013)
