BODY

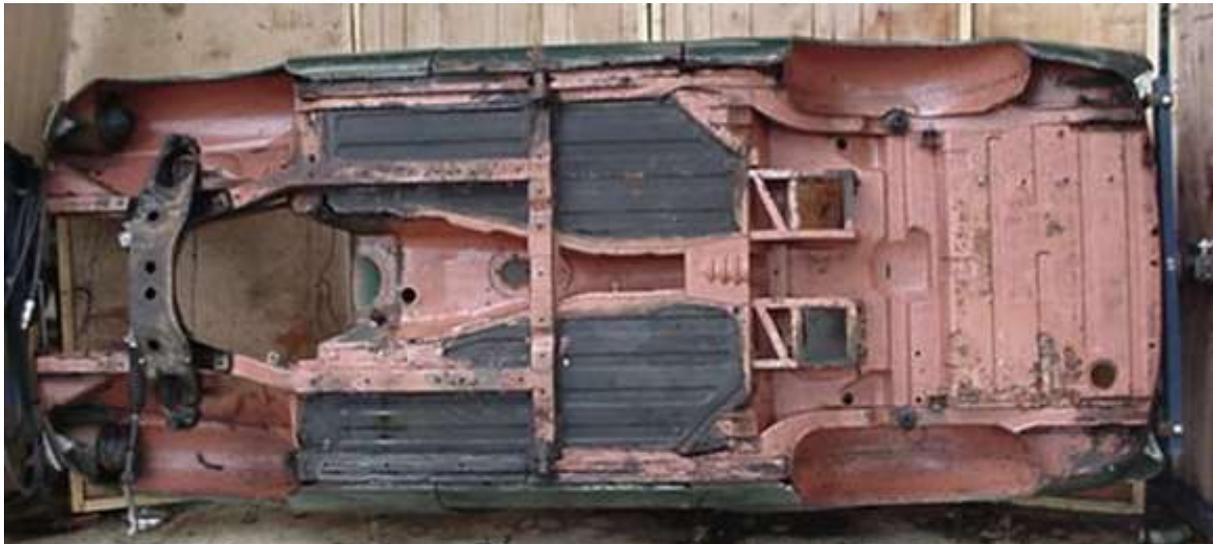
The bones of the vehicle comprised of two side members (front) which ran back to a cross member behind the gearbox. The front of these side members were held by a removable front suspension cross member (which was bolted on). The rear side members, which curved over the rear axle, were linked with the double-sectioned sills (sill closing and side member) (see photo below). All this was reinforced by: floor pans, transmission tunnel, boot floor, bulkhead, dashboard, door posts and a variety of panels, all adding strength to the construction. Apart from the front wings (which were bolted on), everything else was spot-welded.

Photo showing monocoque construction (photo: mg.net)

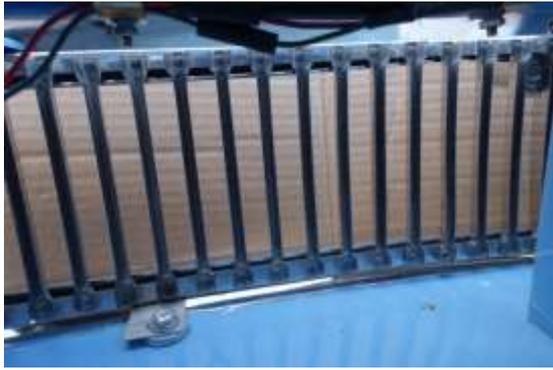
The grille of the early YGHN3 vehicles (up to and including the 18GA engine) had separate stainless steel slats riveted on to the grille frame.

Early grille – slats individually riveted (photo: mymgb.net)

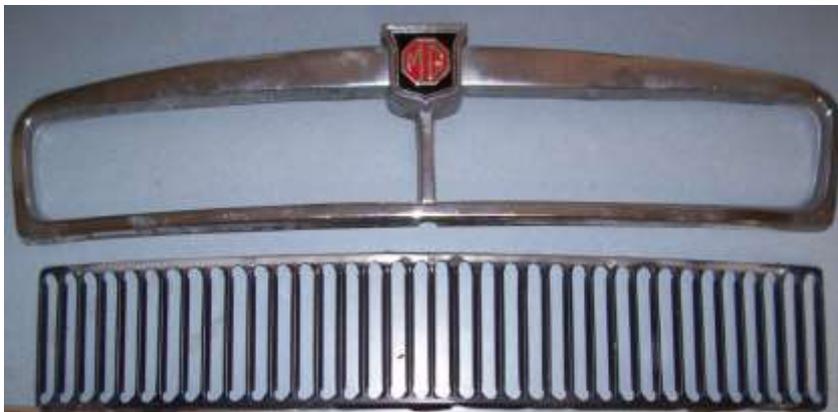
Thereafter, from vehicle YGHN3/1930, the grille, including the slats, were made from one-piece pressed aluminium. (p/no. ARH 218). The fittings didn't alter.

Later grille (Mk I & II). Grille made of pressed aluminium.

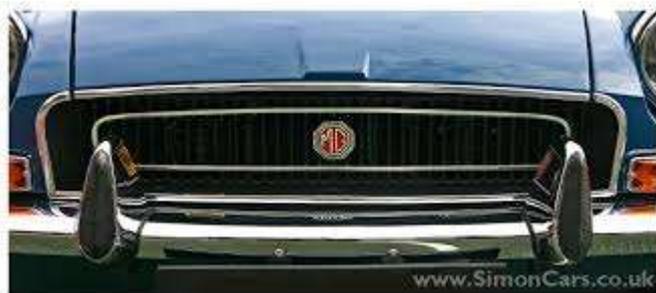
With the introduction of the Mk II (facelift), the grille changed its appearance; recessed black vertical slats with a 'D'-shaped chrome insert (laying on its back). In the centre was a new MG logo

Mk II (facelift) grille

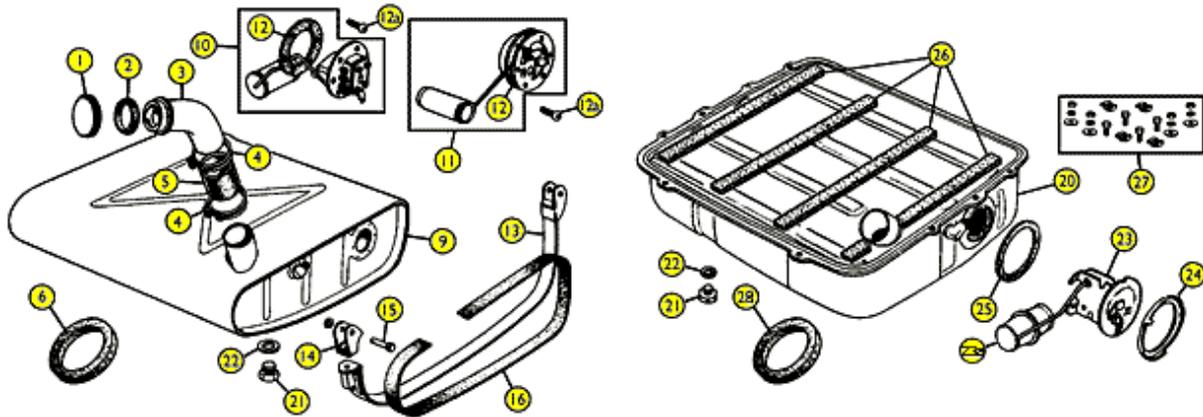
1965 saw modification to the boot floor to allow for the change of fuel tanks, from the 10 gallon tank (which was attached by straps), to the 12.7 gallon tank which was bolted to the boot floor. This change started with YGHN3/2246 and from YGHN3/2258 onwards.

Both tanks – 10 gal and 12.7 gal (on right)

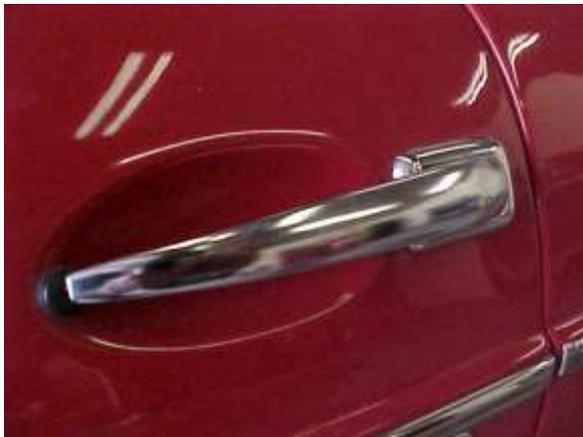
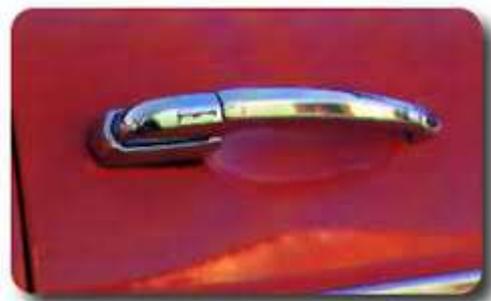
At about this time (1965), the doors were also slightly modified to accommodate the change from 'pull-out' handles to the 'push-button'.

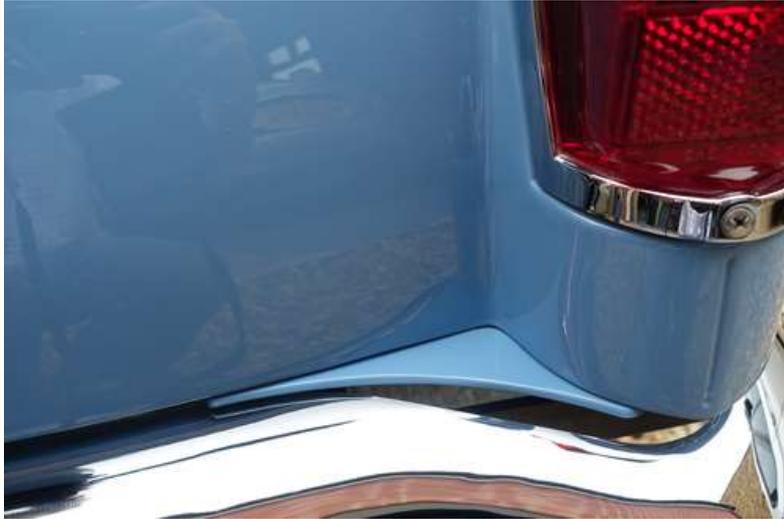
On the early Mk I cars, the infills between the rear bumper and the body (next to tail lights) were painted body colour.

Early, large, painted bumper infill

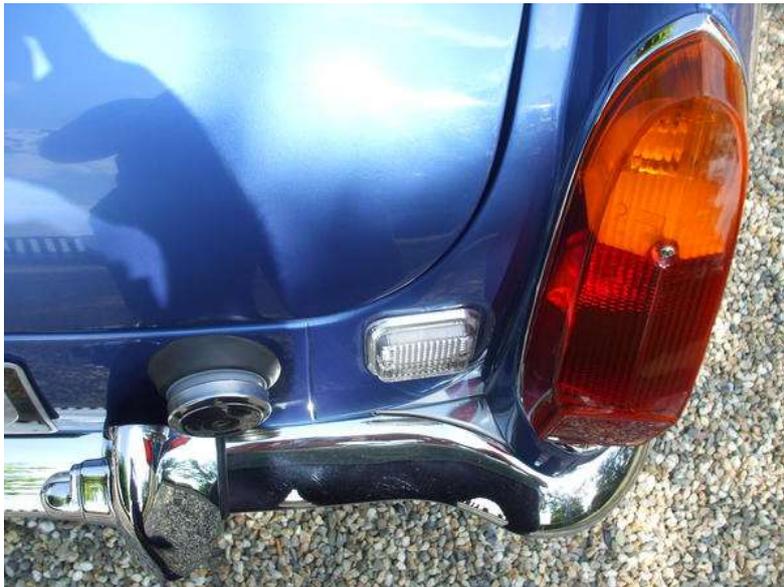
Thereafter (YGHN3/1001) they were smaller and polished aluminium.

Later smaller bumper infill (polished alloy)

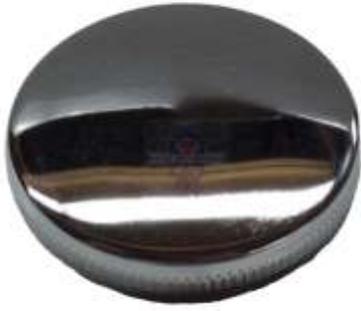
Petrol caps were the non-lockable, vented type. Plain stainless steel with grooves around the circumference

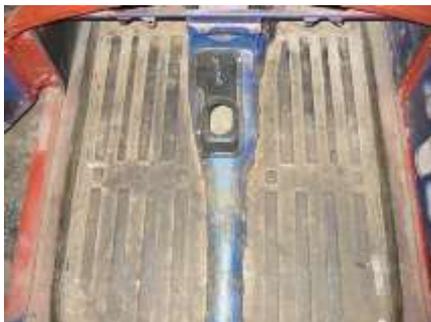
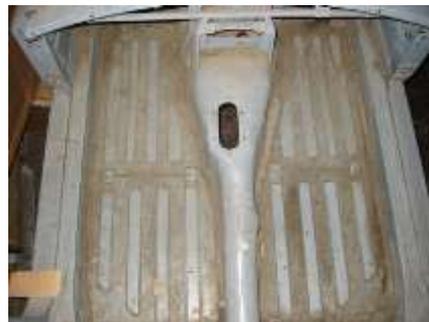
Most of the changes occurred with the introduction of the Mk II series (YGHN 4 onwards); A wider gearbox tunnel was introduced to accommodate the new automatic gearbox configuration .

Figure 1 Early 3-sync tunnel c/f wider 4-sync tunnel. Compare the ribs on both sides to see the difference

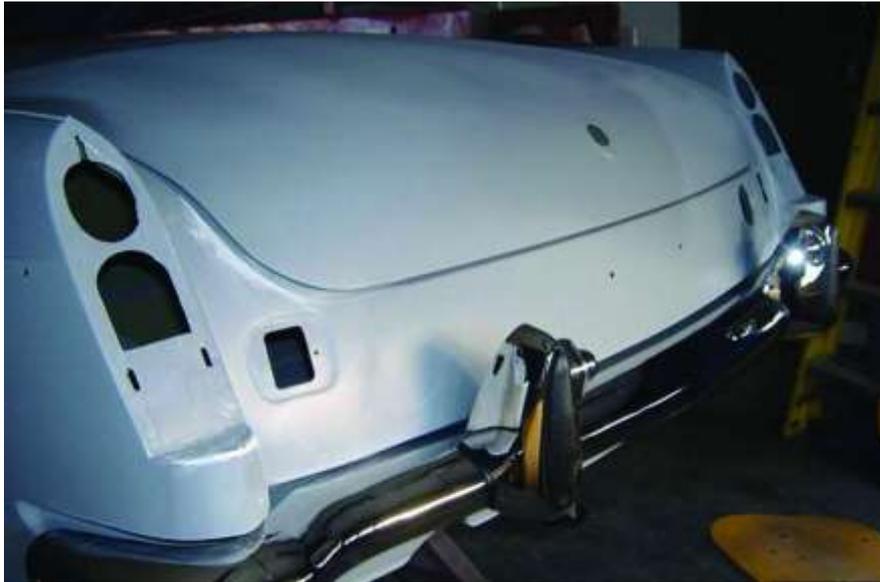
Pressed cut-outs for the inclusion of reversing lights (from car YGHN3/4487)(circa June 1967)

This photo shows the pressings made for the reverse lights (photo: A Helgeson)

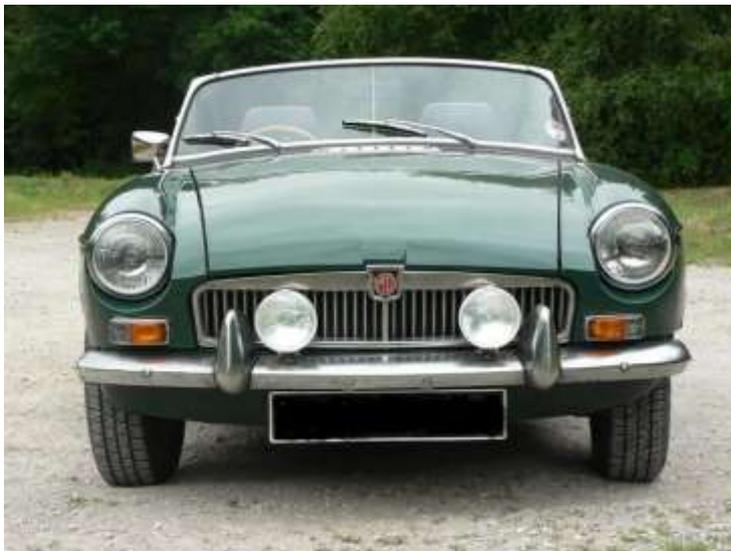
Also, from car YGHN3/4487, the slight inward movement of the parking/indicator cut-out on the front fender assembly. NB: *“While not recorded in contemporary publications at the time, this was done in the UK because of legislation introduced in some European markets that the parking (side) lights centre point should line up with the centre point of the headlights. While the modified front mudguards were introduced for the Australian assembled MGB as these panels came on line, the indicator/parking light units remained reversed compared to the UK built product, till the introduction of the YGHN9 models with their recessed grilles.”* (Tom Aczel, 2013)

There is no better way to show this change. This car has mismatched guards. Look at the distance the park lights are from the grille.
