BODY

The MGB's body was a major change in engineering direction for MG. The decision was made to use the monocoque construction method that they had used on the ZA Magnette sedan. The body was made of steel, with aluminium bonnet (until 1969).

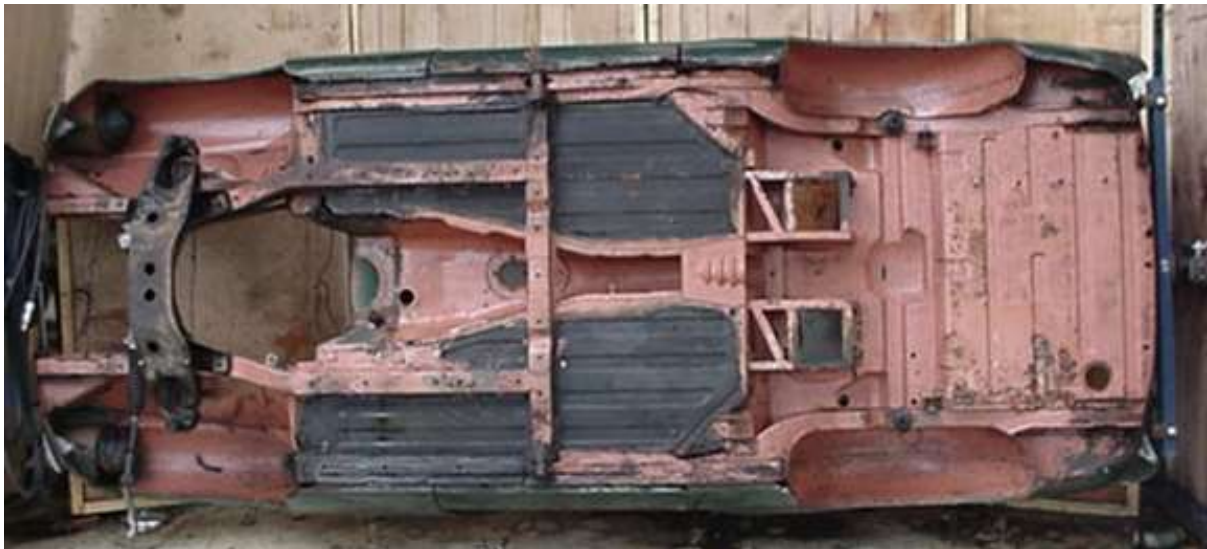
Photo showing monocoque construction (photo: mg.net)

The bones of the vehicle comprised of two side members (front) which ran back to a cross member behind the gearbox. The front of these side members were held by a removable front suspension cross member (which was bolted on). The rear side members, which curved over the rear axle, were linked with the double-sectioned sills (sill closing and side member) (see photo below). All this was reinforced by: floor pans, transmission tunnel, boot floor, bulkhead, dashboard, door posts and a variety of panels, all adding strength to the construction. Apart from the front wings (which were bolted on), everything else was spot-welded.

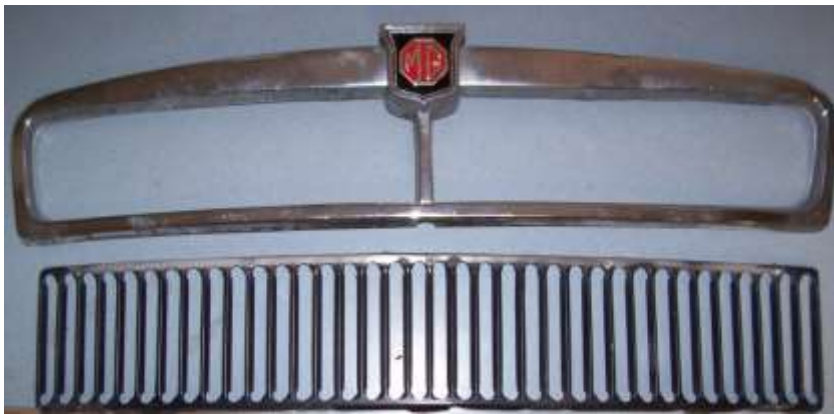
Later grille (Mk I & II). Grille made of pressed aluminium.

Thereafter, from vehicle YGHN3/1930, the grille, including the slats, were made from one-piece pressed aluminium. (p/no. ARH 218). The fittings didn't alter.

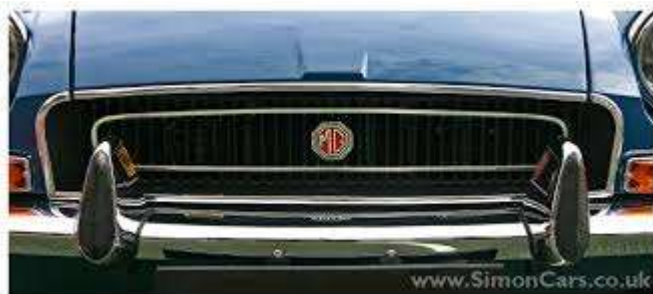
Mk II (facelift) grille

With the introduction of the Mk II (facelift), the grille changed its appearance; recessed black vertical slats with a 'D'-shaped chrome insert (laying on its back). In the centre was a new MG logo

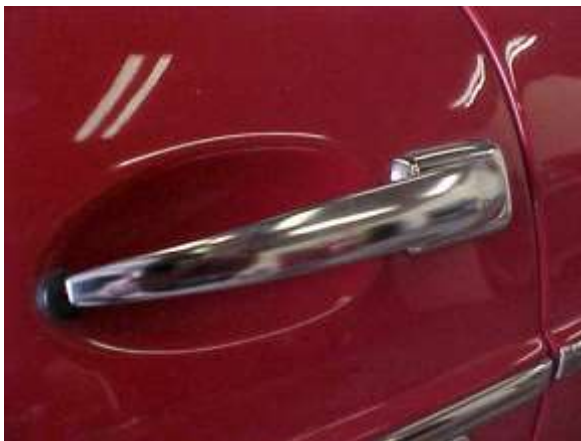
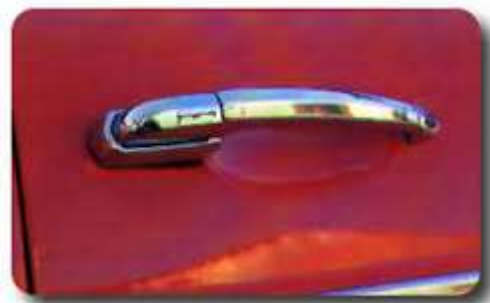
Early 'pull' handle c/f later 'push button'

Around 1965, the doors were also slightly modified to accommodate the change from 'pull-out' handles to the 'push-button'.

The pull handle (p/no AHH6661 & AHH6662) was fitted to cars YGHN3 501 - 2268.

From YGHN3 2269, the push-button (p/no AHH7452 [not handed]) was fitted. There is however, a subsequent listing of a variant [also not handed] (p/no AHH8885) but no changeover date listed (Leacy list it as '1965 -'1980).

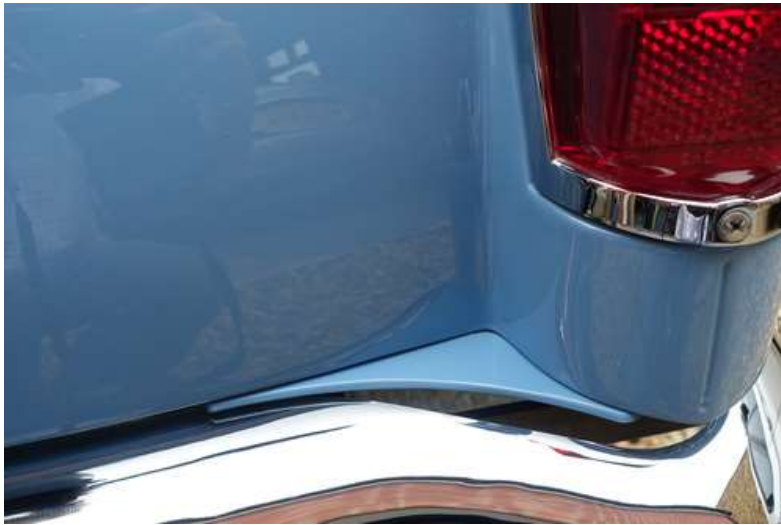
Early, large, painted bumper infill

On the early Mk I cars (YGHN3/501 – YGHN3/100), the infills between the rear bumper and the body (next to tail lights) were painted body colour.

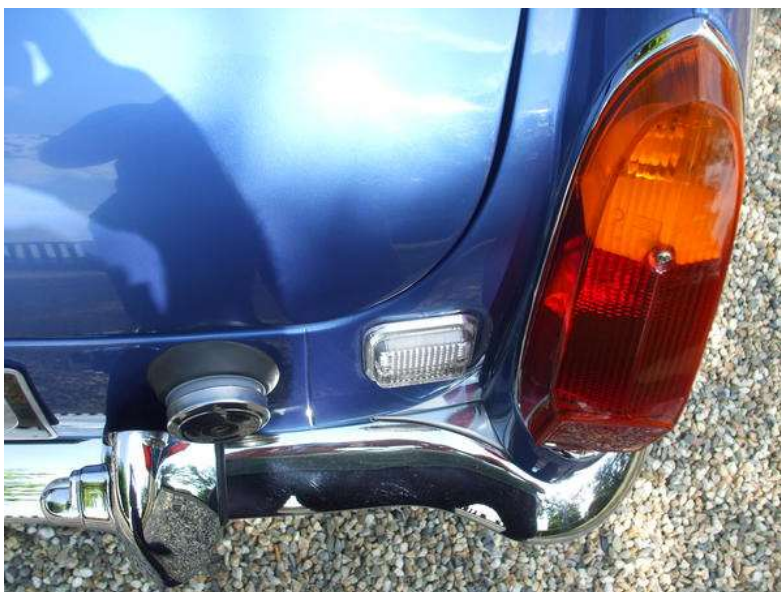
Later smaller bumper infill (polished alloy)

Thereafter (YGHN3/1001) they were smaller and polished aluminium.

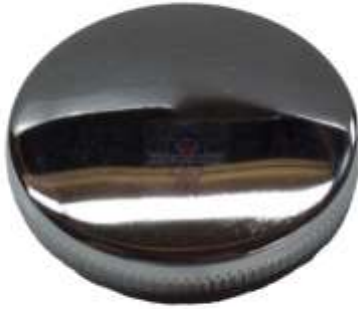
Petrol caps were the non-lockable, vented type. Plain stainless steel with grooves around the circumference

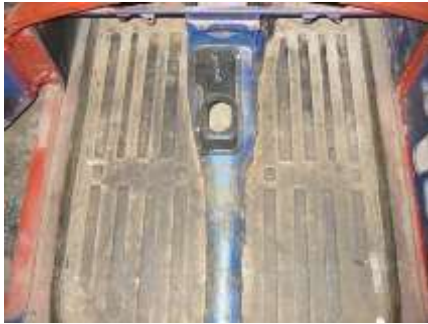
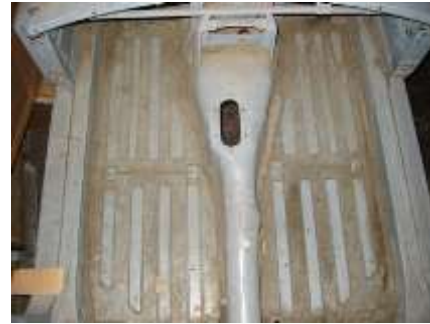
Figure 1 Early 3-sync tunnel c/f wider 4-sync tunnel. Compare the ribs on both sides to see the difference

Most of the changes occurred with the introduction of the Mk II series (YGHN 4 onwards); A wider gearbox tunnel was introduced to accommodate the new automatic gearbox configuration .

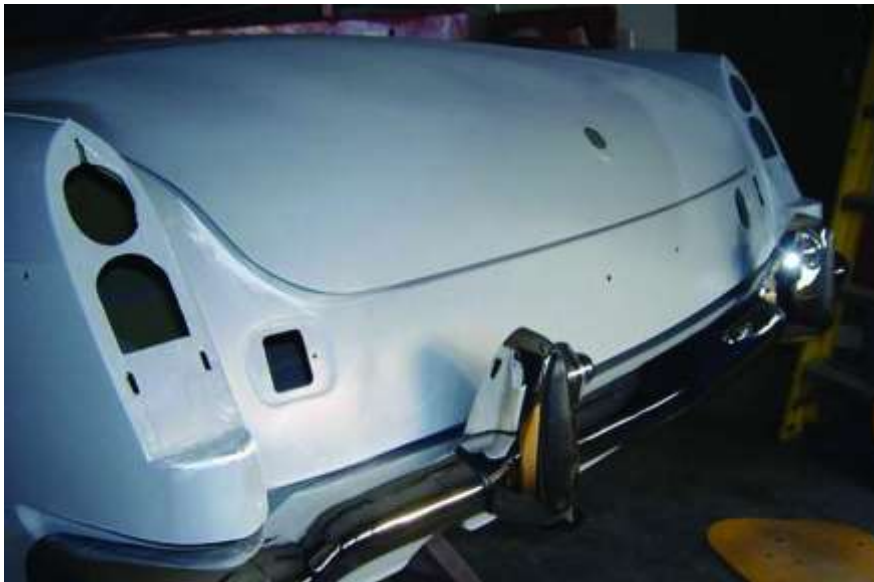
This photo shows the pressings made for the reverse lights (photo: A Helgeson)

Pressed cut-outs for the inclusion of reversing lights (from car YGHN3/4487)(circa June 1967)

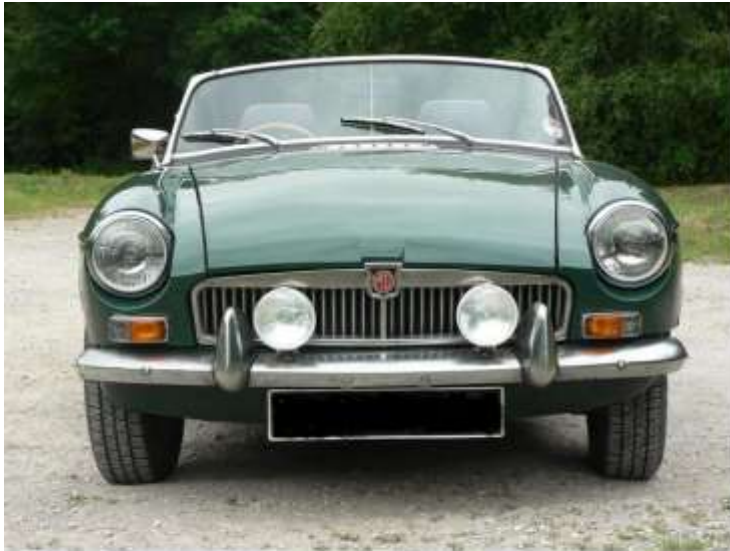
There is no better way to show this change. This car has mismatched guards. Look at the distance the park lights are from the grille.

Also, from car YGHN3/4487, the slight inward movement of the parking/indicator cut-out on the front fender assembly. NB: *"While not recorded in contemporary publications at the time, this was done in the UK because of legislation introduced in some European markets that the parking (side) lights centre point should line up with the centre point of the headlights. While the modified front mudguards were introduced for the Australian assembled MGB as these panels came on line, the indicator/parking light units remained reversed compared to the UK built product, till the introduction of the YGHN9 models with their recessed grilles."* (Tom Aczel, 2013)
