BODY

The MGB's body was a major change in engineering direction for MG. The decision was made to use the monocoque construction method that they had used on the ZA Magnette sedan. The body was made of steel, with aluminium bonnet (until 1969).

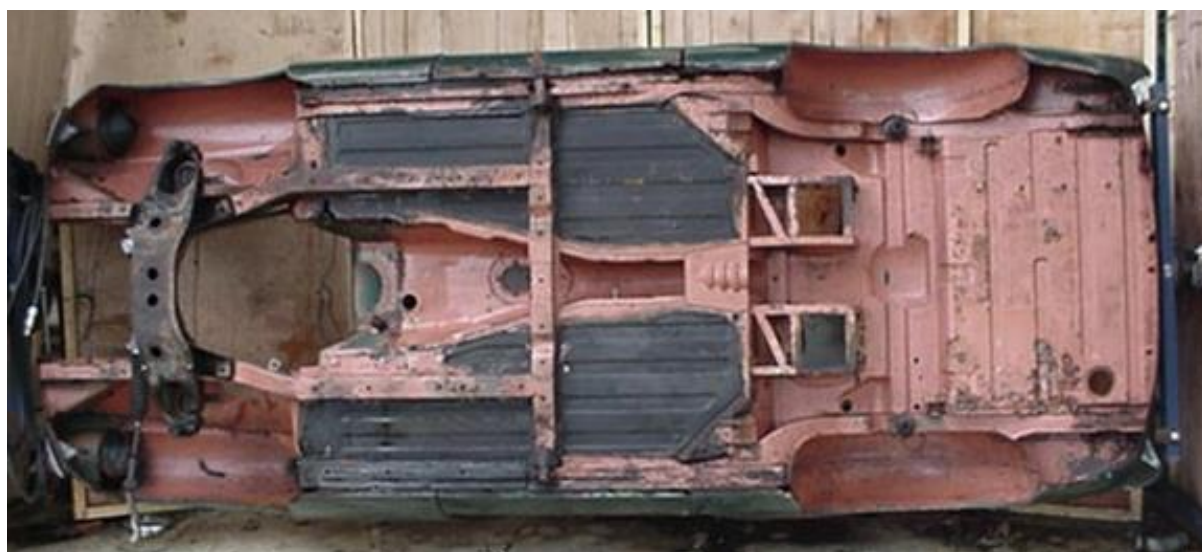
Photo showing monocoque construction (photo: mg.net)

The bones of the vehicle comprised of two side members (front) which ran back to a cross member behind the gearbox. The front of these side members were held by a removable front suspension cross member (which was bolted on). The rear side members, which curved over the rear axle, were linked with the double-sectioned sills (sill closing and side member) (see photo below). All this was reinforced by: floor pans, transmission tunnel, boot floor, bulkhead, dashboard, door posts and a variety of panels, all adding strength to the construction. Apart from the front wings (which were bolted on), everything else was spot-welded.

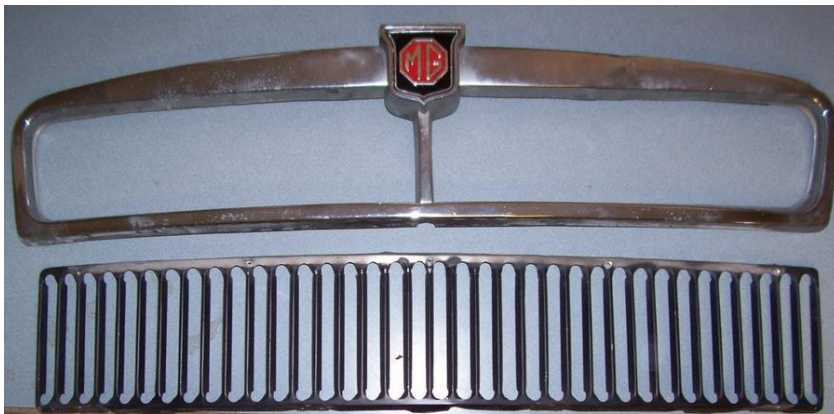
Later grille (Mk I & II). Grille made of pressed aluminium.

Thereafter, from vehicle YGHN3/1930, the grille, including the slats, were made from one-piece pressed aluminium. (p/no. ARH 218). The fittings didn't alter.

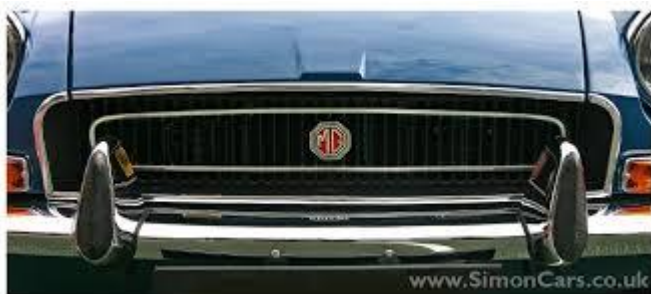
Mk II (facelift) grille

With the introduction of the Mk II (facelift), the grille changed its appearance; recessed black vertical slats with a 'D'-shaped chrome insert (laying on its back). In the centre was a new MG logo

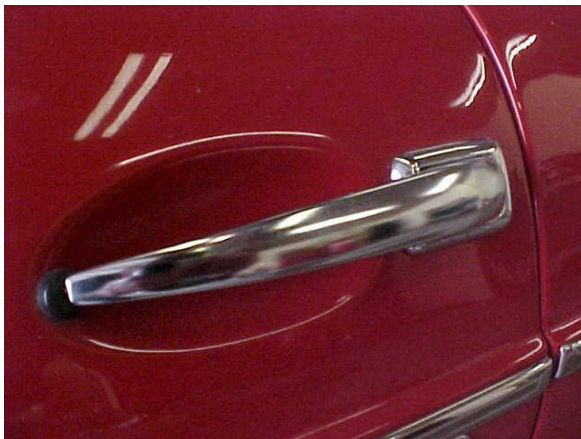
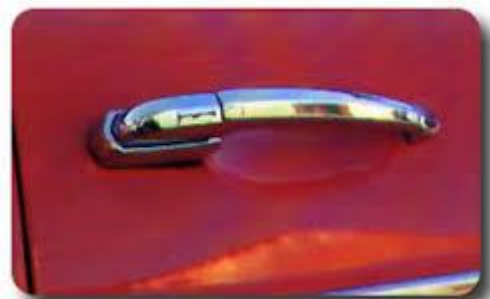
Early 'pull' handle c/f later 'push button'

Around 1965, the doors were also slightly modified to accommodate the change from 'pull-out' handles to the 'push-button'.

The pull handle (p/no AHH6661 & AHH6662) was fitted to cars YGHN3 501 - 2268.

From YGHN3 2269, the push-button (p/no AHH7452 [not handed]) was fitted. There is however, a subsequent listing of a variant [also not handed] (p/no AHH8885) but no changeover date listed (Leacy list it as '1965 -'1980).

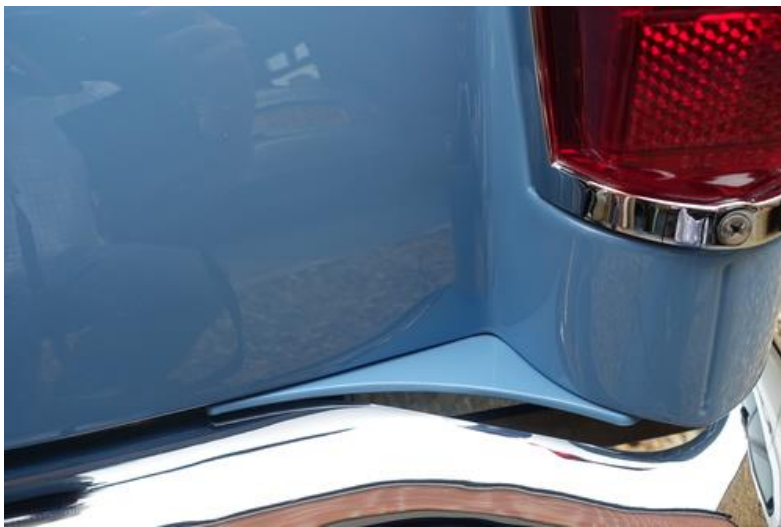
Early, large, painted bumper infill

On the early Mk I cars (YGHN3/501 – YGHN3/100), the infills between the rear bumper and the body (next to tail lights) were painted body colour.

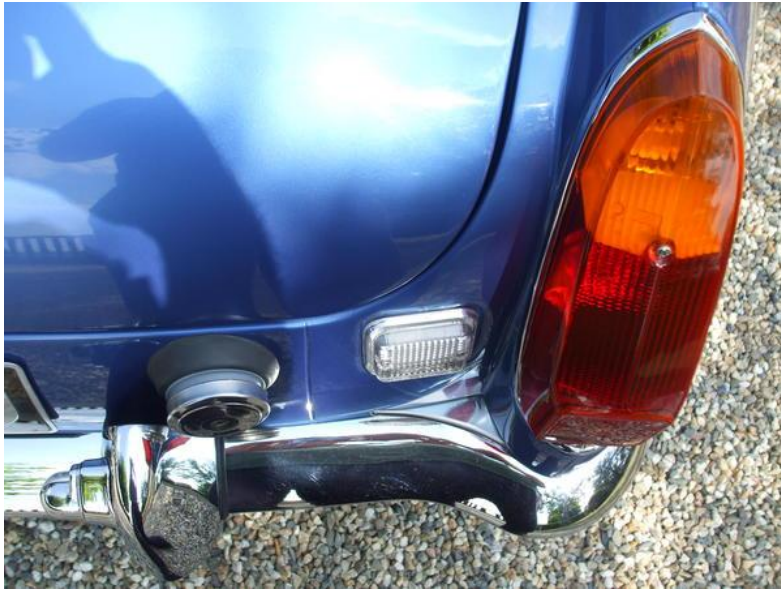
Later smaller bumper infill (polished alloy)

Thereafter (YGHN3/1001) they were smaller and polished aluminium.

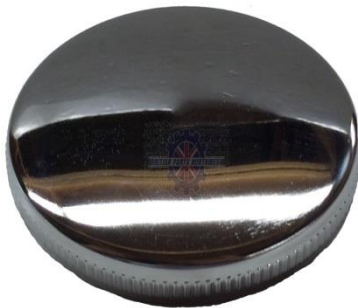
Petrol caps were the non-lockable, vented type. Plain stainless steel with grooves around the circumference

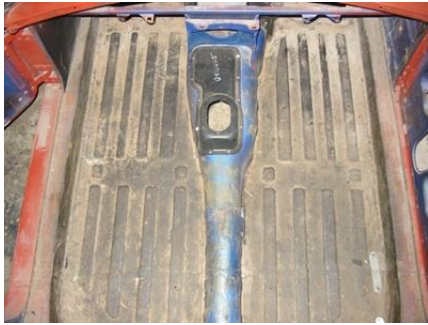
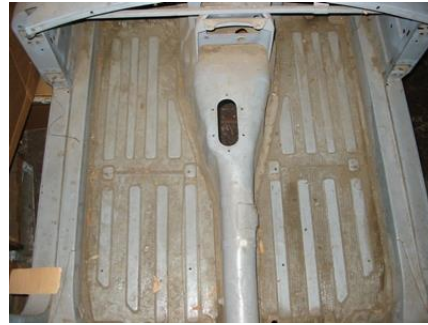
Figure 1 Early 3-sync tunnel c/f wider 4-sync tunnel. Compare the ribs on both sides to see the difference

Most of the changes occurred with the introduction of the Mk II series (YGHN 4 onwards); A wider gearbox tunnel was introduced to accommodate the new automatic gearbox configuration .

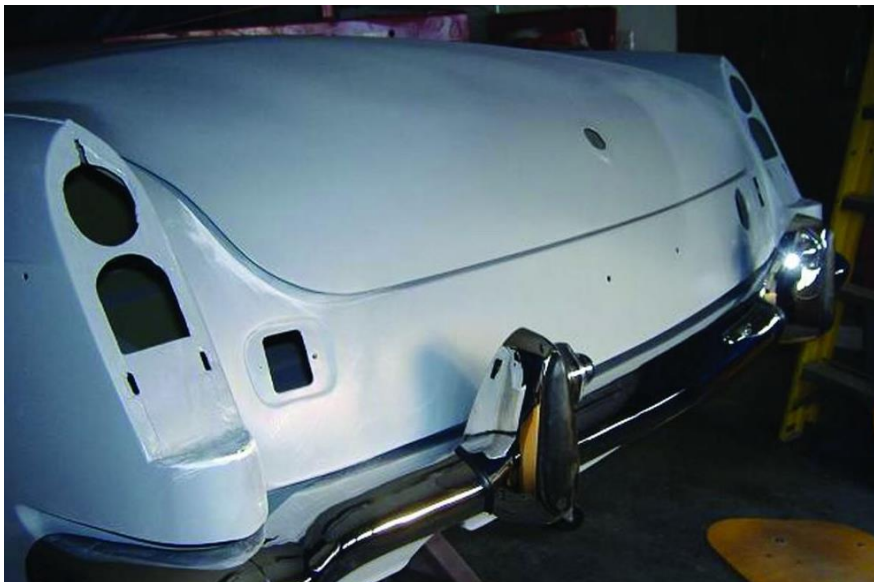
This photo shows the pressings made for the reverse lights (photo: A Helgeson)

Pressed cut-outs for the inclusion of reversing lights (from car YGHN3/4487)(circa June 1967)

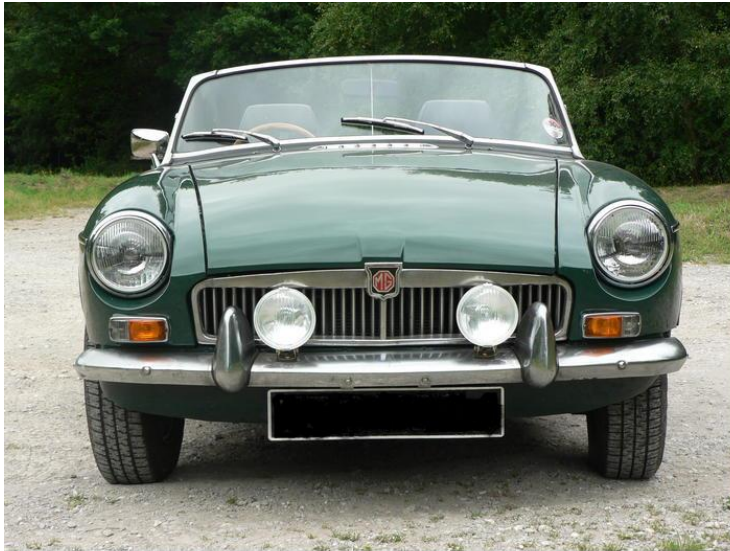
There is no better way to show this change. This car has mismatched guards. Look at the distance the park lights are from the grille.

Also, from car YGHN3/4487, the slight inward movement of the parking/indicator cut-out on the front fender assembly. NB: *“While not recorded in contemporary publications at the time, this was done in the UK because of legislation introduced in some European markets that the parking*

(side) lights centre point should line up with the centre point of the headlights. While the modified front mudguards were introduced for the Australian assembled MGB as these panels came on line, the indicator/parking light units remained reversed compared to the UK built product, till the introduction of the YGHN9 models with their recessed grilles.” (Tom Aczel,2013)
