BODY

The MGB's body was a major change in engineering direction for MG. The decision was made to use the monocoque construction method that they had used on the ZA Magnette sedan. The body was made of steel, with aluminium bonnet (until 1969).

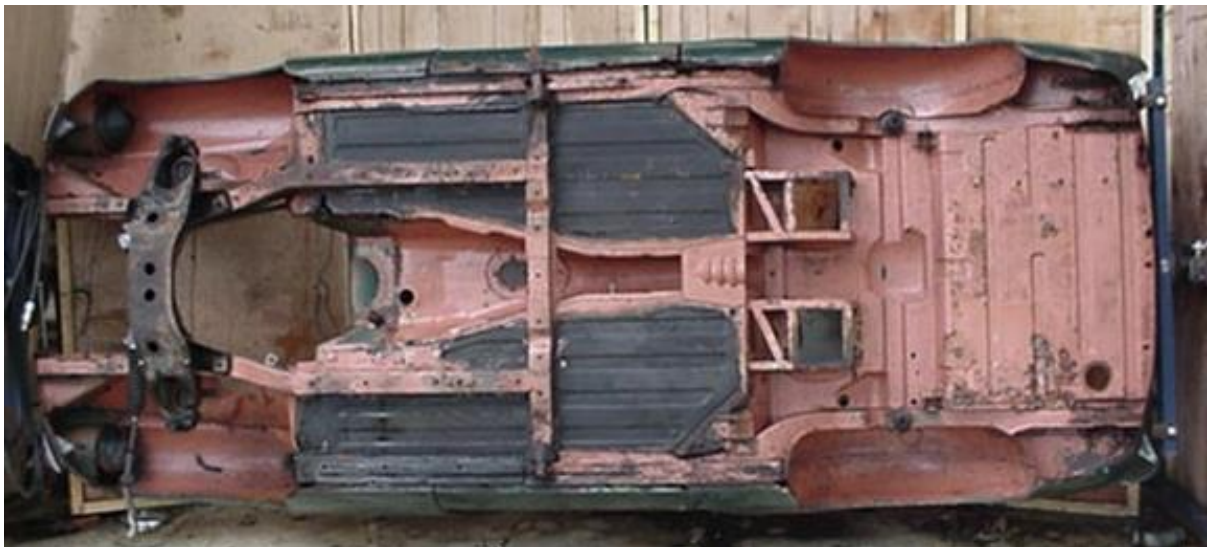
Photo showing monocoque construction (photo: mg.net)

The bones of the vehicle comprised of two side members (front) which ran back to a cross member behind the gearbox. The front of these side members were held by a removable front suspension cross member (which was bolted on). The rear side members, which curved over the rear axle, were linked with the double-sectioned sills (sill closing and side member) (see photo below). All this was reinforced by: floor pans, transmission tunnel, boot floor, bulkhead, dashboard, door posts and a variety of panels, all adding strength to the construction. Apart from the front wings (which were bolted on), everything else was spot-welded.

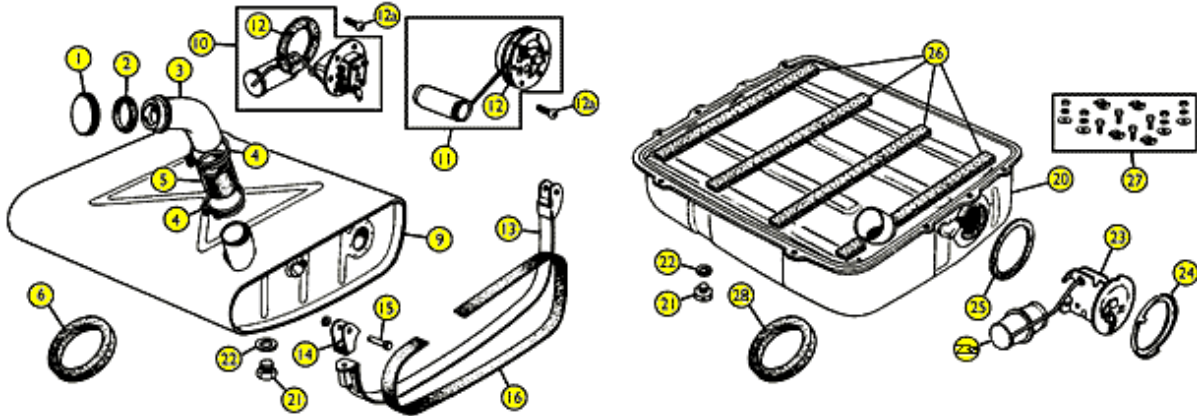
Both tanks – 10 gal and 12.7 gal (on right)

1965 saw modification to the boot floor to allow for the change of fuel tanks, from the 10 gallon tank (which was attached by straps), to the 12.7 gallon tank which was bolted to the boot floor. This change started with YGHN3/2246 and from YGHN3/2258 onwards.

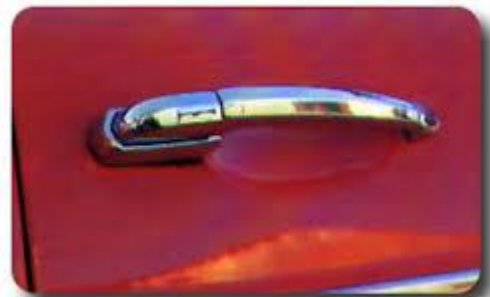
Early 'pull' handle c/f later 'push button'

Around 1965, the doors were also slightly modified to accommodate the change from 'pull-out' handles to the 'push-button'.

The pull handle (p/no AHH6661 & AHH6662) was fitted to cars YGHN3 501 - 2268.

From YGHN3 2269, the push-button (p/no AHH7452 [not handed]) was fitted. There is however, a subsequent listing of a variant [also not handed] (p/no AHH8885) but no changeover date listed (Leacy list it as '1965 -'1980).

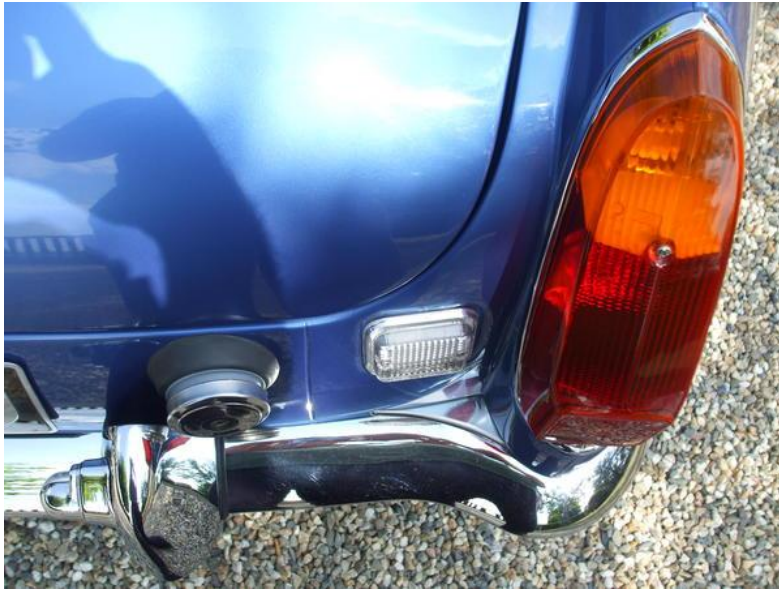
Later smaller bumper infill (polished alloy)

Thereafter (YGHN3/1001) they were smaller and polished aluminium.

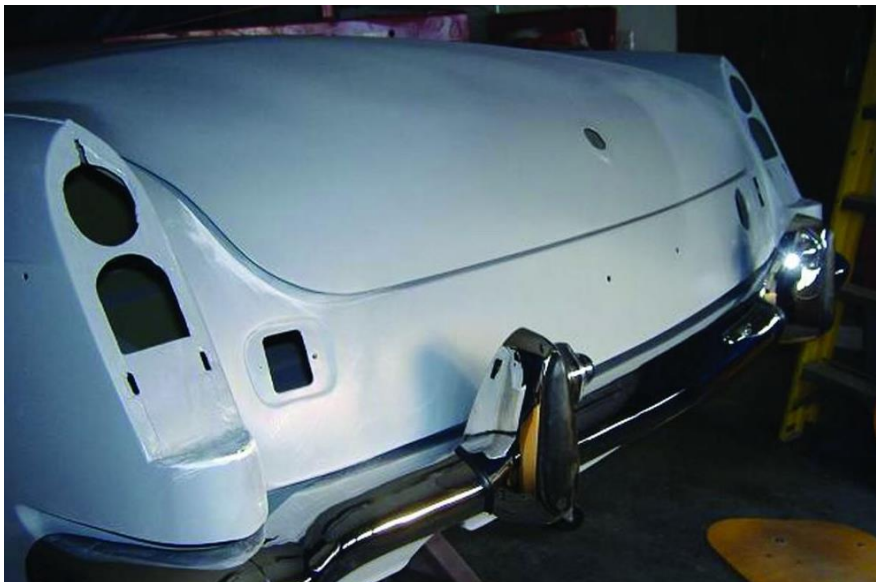
This photo shows the pressings made for the reverse lights (photo: A Helgeson)

Pressed cut-outs for the inclusion of reversing lights (from car YGHN3/4487)(circa June 1967)

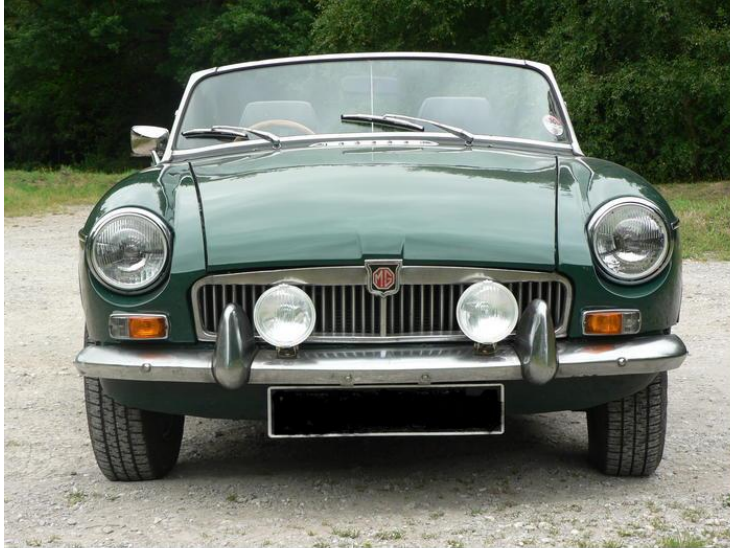
There is no better way to show this change. This car has mismatched guards. Look at the distance the park lights are from the grille.

Also, from car YGHN3/4487, the slight inward movement of the parking/indicator cut-out on the front fender assembly. NB: *“While not recorded in contemporary publications at the time, this was done in the UK because of legislation introduced in some European markets that the parking*

(side) lights centre point should line up with the centre point of the headlights. While the modified front mudguards were introduced for the Australian assembled MGB as these panels came on line, the indicator/parking light units remained reversed compared to the UK built product, till the introduction of the YGHN9 models with their recessed grilles.” (Tom Aczel,2013)
