# THE MGB CASE OF "THE BENDS"

By Tom Aczel

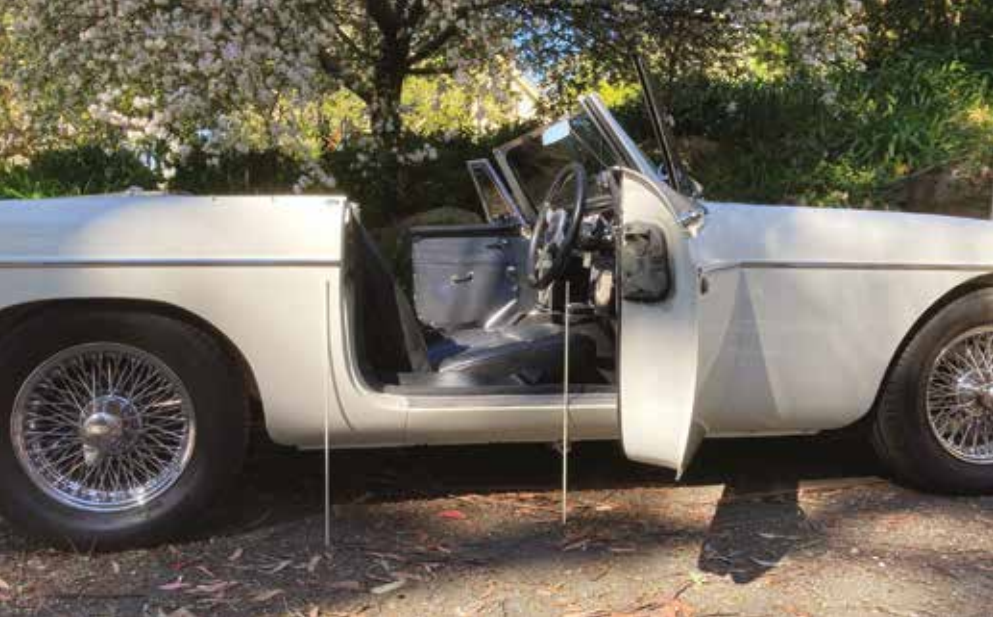
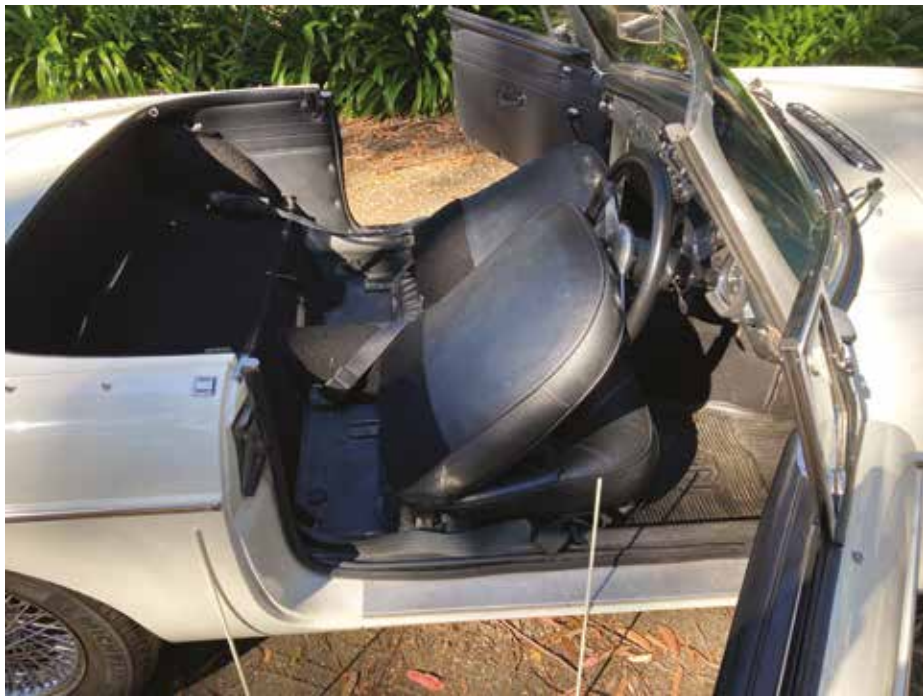
MGB engine bay at the front, or into the boot at the back. These members are of course also visible if you look under the car. *Insert the two photos of the yellow MGB from below here.* The surprising thing (to me) however is that these longitudinal members don't join up - there's a big gap

between them! The front members finish at the level of the jacking apertures that you can readily see from the side of the car, roughly just 1/3 the way along the door apertures and the rear members finish at the front of the rear bulkhead, a little distance behind the door apertures.
