# BADGES

Badging on Australian-assembled vehicles pretty much followed the UK development, with some notable differences.

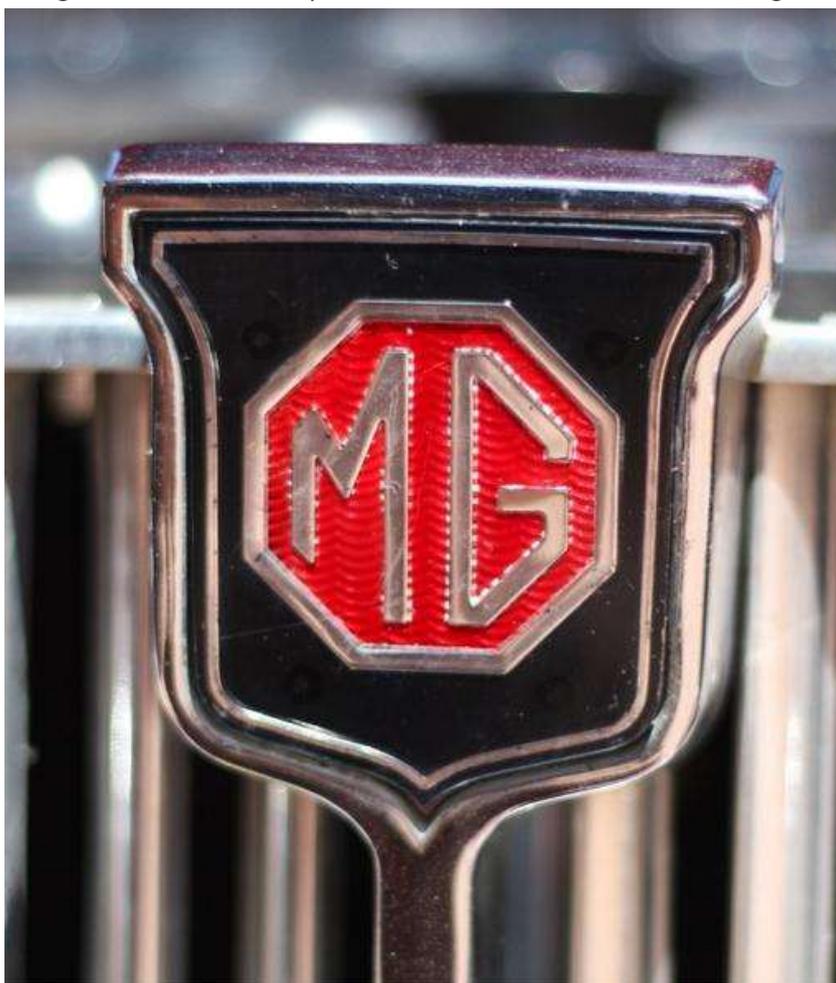
- **radiator grille:** a chromed plinth was situated in the centre of the grille with a black, plastic shield, edged in chrome paint. In the centre was a chrome-painted octagon. Inside the octagon was the chrome-painted 'MG', on a red, curtained background.

Early grille badge (photo: A. Brown)

With the possible exception on the very first cars (see Note 1), this badge remained the same right through to 1970 in Australia. The badge was changed with the introduction of the Mk II 'facelift' vehicles; with the recessed grille, a totally new emblem was situated still in the centre of the new grille.

*Note 1: For safety reasons the very first badge was changed as it was found that the paint/colour used on the curtained background was reflective. It is believed that this took place prior to full production in UK. I have not seen an Australian-produced Mk I with one of these badges.*

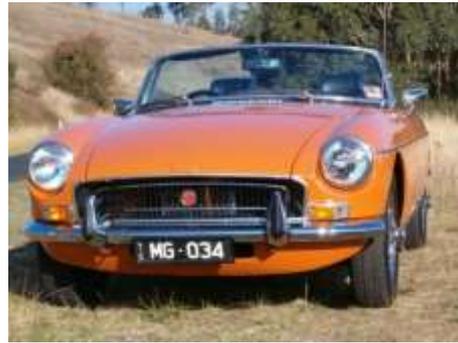
Facelift grille badge

Facelift grille badge positioned

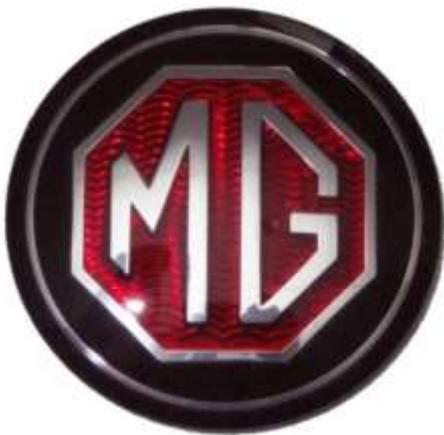
- **steering wheel:** In the centre of the wire-spoked steering wheel was a large plastic horn-push with the MG logo, similar to that of the early grille badge. This remained unchanged until the 1970 (facelift) model.

Early horn-push

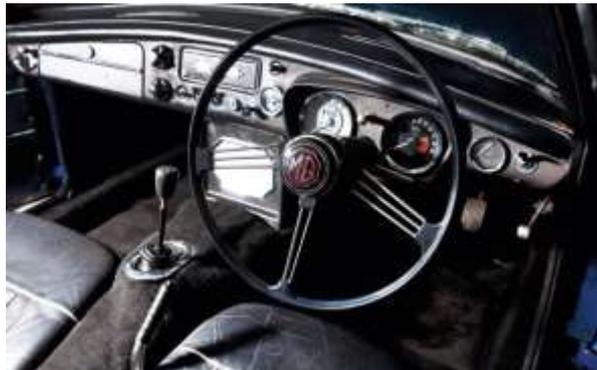
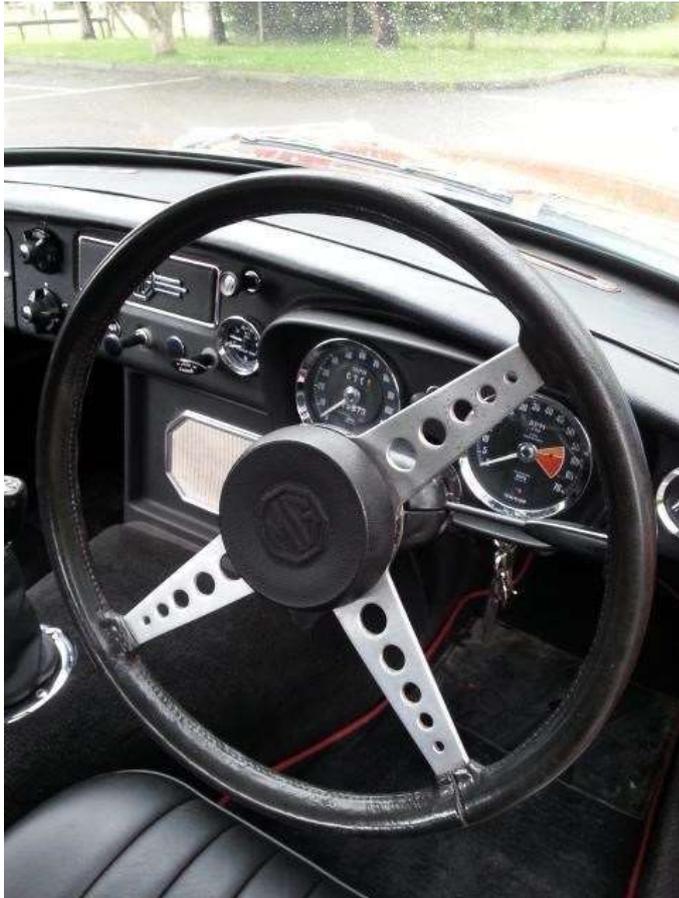
With the change of steering wheels, a different badge was used for the horn-push.

1970 New wheel, new horn push

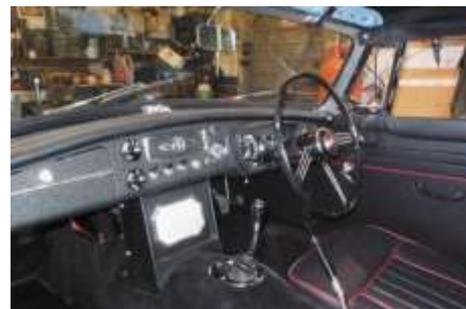
- **radio blanking plate:** The chrome, die-cast MG emblem (looking very art-deco), was positioned on the blanking plate for the radio recess. After fitting a radio, a lot of people, perhaps feeling it was too nice to discard, decided to position this badge elsewhere on the car, but it was only ever used for the radio blanking plate.

Chrome badge on radio blanking plate

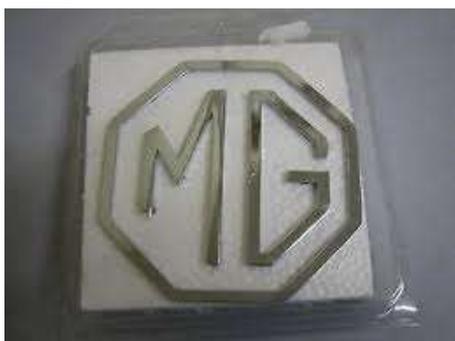
- **boot lid:** On the early Mk I cars, there was a 3-piece, chrome, die-cast 'MG' logo surrounded by an octagon. These were attached inside the boot with clips like the above black clips for the radio blanking plate.

Early 3-piece boot badge

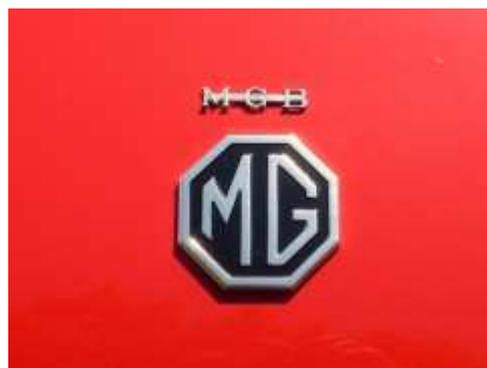
Later, solid boot badge

This badge was changed on the later cars (Mk II facelift) to a solid badge as shown in Fig 6.

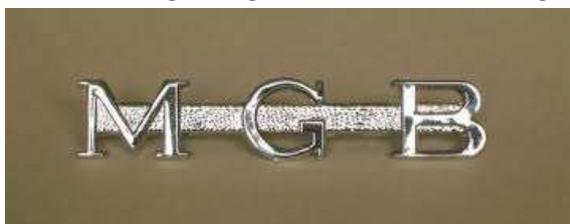
Above the large badge was a small MGB badge with a thick strikethrough

MGB badge with strikethrough

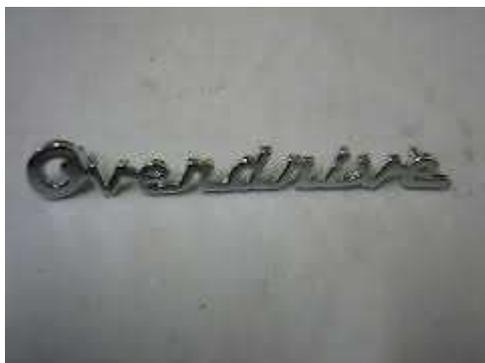
Unique to Australian-assembled cars with overdrive (see Note 2) was the inclusion of a badge below the large MG badge.

Australian 'overdrive' badge

*NB: Some confusion surrounds the placing of the 'overdrive' badge on the last of the YGHN3 vehicles that were still being assembled well after the order for the badges was placed. Some cars received them, some didn't. It is suspected that some dealers, not wanting to appear to be stuck with old stock, had the badges fitted themselves.*

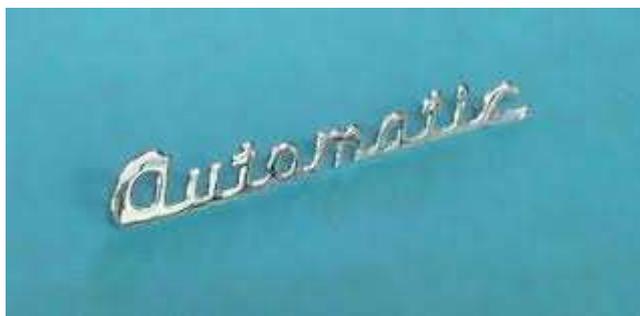
Australian 'automatic' badge

Another unique badge to the Australian market was the use of an 'Automatic' badge on the YGHN7 and YHN10 cars. It was positioned similarly to the 'overdrive' badge.

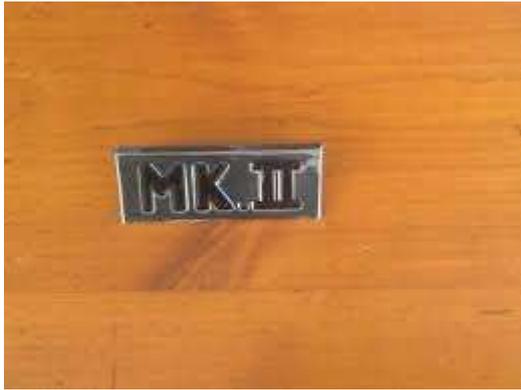
Yet another badge that was unique to Australian-assembled cars (Mk IIs) was the position of a 'Mk II' badge, close to the nearside reversing light. (also see Note 2)

Mk II badge

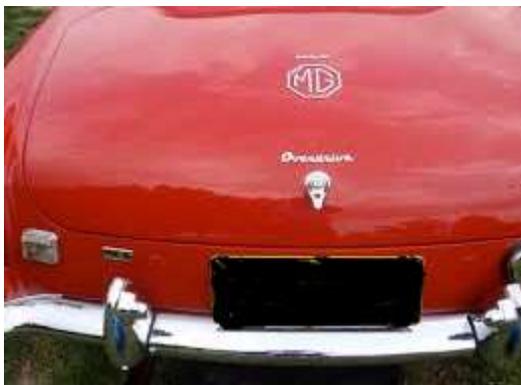
The vehicle in the photo below, shows two of these badges in their designated positions.

Badges position (if 'automatic' then it would go where the 'overdrive' badge is

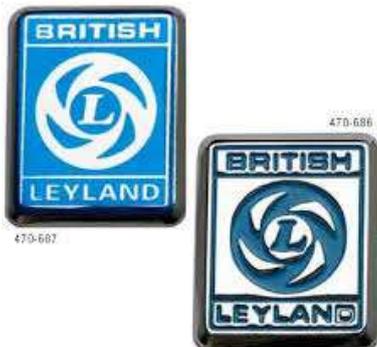
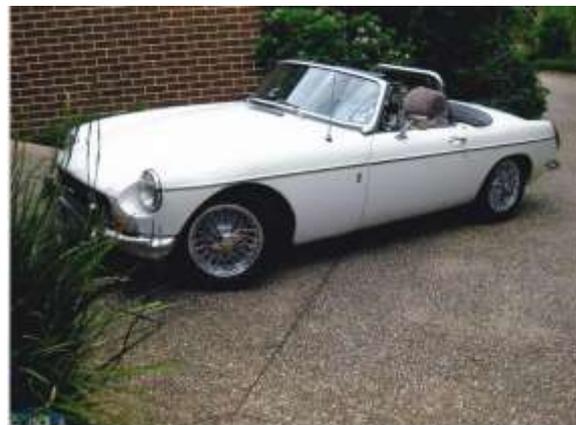
- **Leyland badging:** After the takeover by Leyland, badging was changed to reflect the change of ownership. Some might say subtle, the front guards were graced with a small Leyland logo badge, close to the door. There were two versions of this badge, as shown (colours reversed and one was pressed whilst the other just screen-printed).

Leyland badge (below and right of antennae)
