HOODS

From 1963 to 1970, all Australian-assembled MGBs were sold with a locally produced 'packaway' hood. There was the hood, which was a PVC material, the frame, which came in two separate pieces to be joined and the two bags to carry each part when not in use.

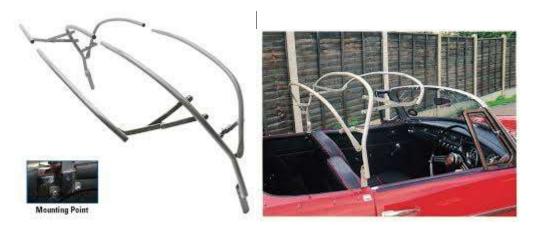
The two separate components (which interlock)

Hood frame assembled

The MGB hood was considered to be a fairly efficient design, with little ingress of water or wind. However, there was always concern about the seams. In 1966, after laboratory testing, instructions were given as to how to treat the hoods with 3M Bitrile sealer (complete instructions found in 'Good Stuff'). In 1968, a more serious attempt at rectifying the problems was carried out at Zetland, from YGHN4/669 onwards. Seams were double-stitched; needle size reduced from 22 to 20; redesign of hood at A post for appearance and water sealing; redesign of flap attachment at B post area to overcome draught issues and a jig made to improve fitment.

Another attempt to solve the issue with the seams in 1969, this time using Carson's Polyurethane Trim Sealer (complete instructions found in 'Good Stuff'). It seemed the problem was never going to go away.

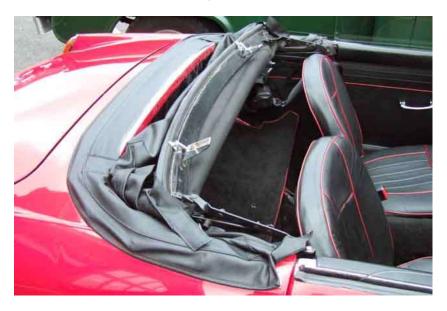
Finally, it seemed that the previous issues with sealing were resolved. From cars YHN9/1063 and YHN10/537, a new foldaway hood with welded seams was introduced.

Michelotti fold-away hood (this one has zip-out rear window)

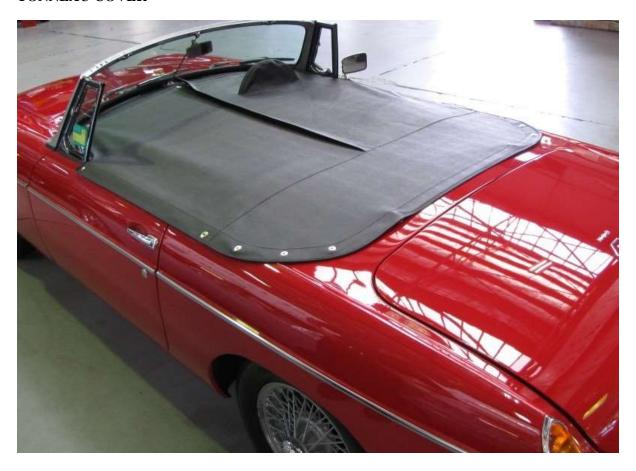
Optional Tonneau cover

Always an optional extra in Australia, the tonneau cover came in a variety of sizes and patterns. At the time (and I guess today also) many auto trim firms would make them.
