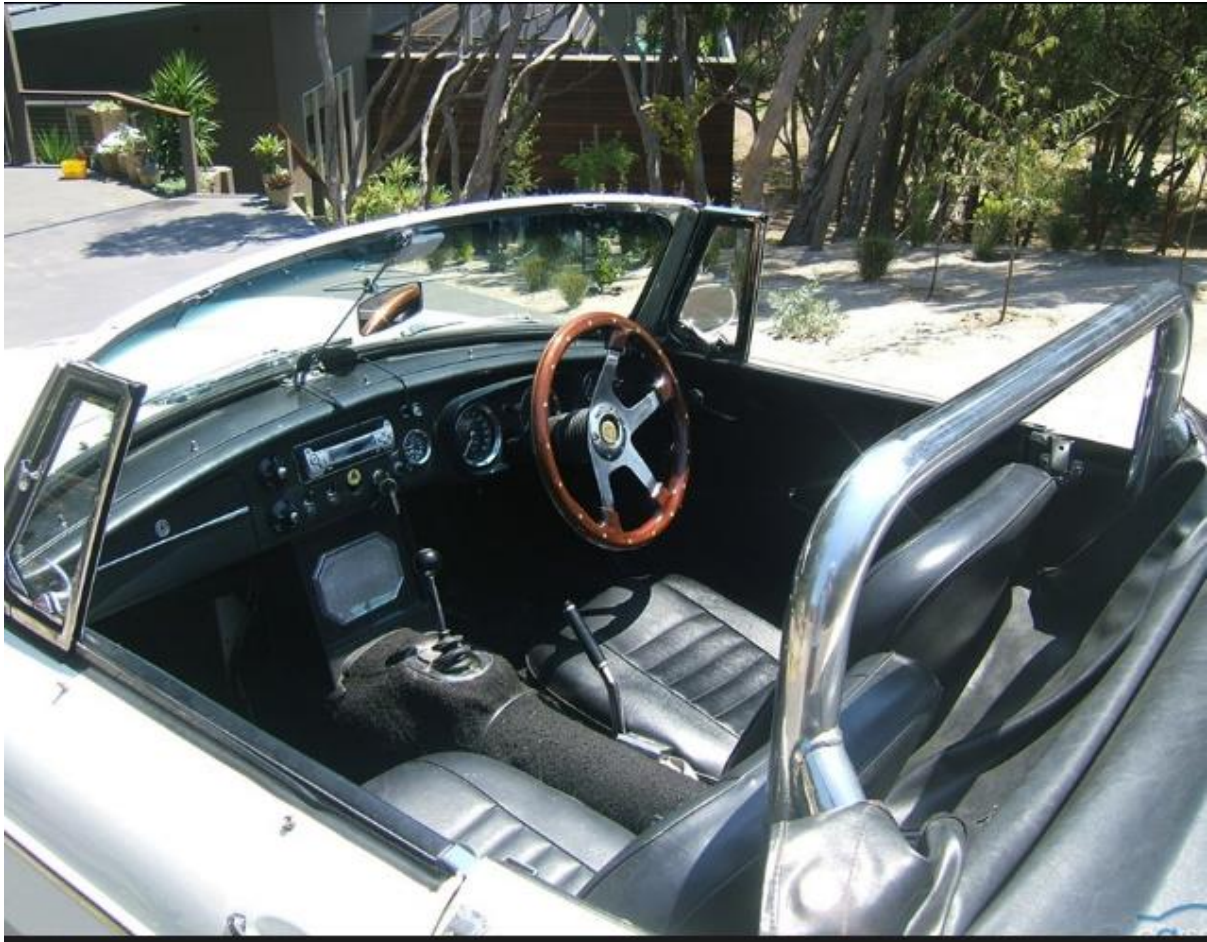
Narrow gearbox tunnel on YGHN3/5166 (note the hump below the gear lever and the overall narrowness of the tunnel)

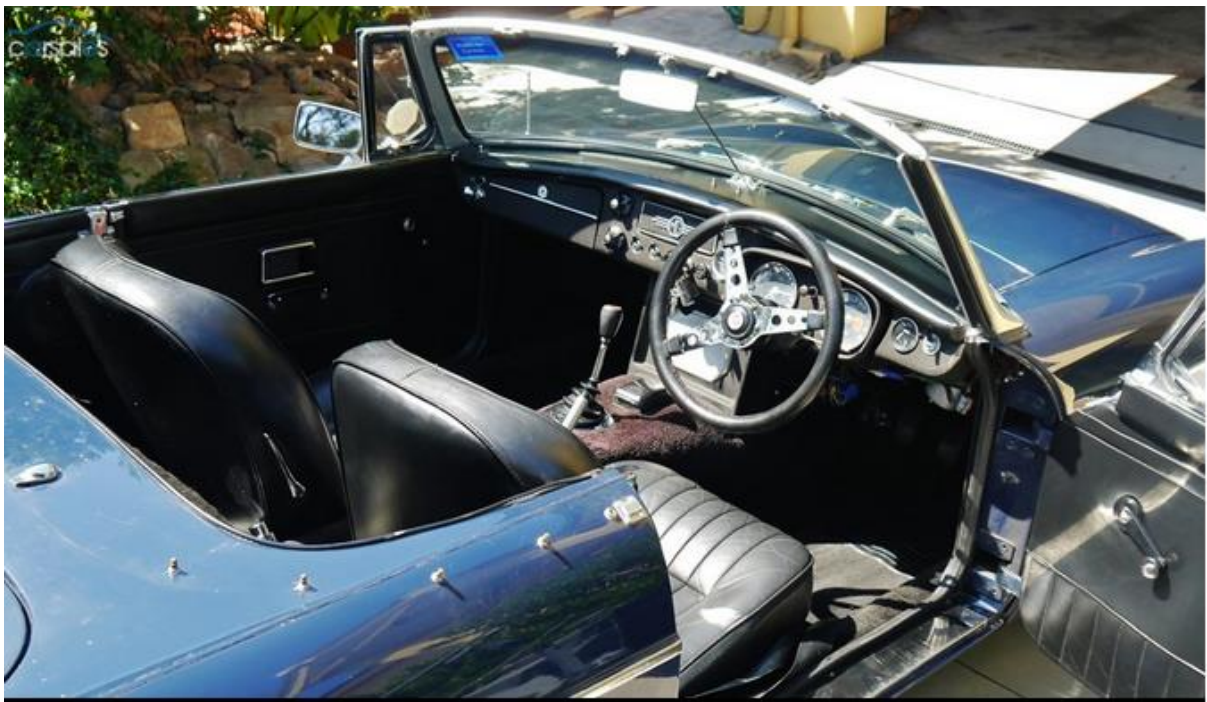
1968 Wide tunnel on a YGHN4 (note that the hump has gone and the tunnel is flatter and wider)
