BADGES

Badging on Australian-assembled vehicles pretty much followed the UK development, with some notable differences.

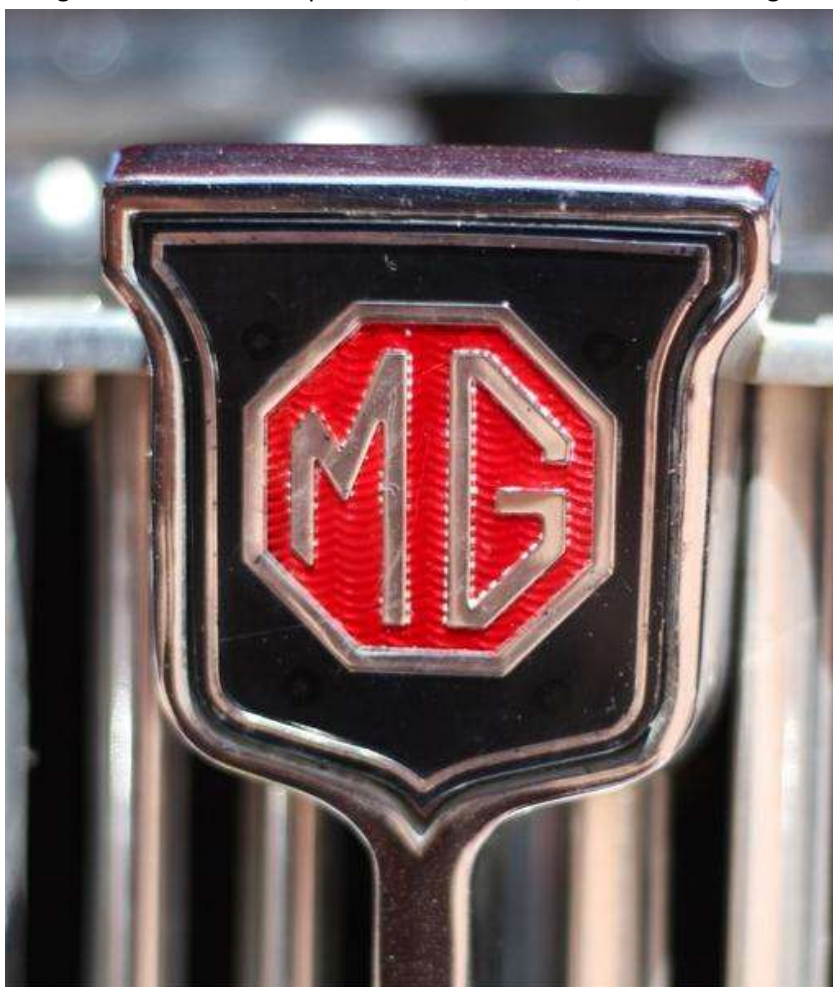
- **radiator grille:** a chromed plinth was situated in the centre of the grille with a black, plastic shield, edged in chrome paint. In the centre was a chrome-painted octagon. Inside the octagon was the chrome-painted 'MG', on a red, curtained background.

Early grille badge (photo: A. Brown)

With the possible exception on the very first cars (see Note 1), this badge remained the same right through to 1970 in Australia. The badge was changed with the introduction of the Mk II 'facelift' vehicles; with the recessed grille, a totally new emblem was situated still in the centre of the new grille.

Note 1: For safety reasons the very first badge was changed as it was found that the paint/colour used on the curtained background was reflective. It is believed that this took place prior to full production in UK. I have not seen an Australian-produced Mk I with one of these badges.

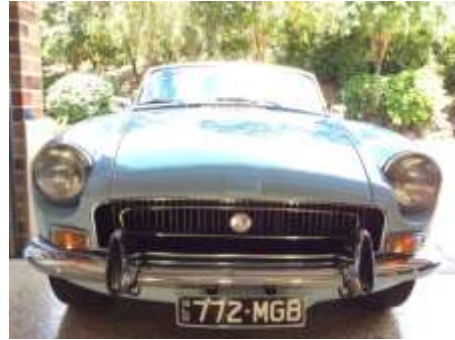
Facelift grille badge positioned Photo: P Rogers

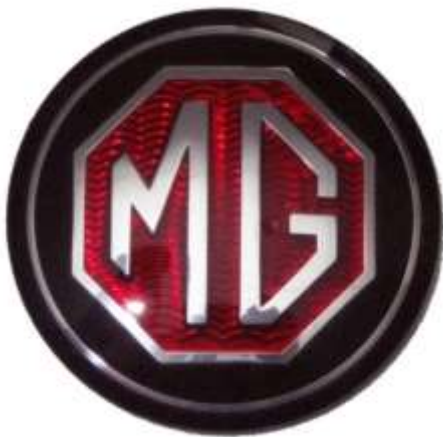
- **steering wheel:** In the centre of the wire-spoked steering wheel was a large plastic horn-push with the MG logo, similar to that of the early grille badge. This remained unchanged until the 1970 (facelift) model.

Early horn-push

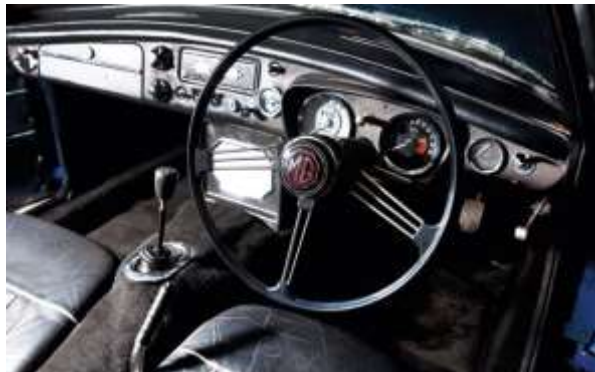
Mk I steering wheel showing early horn push

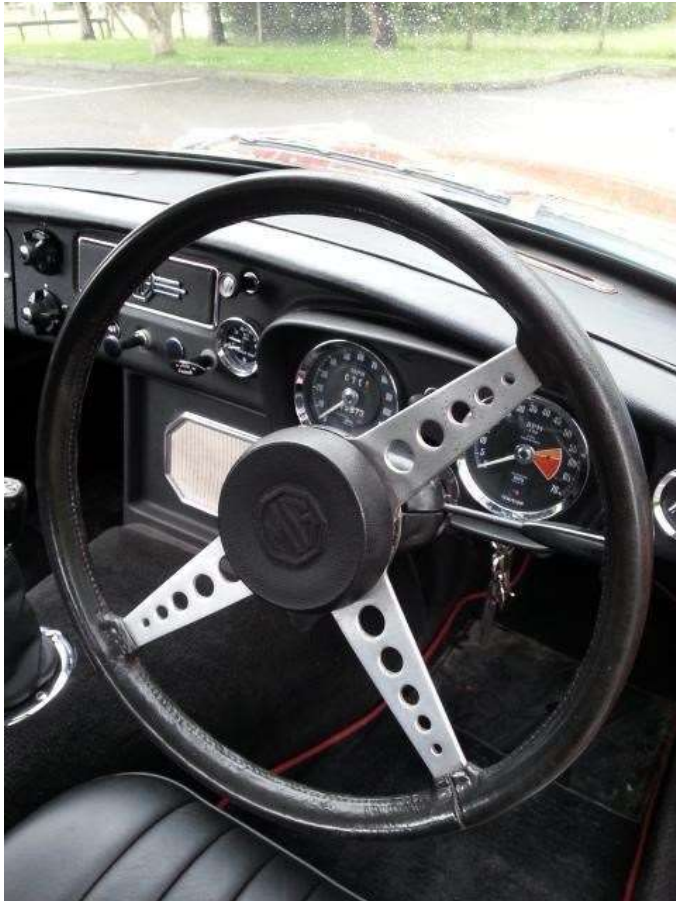
With the change of steering wheels, a different badge was used for the horn-push.

1970 New wheel, new horn push

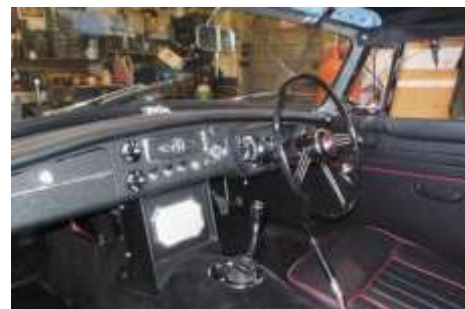
- **radio blanking plate:** The chrome, die-cast MG emblem (looking very art-deco), was positioned on the blanking plate for the radio recess. After fitting a radio, a lot of people, perhaps feeling it was too nice to discard, decided to position this badge elsewhere on the car, but it was only ever used for the radio blanking plate.

Chrome badge on radio blanking plate

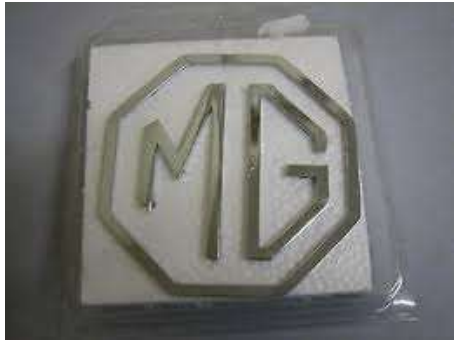
- **boot lid:** On the early Mk I cars, there was a 3-piece, chrome, die-cast 'MG' logo surrounded by an octagon. These were attached inside the boot with clips like the above black clips for the radio blanking plate.

Early 3-piece boot badge

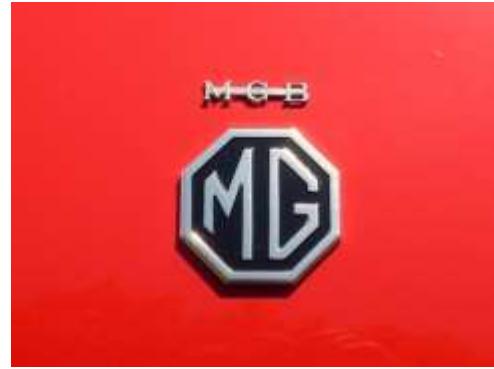
Later, solid boot badge

This badge was changed on the later cars (Mk II facelift) to a solid badge.

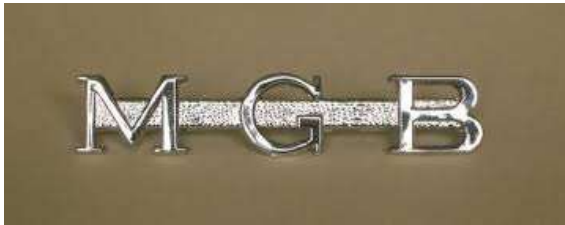
Above the large badge was a small MGB badge, showing the letters 'MGB' with a thick strikethrough.

MGB badge with strikethrough

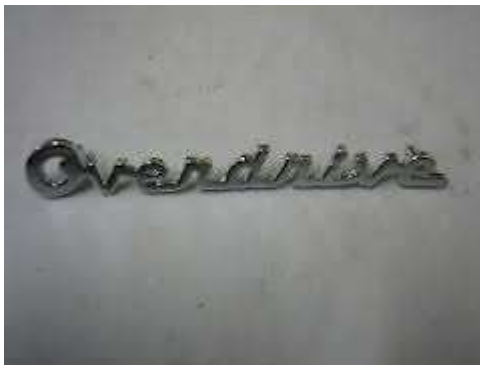
Unique to Australian-assembled cars with overdrive *(see Note below)* was the inclusion of a badge below the large MG badge.

Australian 'overdrive' badge

Note: Some confusion surrounds the placing of the 'overdrive' badge on the last of the YGHN3 vehicles that were still being assembled well after the order for the badges was placed. Some cars received them, some didn't. It is suspected that some dealers, not wanting to appear to be stuck with old stock, had the badges fitted themselves.

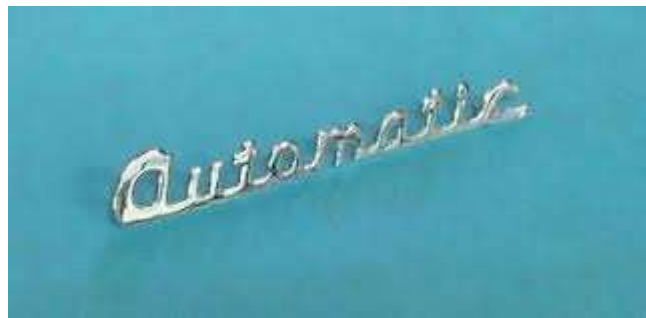
Australian 'automatic' badge

Another unique badge to the Australian market was the use of an 'Automatic' badge on the YGHN7 and YHN10 cars. It was positioned similarly to the 'overdrive' badge.

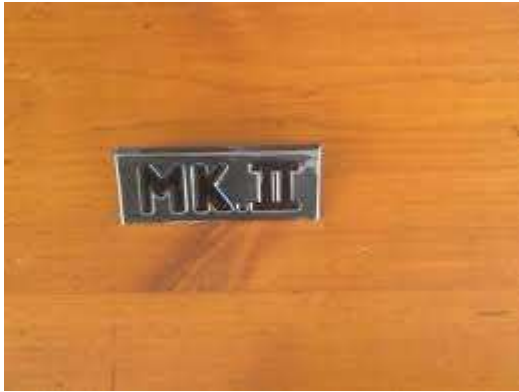
Yet another badge that was unique to Australian-assembled cars (Mk IIs) was the position of a 'Mk II' badge, close to the nearside reversing light. *(also see Note below)*

Mk II badge

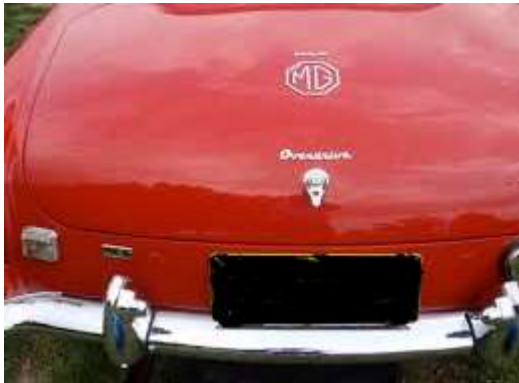
The vehicles in the photos below, show these badges in their designated positions.

Badges on Mk II with overdrive

(if the vehicle was an 'automatic' then the badge (*Automatic*) would go where the 'overdrive' badge is)

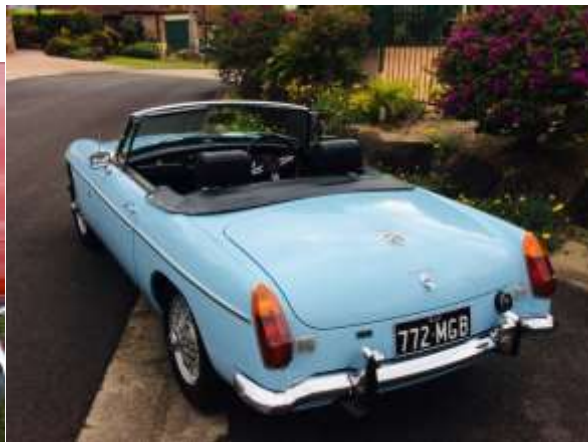
Badges on MGBL

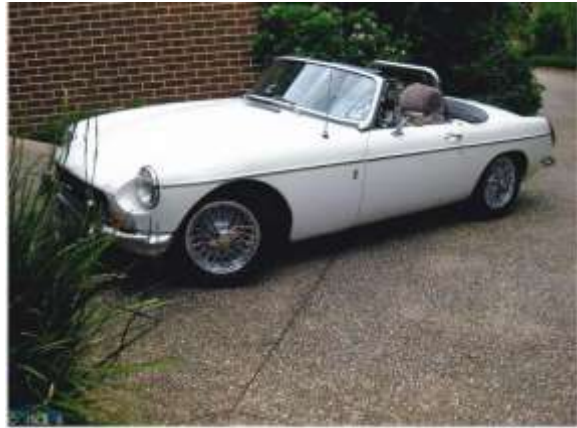
- **Leyland badging:** After the takeover by Leyland, badging was changed to reflect the change of ownership. Some might say subtle, the front guards were graced with a small Leyland logo badge, close to the door. There were two versions of this badge, as shown (colours reversed and one was pressed whilst the other just screen-printed).

Leyland badge (below and right of antennae)
