BADGES

Badging on Australian-assembled vehicles pretty much followed the UK development, with some notable differences.

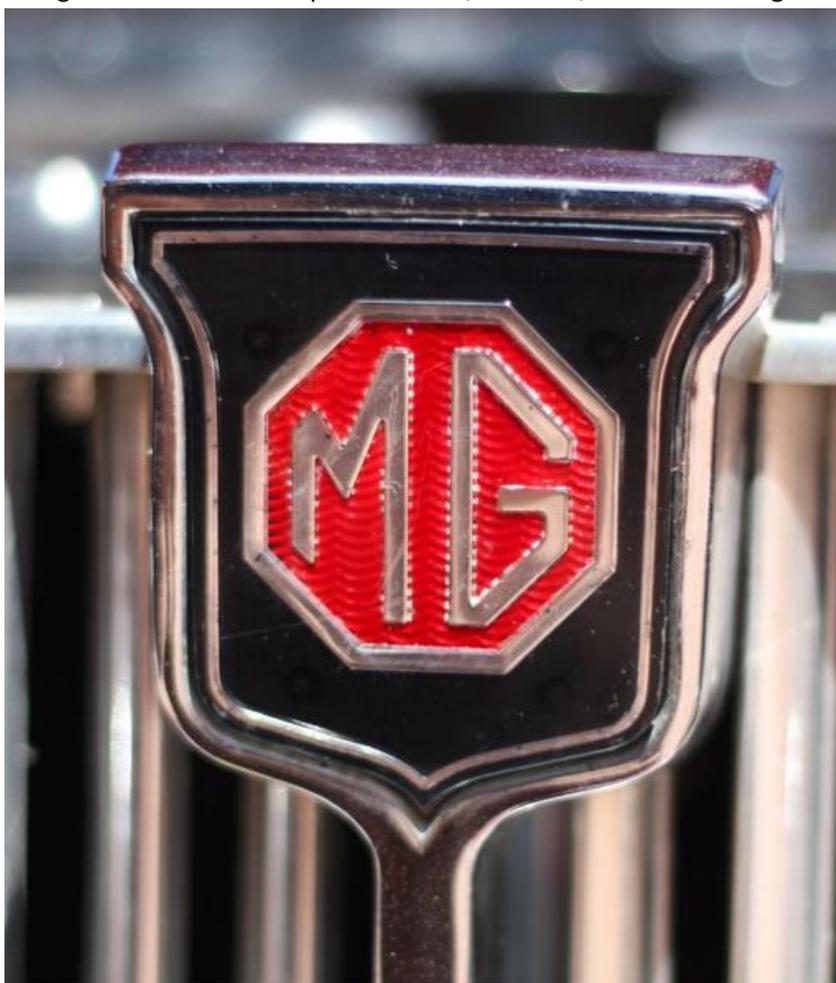
- **radiator grille:** a chromed plinth was situated in the centre of the grille with a black, plastic shield, edged in chrome paint. In the centre was a chrome-painted octagon. Inside the octagon was the chrome-painted 'MG', on a red, curtained background.

Early grille badge (photo: A. Brown)

With the possible exception on the very first cars (see Note 1), this badge remained the same right through to 1970 in Australia. The badge was changed with the introduction of the Mk II 'facelift' vehicles; with the recessed grille, a totally new emblem was situated still in the centre of the new grille.

Note 1: For safety reasons the very first badge was changed as it was found that the paint/colour used on the curtained background was reflective. It is believed that this took place prior to full production in UK. I have not seen an Australian-produced Mk I with one of these badges.

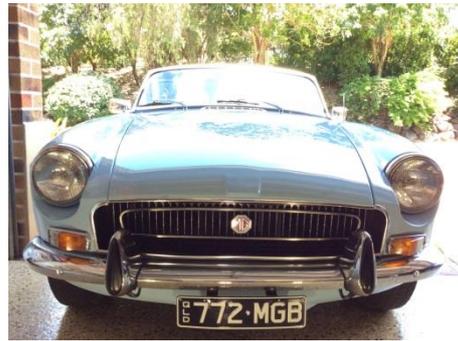
Facelift grille badge positioned Photo: P Rogers

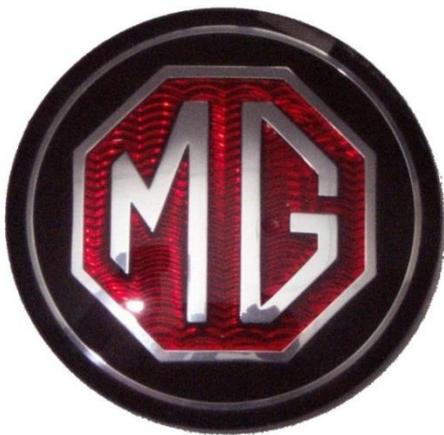
- **steering wheel:** In the centre of the wire-spoked steering wheel was a large plastic horn-push with the MG logo, similar to that of the early grille badge. This remained unchanged until the 1970 (facelift) model.

Early horn-push

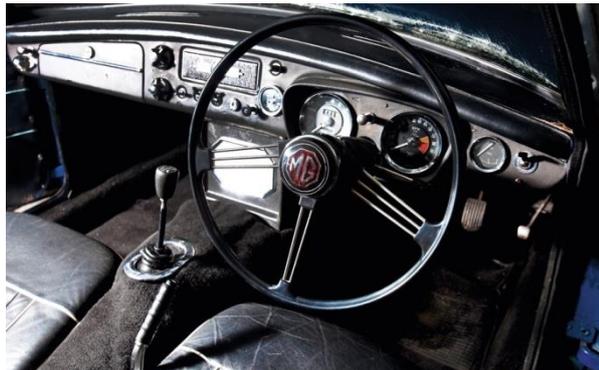
Mk I steering wheel showing early horn push

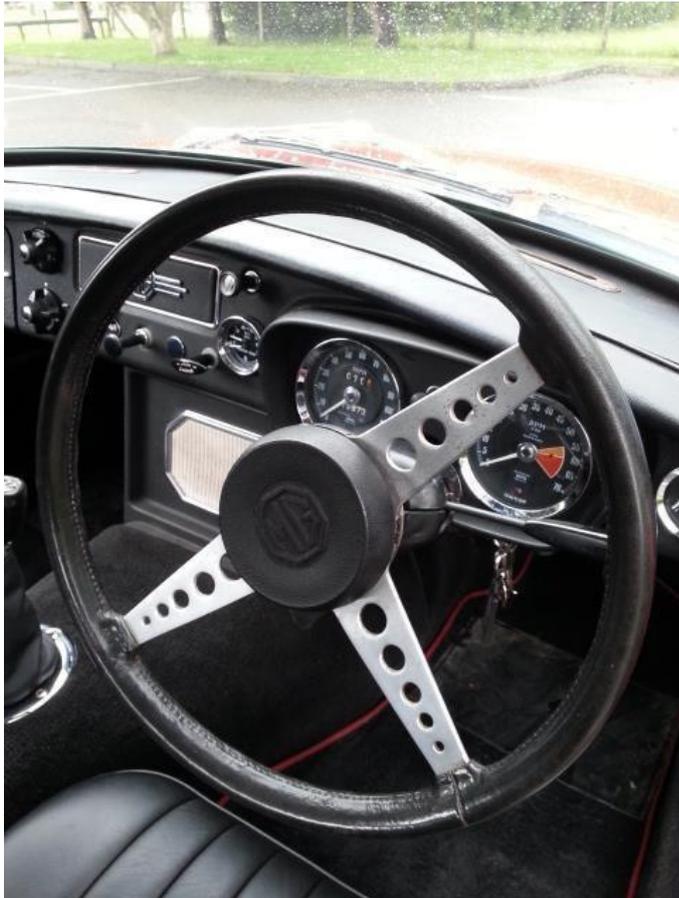
With the change of steering wheels, a different badge was used for the horn-push.

1970 New wheel, new horn push

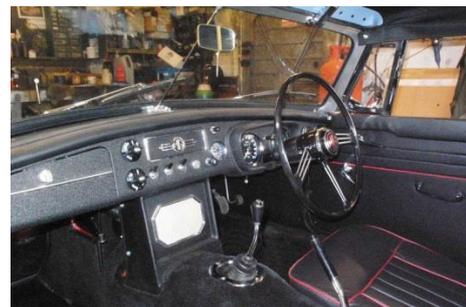
- **radio blanking plate:** The chrome, die-cast MG emblem (looking very art-deco), was positioned on the blanking plate for the radio recess. After fitting a radio, a lot of people, perhaps feeling it was too nice to discard, decided to position this badge elsewhere on the car, but it was only ever used for the radio blanking plate.

Chrome badge on radio blanking plate

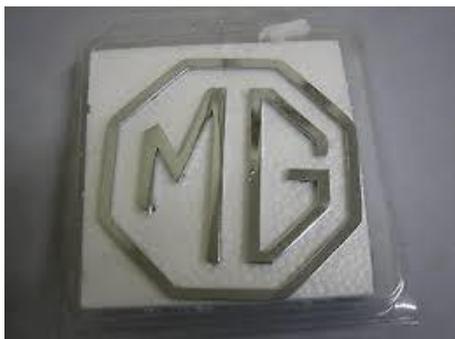
- **boot lid:** On the early Mk I cars, there was a 3-piece, chrome, die-cast 'MG' logo surrounded by an octagon. These were attached inside the boot with clips like the above black clips for the radio blanking plate.

Early 3-piece boot badge

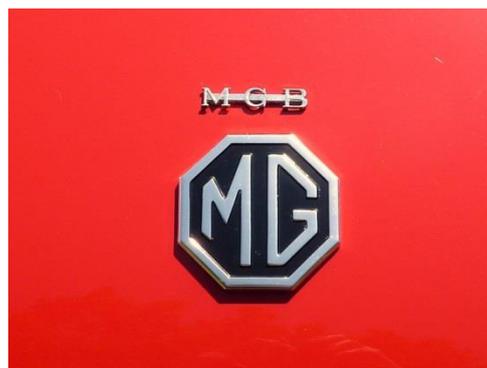
Later, solid boot badge

This badge was changed on the later cars (Mk II facelift) to a solid badge.

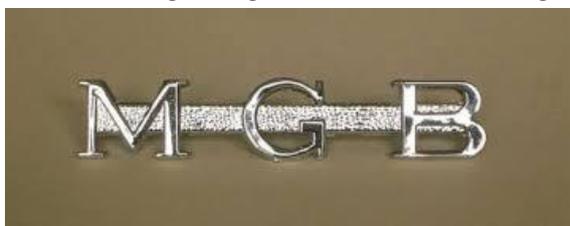
Above the large badge was a small MGB badge, showing the letters 'MGB' with a thick strikethrough.

MGB badge with strikethrough

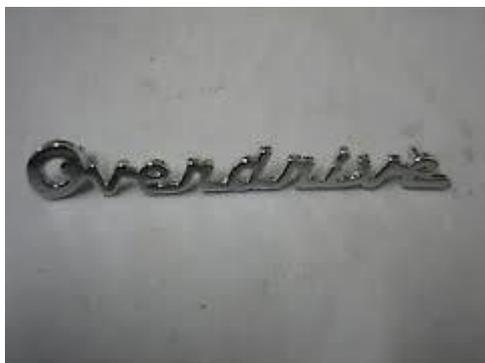
Unique to Australian-assembled cars with overdrive (*see Note below*) was the inclusion of a badge below the large MG badge.

Australian 'overdrive' badge

Note: Some confusion surrounds the placing of the '**overdrive**' badge on the last of the YGHN3 vehicles (Mk 1) that were still being assembled well after the order for the badges was placed. Some cars received them, some didn't. It is suspected that some dealers, not wanting to appear to be stuck with old stock, had the badges fitted themselves.

I eventually concluded that the overdrive badge was fitted only from the Mk II overdrive cars. The earlier overdrive cars' badges would have been fitted by dealers or owners.

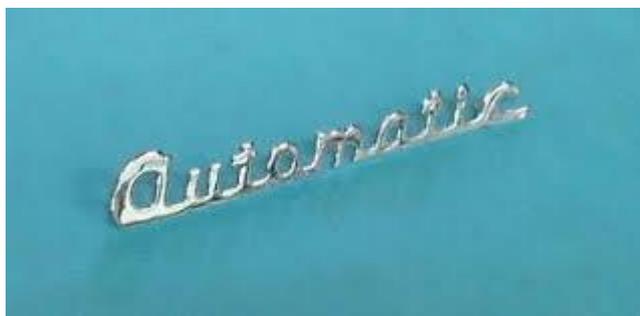
Australian 'automatic' badge

Another unique badge to the Australian market was the use of an 'Automatic' badge on the YGHN7 and YHN10 cars. It was positioned similarly to the 'overdrive' badge.

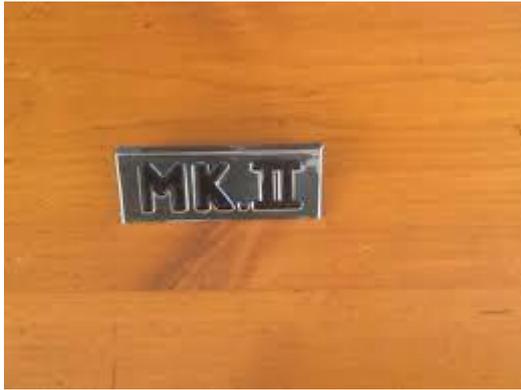
Yet another badge that was unique to Australian-assembled cars (Mk IIs) was the position of a 'Mk II' badge, close to the nearside reversing light. (*also see Note below*)

Mk II badge

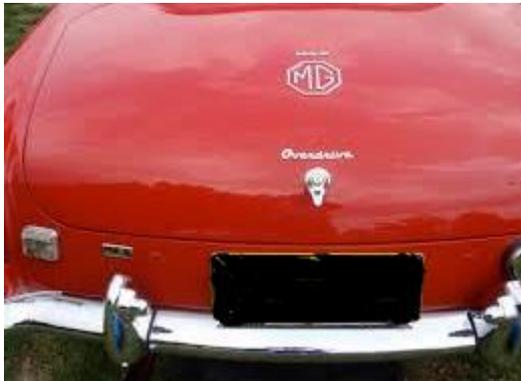
The vehicles in the photos below, show these badges in their designated positions.

Badges on Mk II with overdrive

(if the vehicle was an 'automatic' then the badge (*Automatic*) would go where the 'overdrive' badge is)

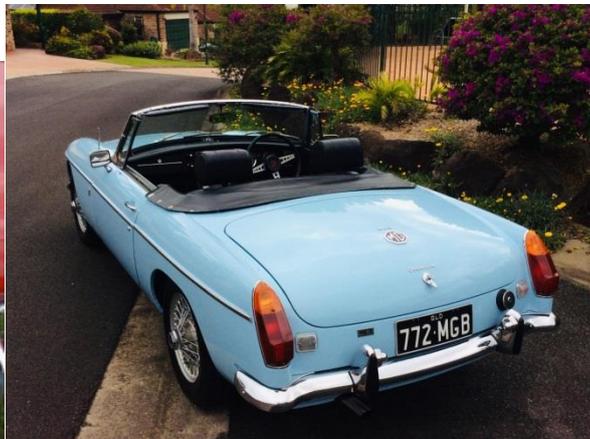
Badges on MGBL

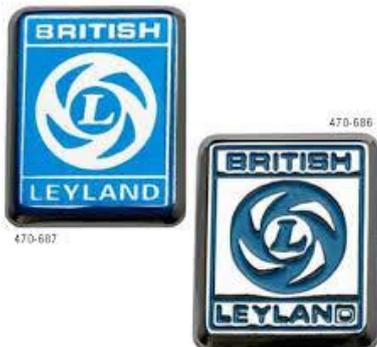
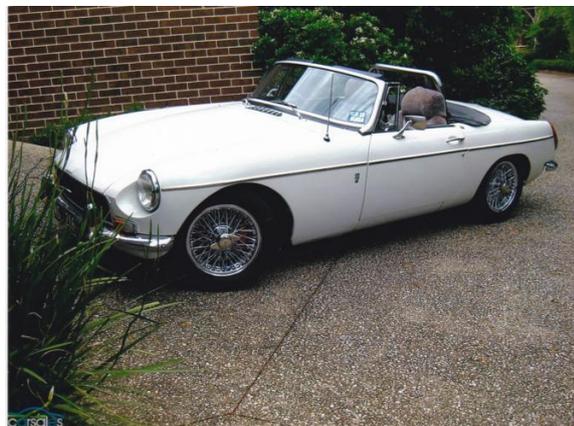
Leyland badge (below and right of antennae)
